Tree Health Assessment

Level II

15302 Salmonberry Ave

Project: 2 Douglas firs

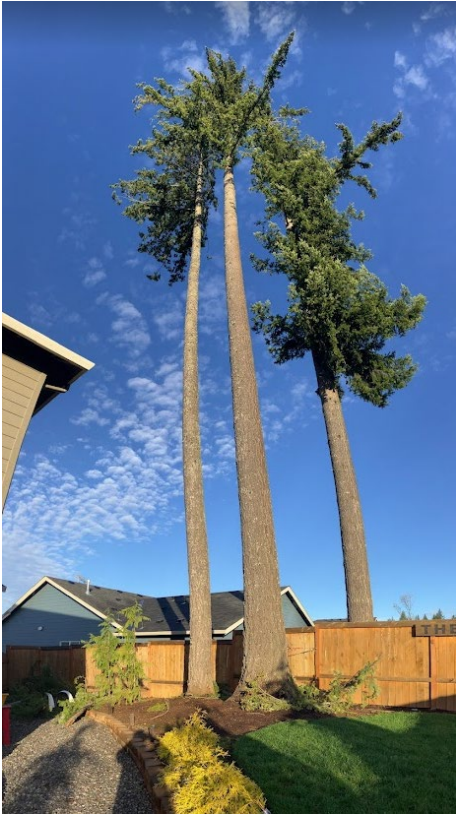
Image 1: Client's trees and neighbor's last standing tree

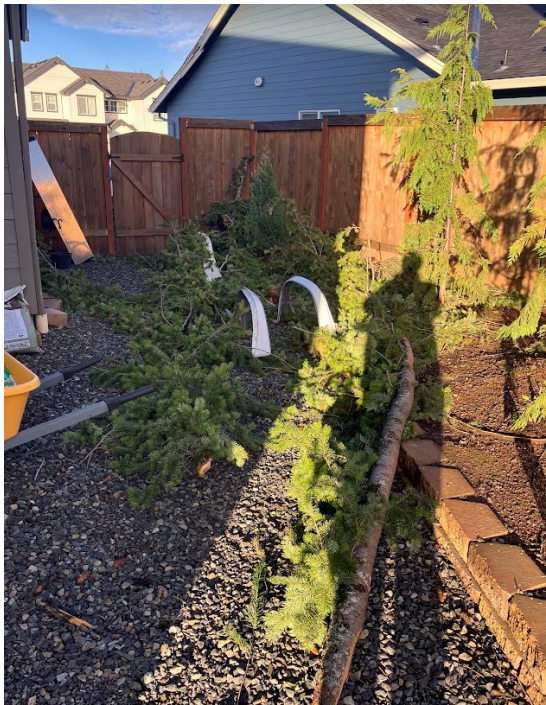
Image 2: Failing branches

Tree risk can be eliminated by removing the trees or the targets. My recommendation for risk mitigation is to remove both of the Douglas-firs and replant with native species though the homeowner has planted multiple native species on the property. Both trees have drastically dropped their branches which is most likely due to new exposure to wind loads from the neighboring tree removals. In addition, both trees have Doug-fir beetle and aphids which increases the likelihood of failures in the future and negatively impacts the health of the trees. There is too much irreversible damage that even with a plant health care program the trees would likely not improve. The removal recommendation will eliminate the risk factor. I am also working with the next-door neighbor to assess the damage/risk of the trees on their property.

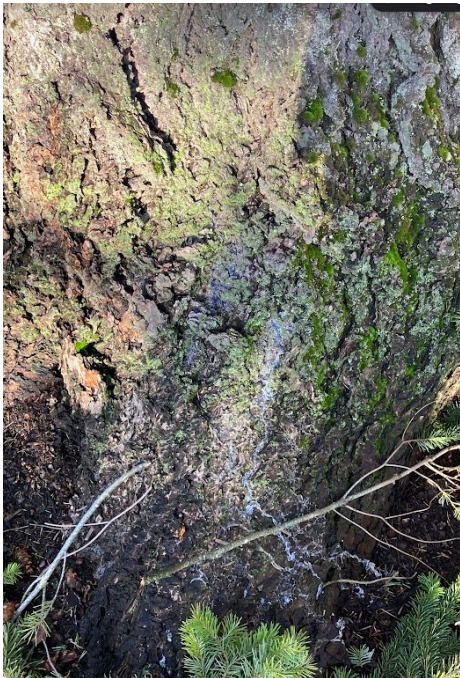
Image 3: Aphid honeydew

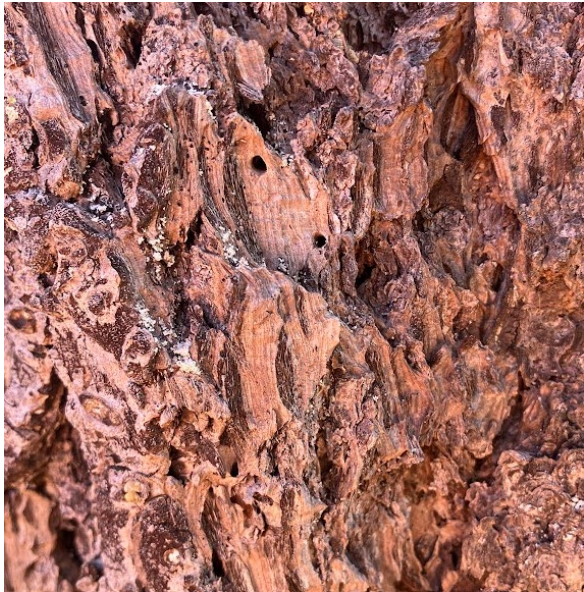
Image 4: Doug-fir beetle exit holes

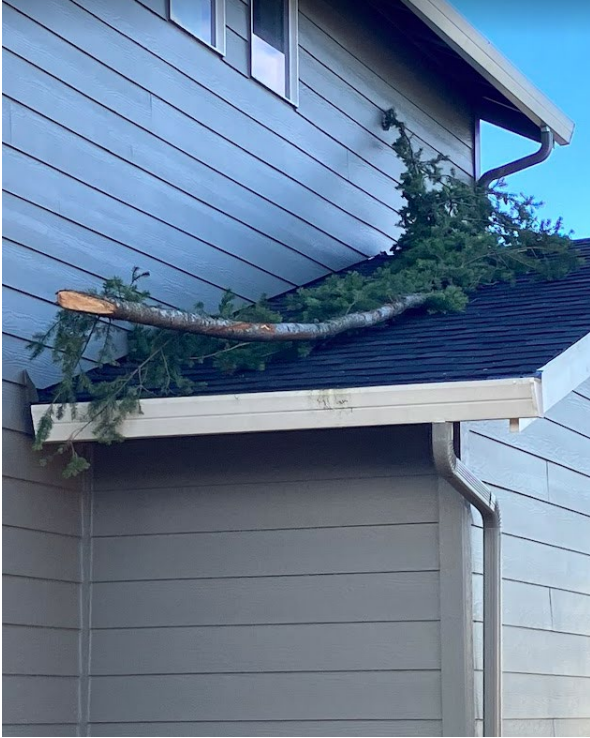
Image 5: Failed branch on client's house

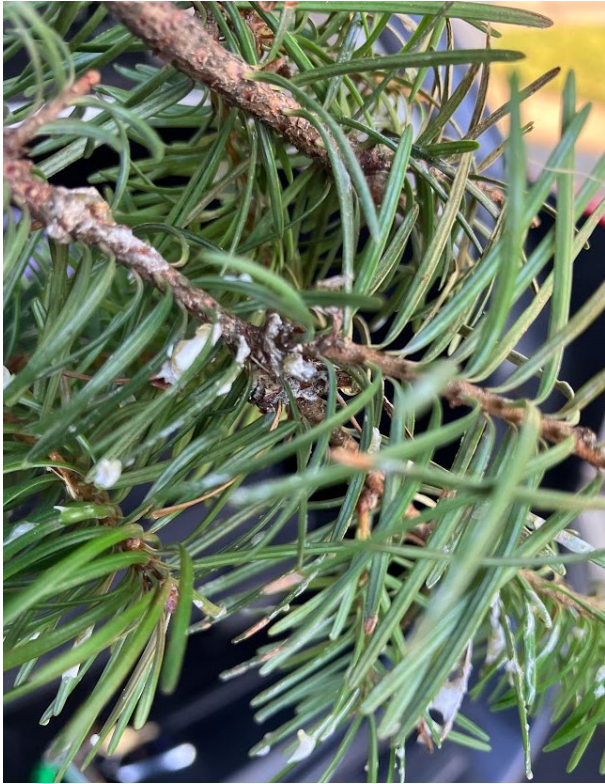
Image 6: Evidence of Doug-fir beetle and aphids
