4/21/2022

Jim Raze  
Raze Custom Homes, Inc.  
4020 NE 216th Ave  
Fairview, OR 97024

**RE: Level II, Basic Tree Risk Assessment for Three (3) Trees in Jewelberry Ridge Subdivision**

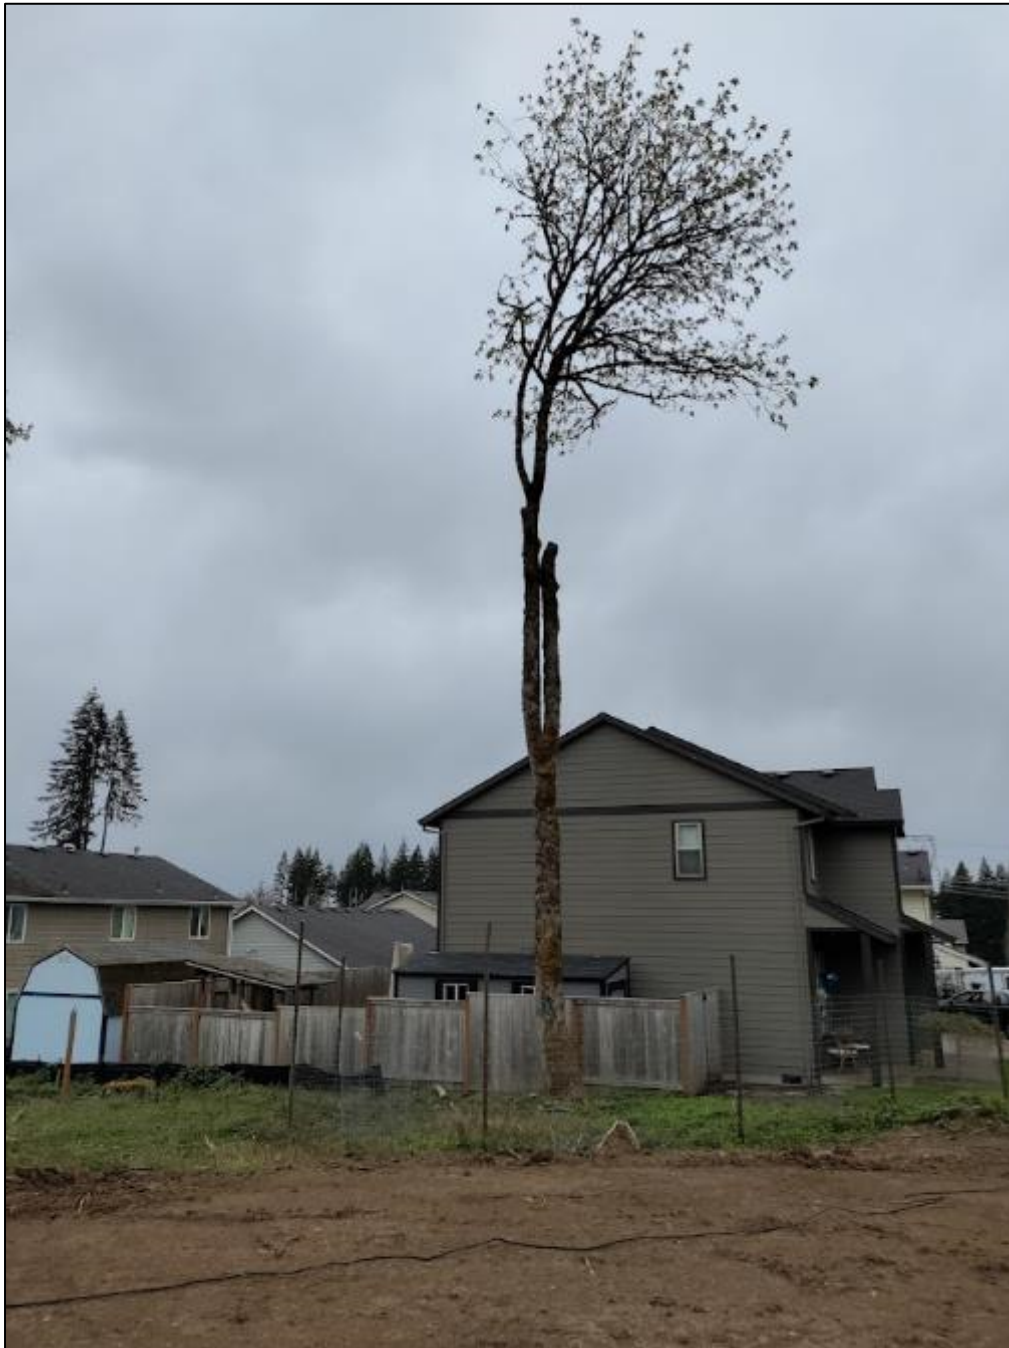
Tree #26 is a 21" DBH bigleaf maple (*Acer macrophyllum*). The tree was not tagged and is assumed to be tree #26 based on distances to nearby structures and the site map provided. It is 70-75' tall. The tree is in poor health and poor structural condition. Mechanical damage was observed on a surface root, 16" east of the trunk. Girdling roots are present on the south side of the trunk flare. The lower trunk sweeps slightly south and then self-corrects. The trunk splits into codominant leaders at approximately 35' above ground level and the northwest leader was topped 10' above the split. The live crown ratio is approximately 30%<sup>1</sup>. The canopy was significantly raised in the past and is also unbalanced to the west/northwest. Tree #26 is fully exposed to wind and nearby trees were recently removed. Mechanical root damage on the east side suggests that heavy equipment was likely operating within

the dripline of the tree at one point. It is possible that some soil compaction has occurred near this tree prior to tree protection fencing being erected. A new(er) home (37330 American St) is 16' west of the tree. Based on the proximity of the home to the tree, it is possible that tree #26 experienced root disturbance or damage, and/or loss of roots to accommodate the home. Photographs of tree #26 are in Appendix 3, Figures 1-3.

**Figure 1** Tree #26, 21" DBH bigleaf maple. This tree has a high risk rating. 4/18/2022.

In the next five years, the likelihood that tree #26 will fail due to a compromised root system (mechanical damage 16" east of trunk, girdling roots on south side, and suspected compaction) interacting with a high and unbalanced canopy and recent exposure to wind is *probable*. The likelihood of tree #26 failing west or northwest onto 37330 American St is *high*. The home is within the dripline of the tree. The compromised roots are on the east and south side and the canopy is high and unbalanced to the west and northwest. This creates a long lever arm with an imbalance of static and dynamic forces playing against the canopy and roots. The most likely direction of failure is to the west or northwest. The consequence of failure of tree #26 falling on the home is *severe*. A 21" DBH tree falling onto a home would cause significant property damage. **Removal is recommended to mitigate for the high risk.**

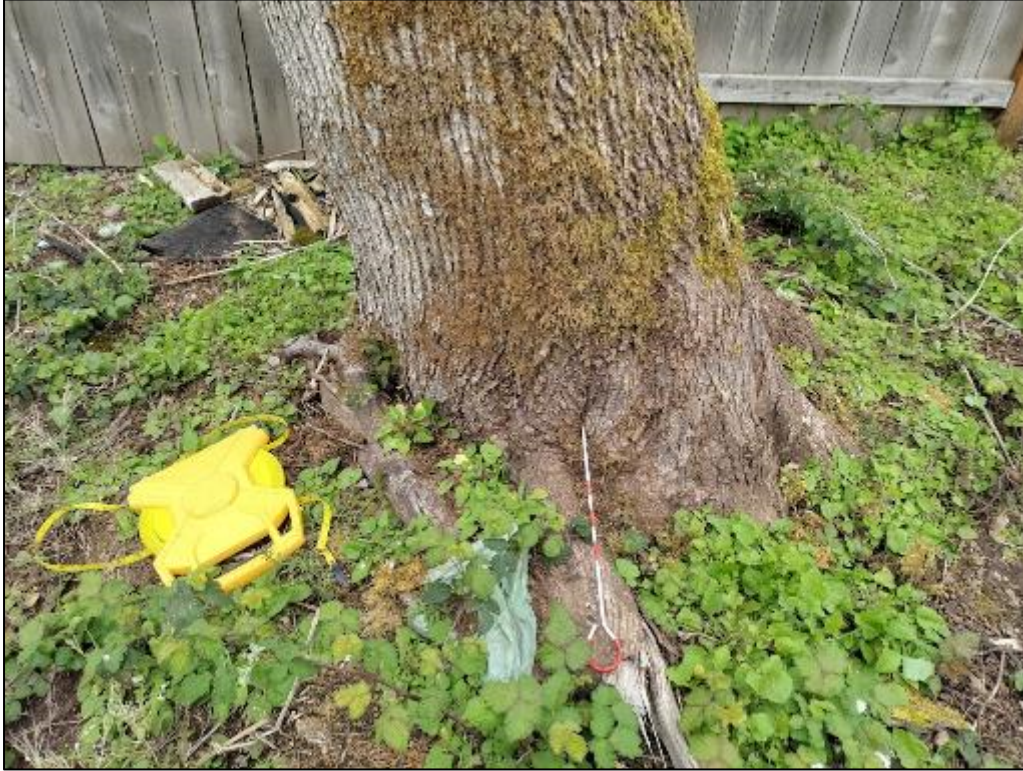
**Figure 2** Tree #26, mechanical root damage on the east side 16" from the trunk. 4/18/2022.

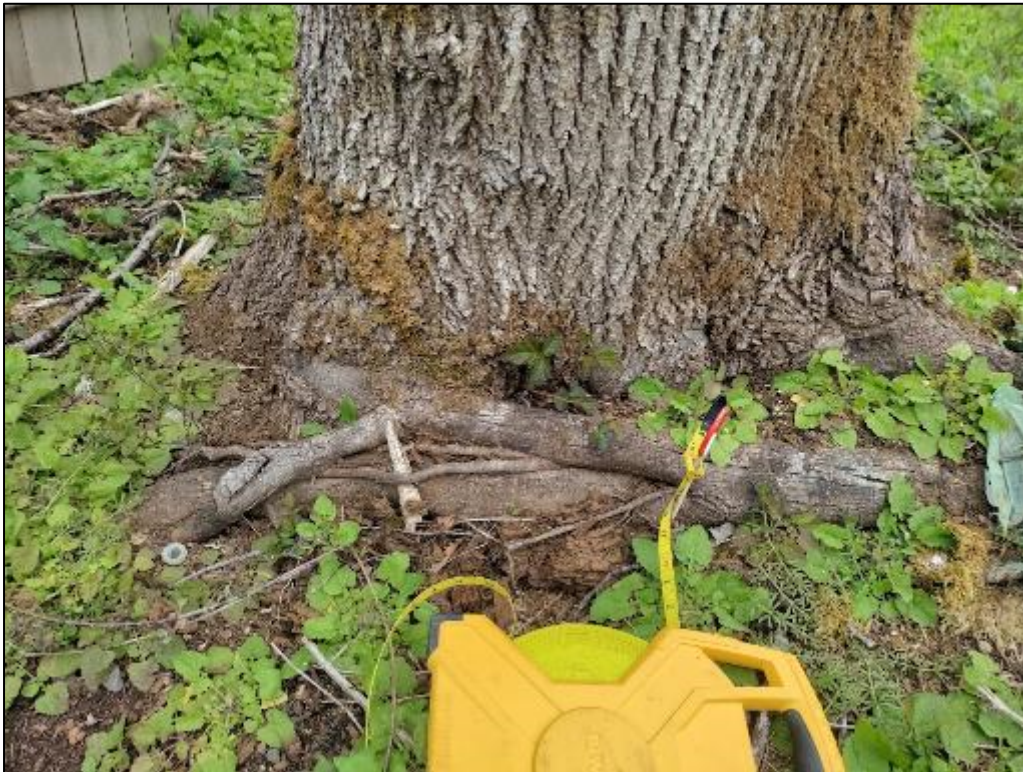
**Figure 3** Tree #26, girdling roots on the south side of the trunk flare. 4/18/2022.

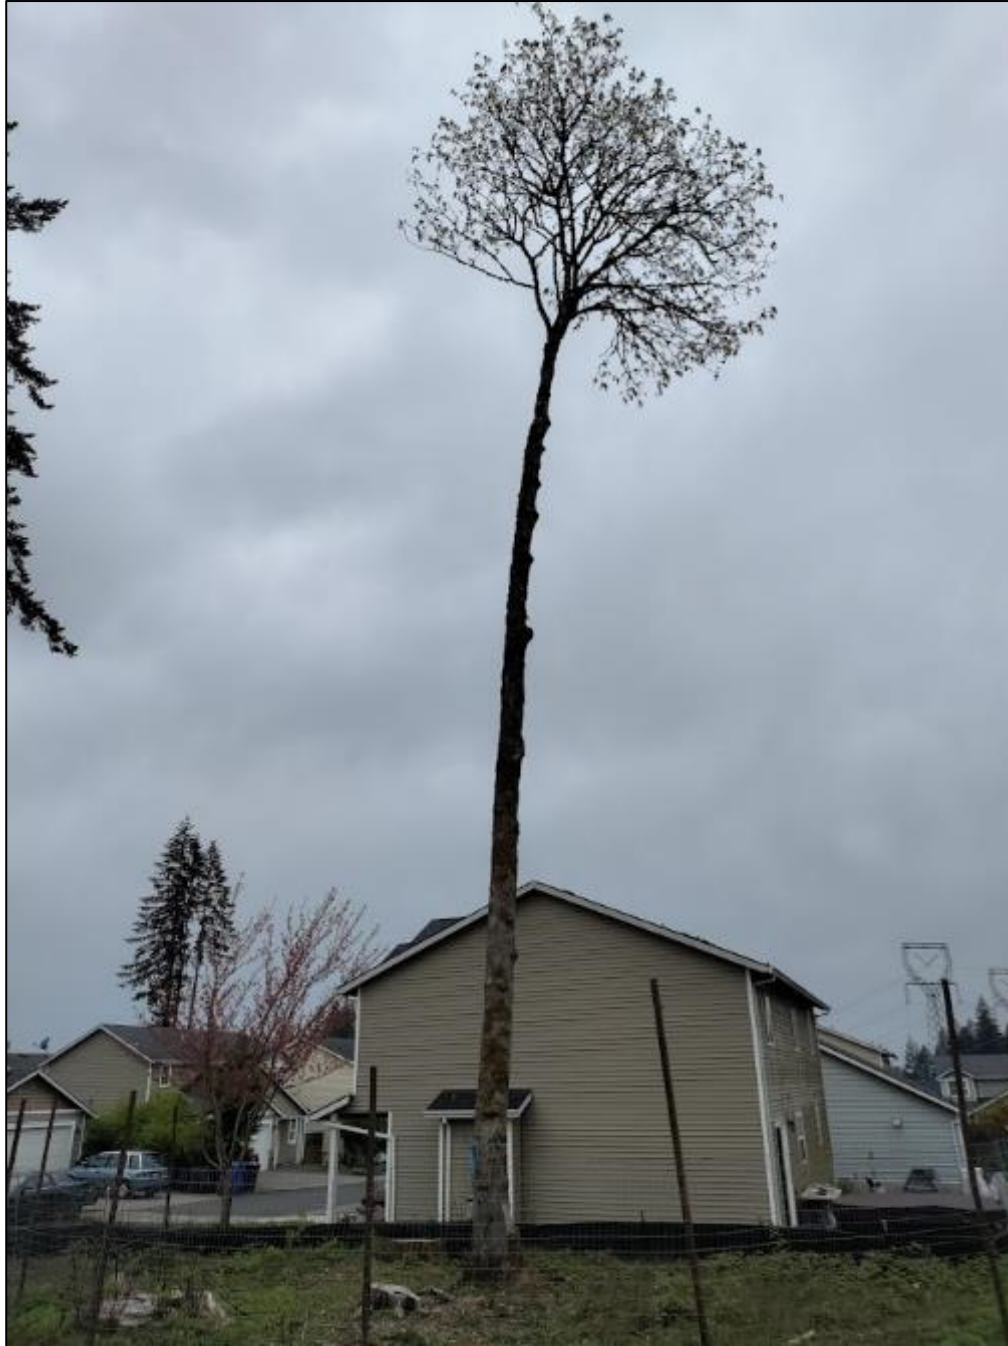
Tree #35 is also a 21" DBH bigleaf maple. The tree was not tagged and is assumed to be tree #35 based on distances to nearby structures. It is 70-75' tall. The tree is in poor health and poor structural condition. There are two injuries on the lower trunk. On the northwest side there is a decay cavity and seam that stretches from approximately 3' to 20' above ground level. On the east side there is a decay cavity at 3.5' above ground level. Soil has been piled on the north side of the trunk. Epicormic growth is present on all sides of the lower trunk. The live crown ratio is approximately 30%. The canopy is unbalanced to the west/northwest. Tree #35 is fully exposed to wind and nearby trees were recently removed. Piles of soil around the base of the trunk suggest that construction may have occurred close to this tree at one time. It is possible that some soil compaction has occurred near this tree prior to tree protection fencing being erected. A new(er) home (15262 Penny Ave) is 21' west of the tree and a retaining wall sits at the property line, approximately 20' west. Based on the proximity of the home and retaining wall to the tree, it is possible that this tree experienced root disturbance or damage, and/or loss of roots to accommodate the retaining wall and home. Photographs of tree #35 are located in Appendix 3, Figures 4-6.

**Figure 4** Tree #35, 21" DBH bigleaf maple. This tree has a high risk rating. 4/18/2022.

In the next five years, the likelihood that tree #35 will fail due to decay in the lower trunk (decay cavity and seam on north side and decay cavity on east side) and possibly a compromised root system (suspected compaction and grade changes) interacting with a high and unbalanced canopy and recent exposure to wind is *probable*. The likelihood of tree #35 failing west or northwest onto 15262 Penny Ave is *high*. The home is within the dripline of the tree. Stem decay on the east and northwest sides of the tree in combination with the high and unbalanced canopy to the west and northwest creates a long lever arm with an imbalance of static and dynamic forces. It is difficult to predict the direction of failure of this tree due to the multiple defects, but the locations of lower stem defects and the unbalanced canopy are most likely to cause the tree to fail west, either northwest, west, or southwest. The consequence of failure of tree #35 falling on the home is *severe*. A 21" DBH tree failing onto a home would cause significant property damage. **Removal is recommended to mitigate for the high risk.**

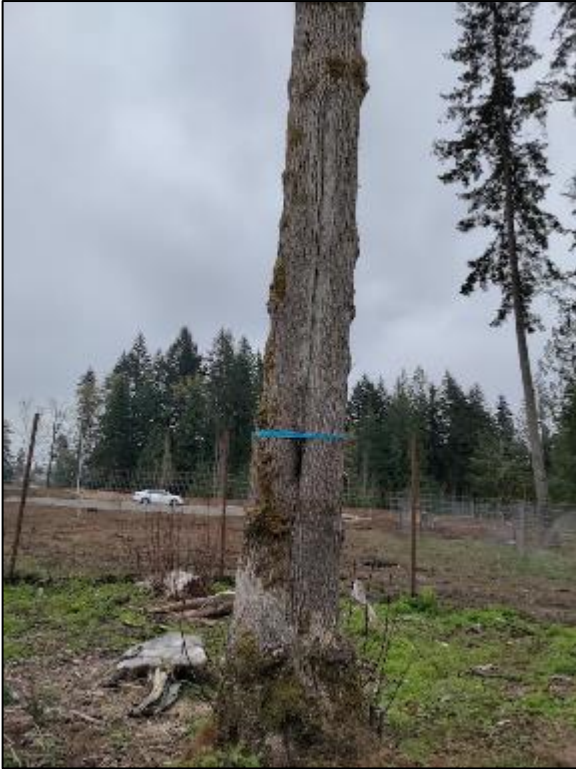
**Figure 5** Tree #35, seam and decay cavity on northwest side of trunk. 4/18/2022

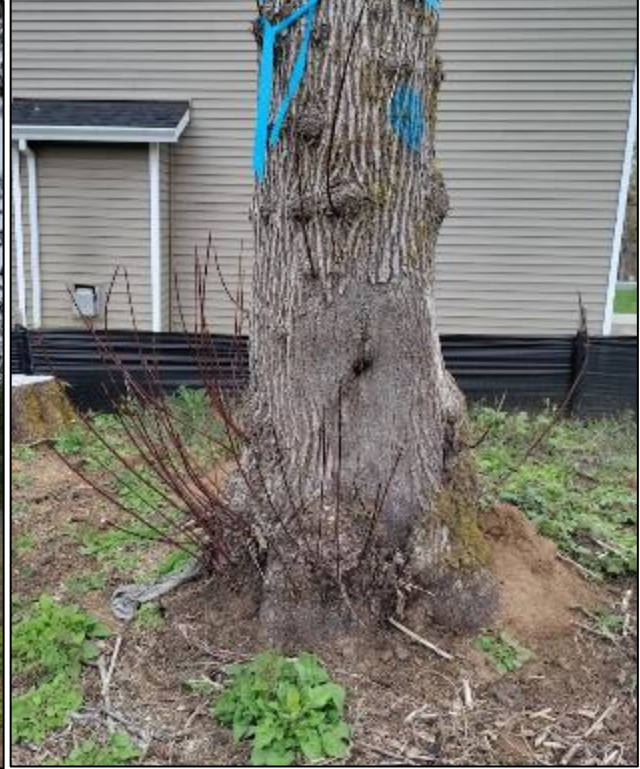
**Figure 6** Tree #35, decay cavity and epicormic growth on east side of trunk. 4/18/2022.

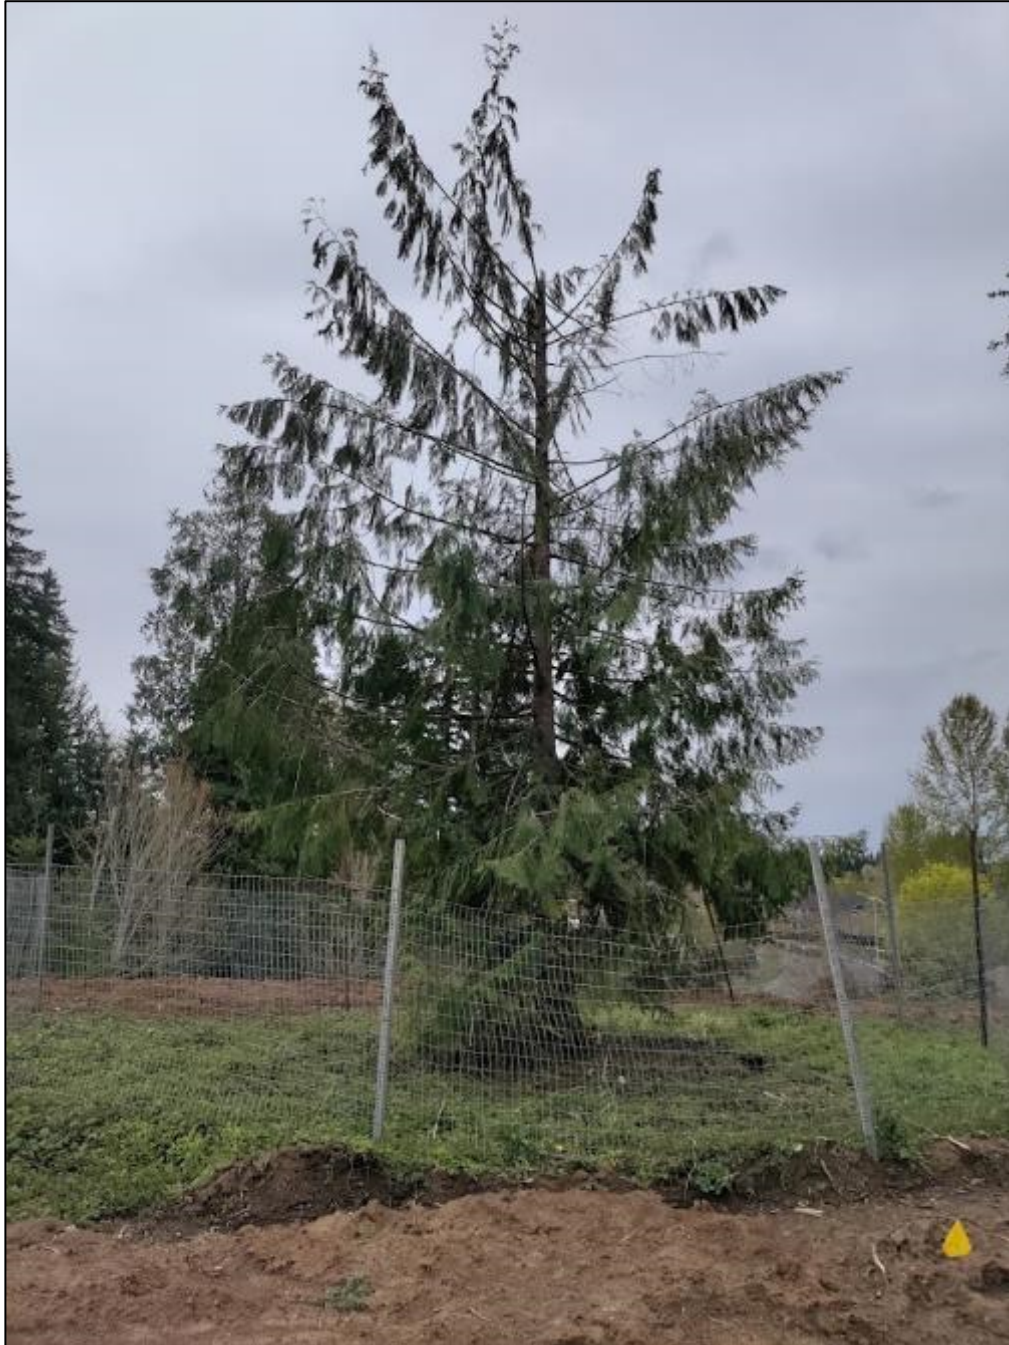
Tree #116 is a 14" DBH western redcedar (*Thuja plicata*). The tree was tagged. It is 30' tall. The tree is in poor health and poor structural condition. The central leader broke of natural causes several years ago and the tree is dying from the top down. Dead branches are present in the lower canopy. Foliage was thin, chlorotic, and uncharacteristically brown. There are no targets near the tree at this time, however a sidewalk and/or street will likely be within 14' of tree #116 with the proposed subdivision and a proposed home will be within 20'. Photographs of tree #116 are located in Appendix 3, Figures 7-9.

**Figure 7** Tree #116, 14" DBH western redcedar. Notice the lost top, dead, dying, and thin foliage. 4/18/2022.

the direction of failure of a dead tree. Since both targets are within 30' of the tree, either could be impacted. The consequence of failure of tree #116 falling onto the proposed sidewalk/home is *severe*. A 14" DBH tree could severely injure a person. If the sidewalk is not occupied by a pedestrian, then the consequence would be negligible. The consequence of failure of tree #116 falling onto the proposed home is minor. The top of the tree is dead so if it were to reach the house it would likely break on impact and cause some minor damage, but not structural damage. A gutter may be dented. Tree #116 is in an irreversible state of decline and will not recover. **The only mitigation to lower the low risk is removal.**

Trees #26 and #35 are recommended for removal to mitigate high risk. Tree #116 poses a low risk, but will not recover from its poor state of health. Removal of this tree is recommended based on the poor condition of the tree and not the risk.

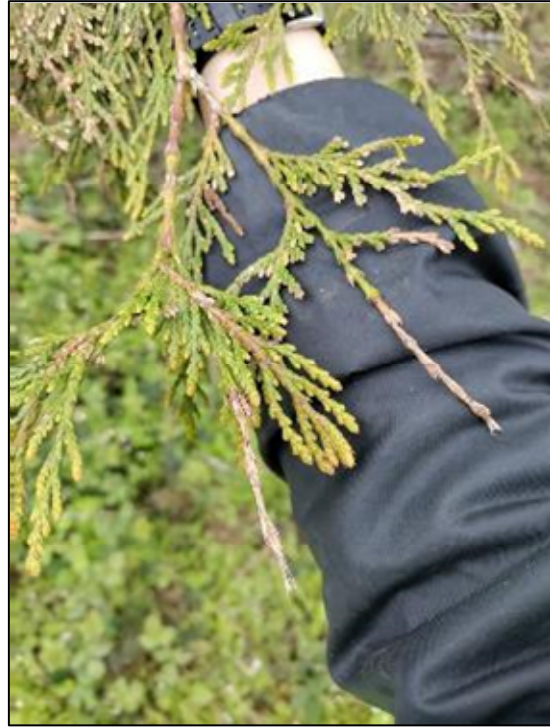
**Figure 9** Tree #116, Dead and chlorotic foliage at the tips of branches. 4/18/2022.
