Name of Project:	Hazard tree removal - Tag #488
Location or Address:	37035 SE Olson St. Sandy, OR 97055

Axe Contracting LLC January 7, 2023

Tree Report and Level 3 Risk Assessment (35” Douglas fir *Pseudotsuga menziesii*) TAG# 488

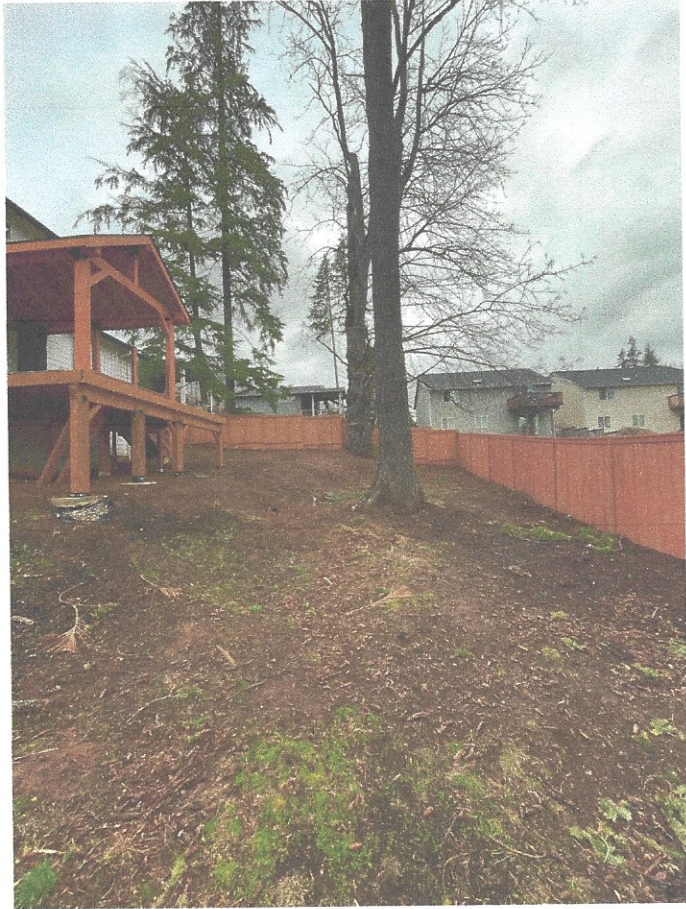
Arriving to the back yard of the home there is visible evidence of grade change and excavation within the critical root zone of the tree (fig.1). A closer look at the root flare showed signs of mechanical injury to structural root flare(fig.2). The root flare opposite the

Fig. 1 grade discrepancy

The assessing arborist recommends removal of the tree to prevent damage to surround structures and mitigate the potential for injury.

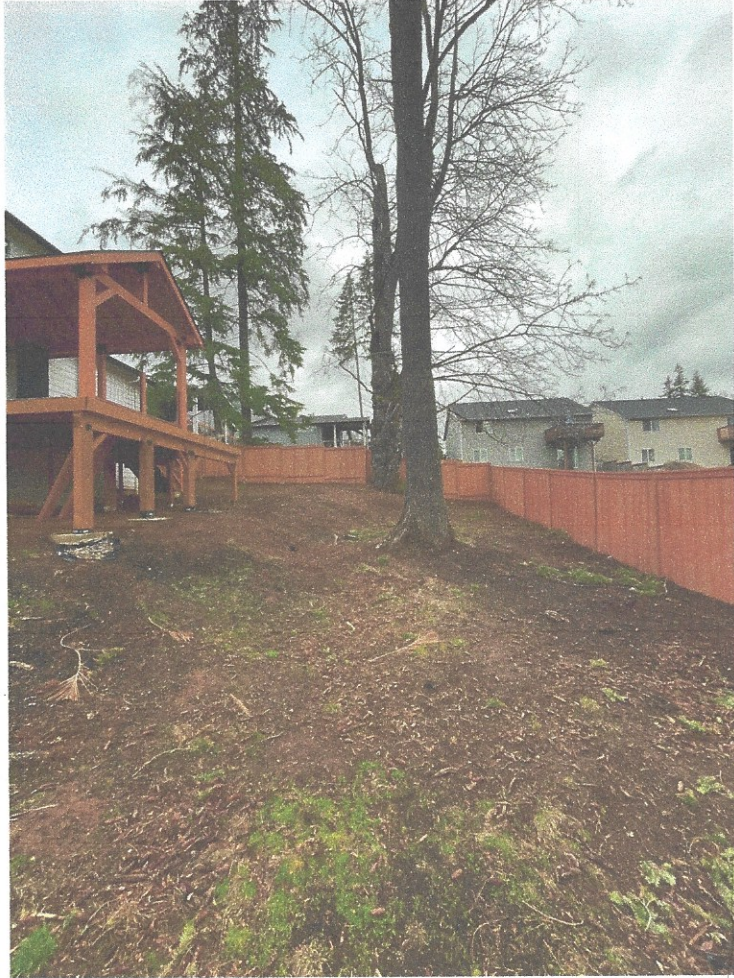
Fig.2 inconsistent root flare and mechanical structural root damage

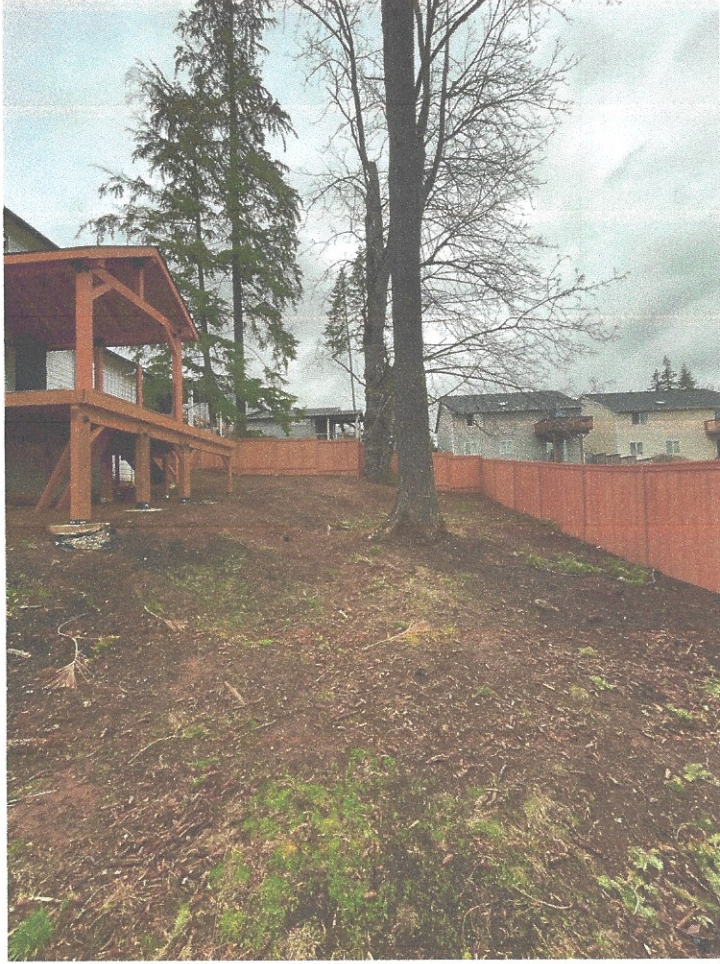
home does not show typical flare shape, but rather disappears straight into the ground. (Fig.3). The bole displays a 17’ long vertical fissure starting at 22” above grade. The depth of the fissure varies, at its visible deepest it is approx. 10” deep into the core of

Fig. 3 Inconsistent root flare

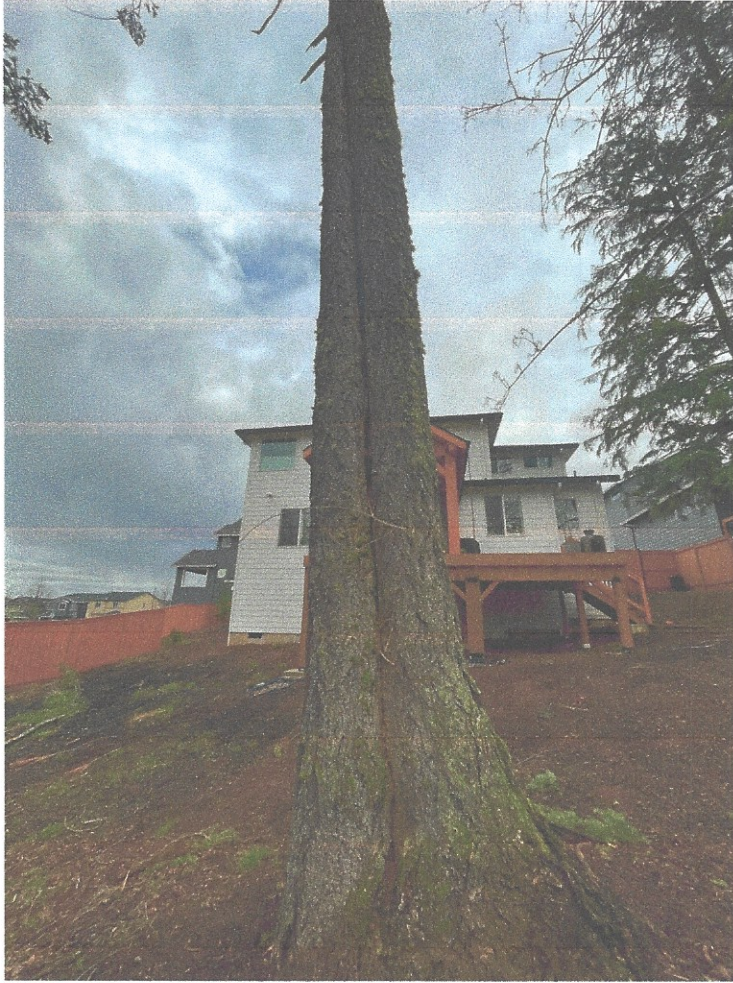
the tree (Fi.4). The UAV was able to locate 3 live limb failures ranging from 2-3.5" with about 6' (fig.5). The UAV discovers a subordinate top with significant included bark. (Fig. 6).

Fig. 4 Fissure

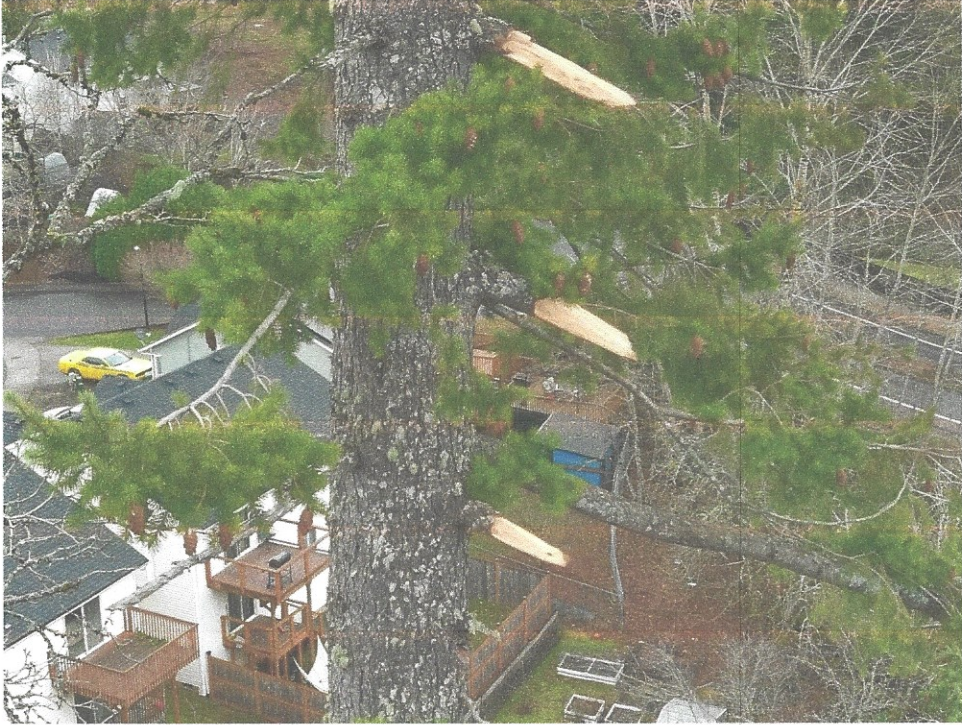
The likelihood of limb failure during severe weather conditions is probable, with the likelihood of limbs impacting a target is high, resulting in a high likelihood of failure.

Fig. 5 live limb failure. Fig.6 (below) subordinate top with included bark
