4/21/2022

Jim Raze
Raze Custom Homes, Inc.
4020 NE 216th Ave
Fairview, OR 97024

RE: Level II, Basic Tree Risk Assessment for Three (3) Trees in Jewelberry Ridge Subdivision

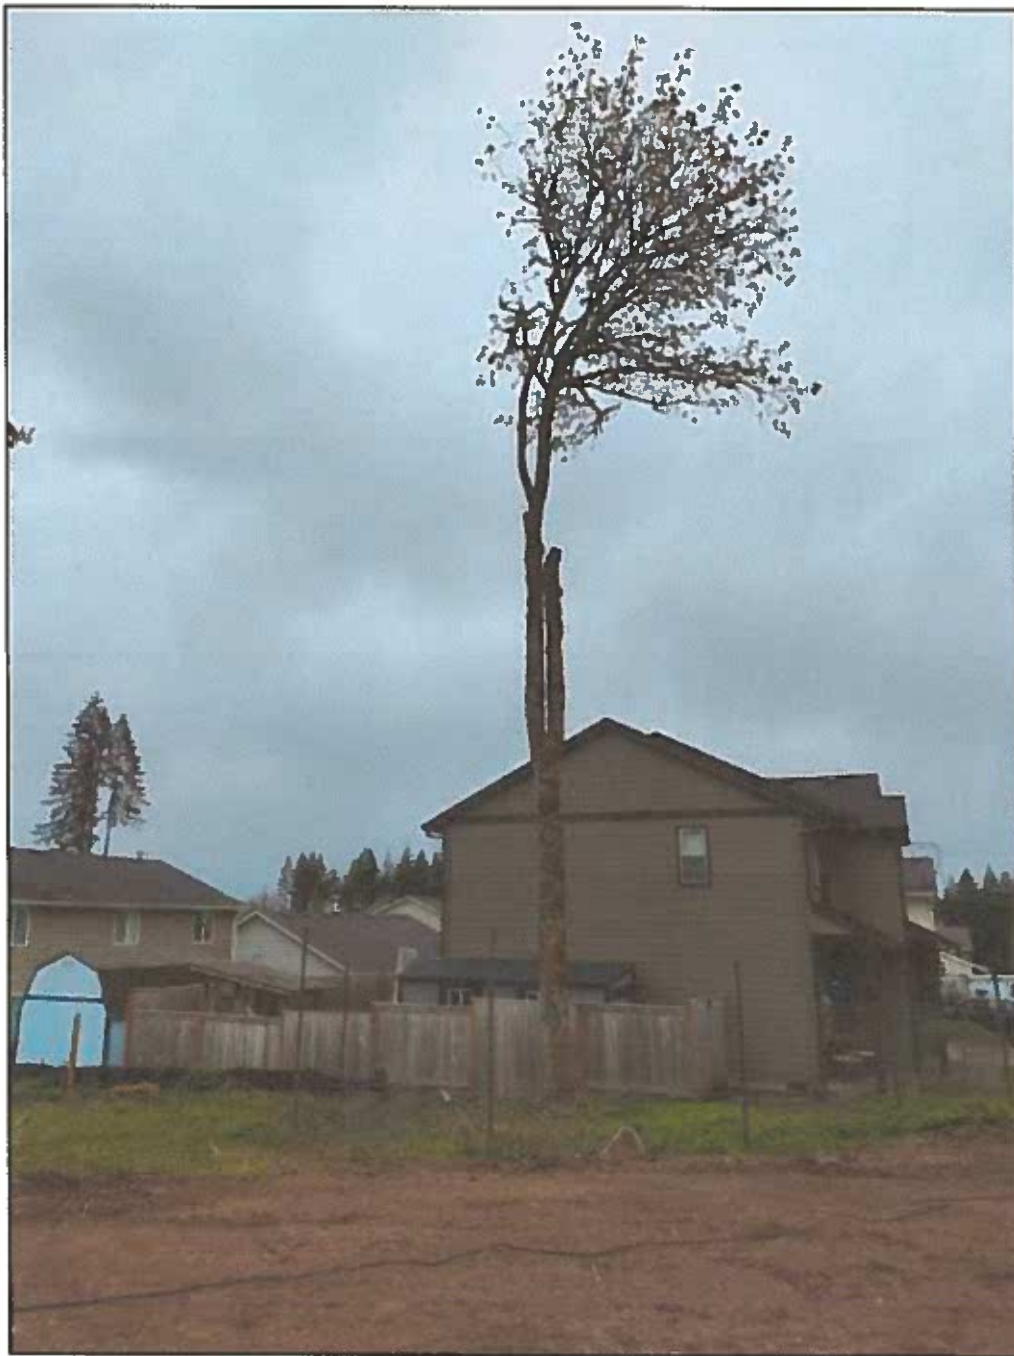
Tree #26 is a 21" DBH bigleaf maple (*Acer macrophyllum*). The tree was not tagged and is assumed to be tree #26 based on distances to nearby structures and the site map provided. It is 70-75' tall. The tree is in poor health and poor structural condition. Mechanical damage was observed on a surface root, 16" east of the trunk. Girdling roots are present on the south side of the trunk flare. The lower trunk sweeps slightly south and then self-corrects. The trunk splits into codominant leaders at approximately 35' above ground level and the northwest leader was topped 10' above the split. The live crown ratio is approximately 30%¹. The canopy was significantly raised in the past and is also unbalanced to the west/northwest. Tree #26 is fully exposed to wind and nearby trees were recently removed. Mechanical root damage on the east side suggests that heavy equipment was likely operating within

In the next five years, the likelihood that tree #26 will fail due to a compromised root system (mechanical damage 16" east of trunk, girdling roots on south side, and suspected compaction) interacting with a high and unbalanced canopy and recent exposure to wind is *probable*. The likelihood of tree #26 failing west or northwest onto 37330 American St is *high*. The home is within the dripline of the tree. The compromised roots are on the east and south side and the canopy is high and unbalanced to the west and northwest. This creates a long lever arm with an imbalance of static and dynamic forces playing against the canopy and roots. The most likely direction of failure is to the west or northwest. The consequence of failure of tree #26 falling on the home is *severe*. A 21" DBH tree falling onto a home would cause significant property damage. **Removal is recommended to mitigate for the high risk.**

Figure 1 Tree #26, 21" DBH bigleaf maple. This tree has a high risk rating. 4/18/2022.

Trees #26 and #35 are recommended for removal to mitigate high risk. Tree #116 poses a low risk, but will not recover from its poor state of health. Removal of this tree is recommended based on the poor condition of the tree and not the risk.

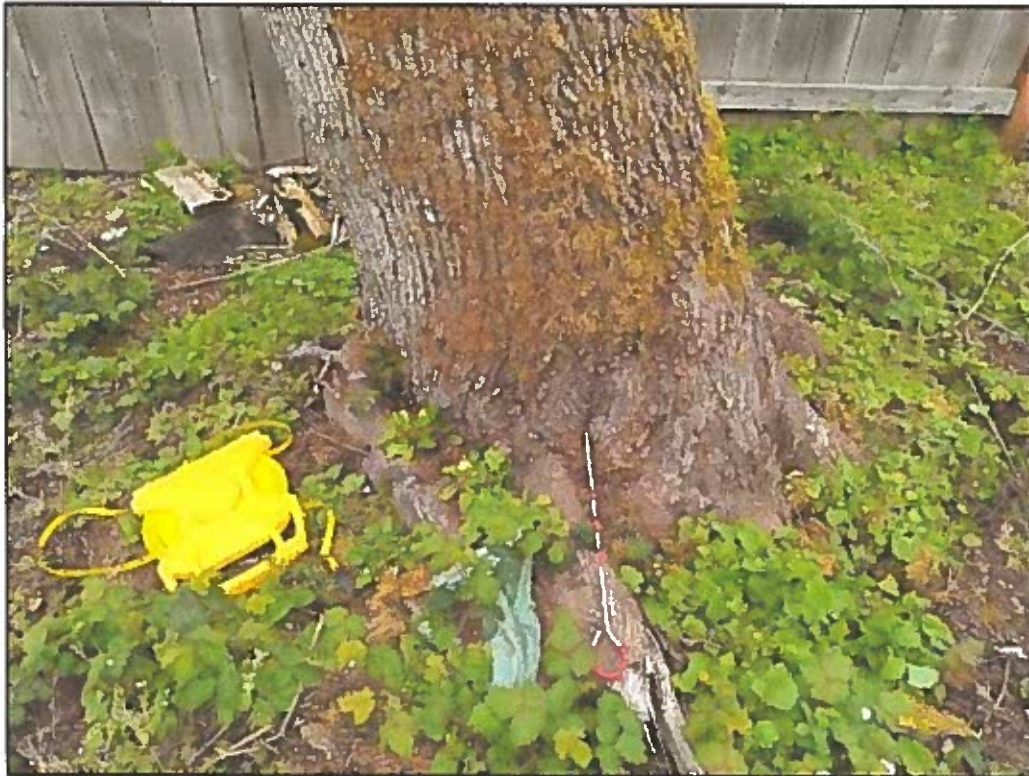
Figure 2 Tree #26, mechanical root damage on the east side 16” from the trunk. 4/18/2022.

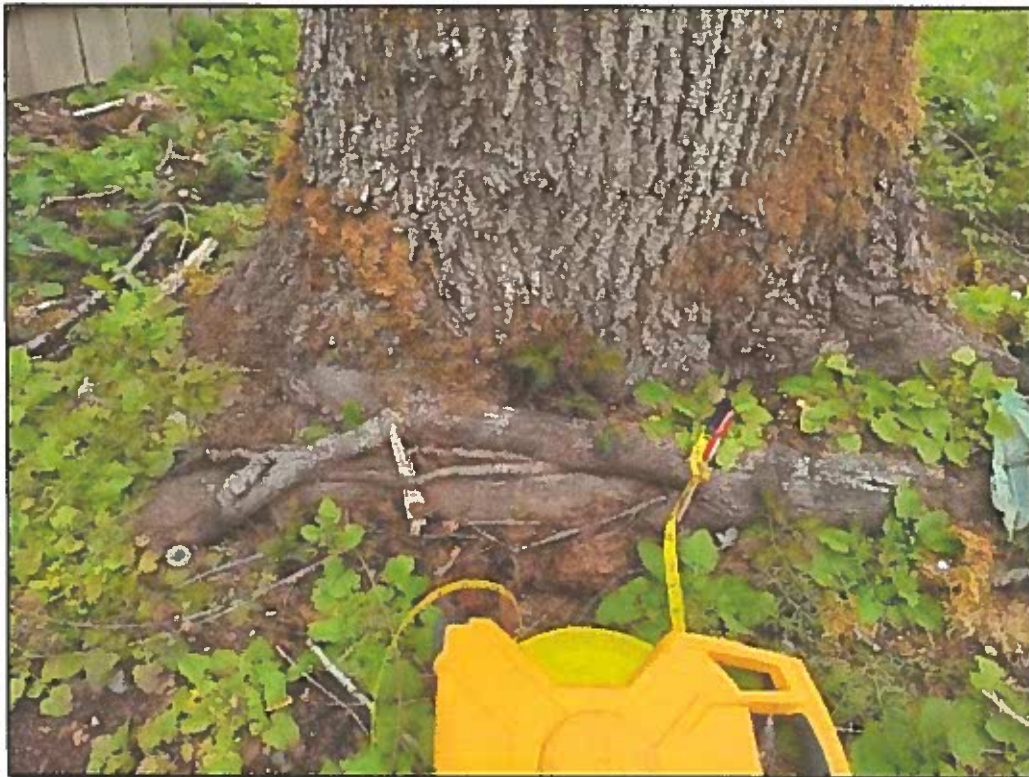
Figure 3 Tree #26, girdling roots on the south side of the trunk flare. 4/18/2022.

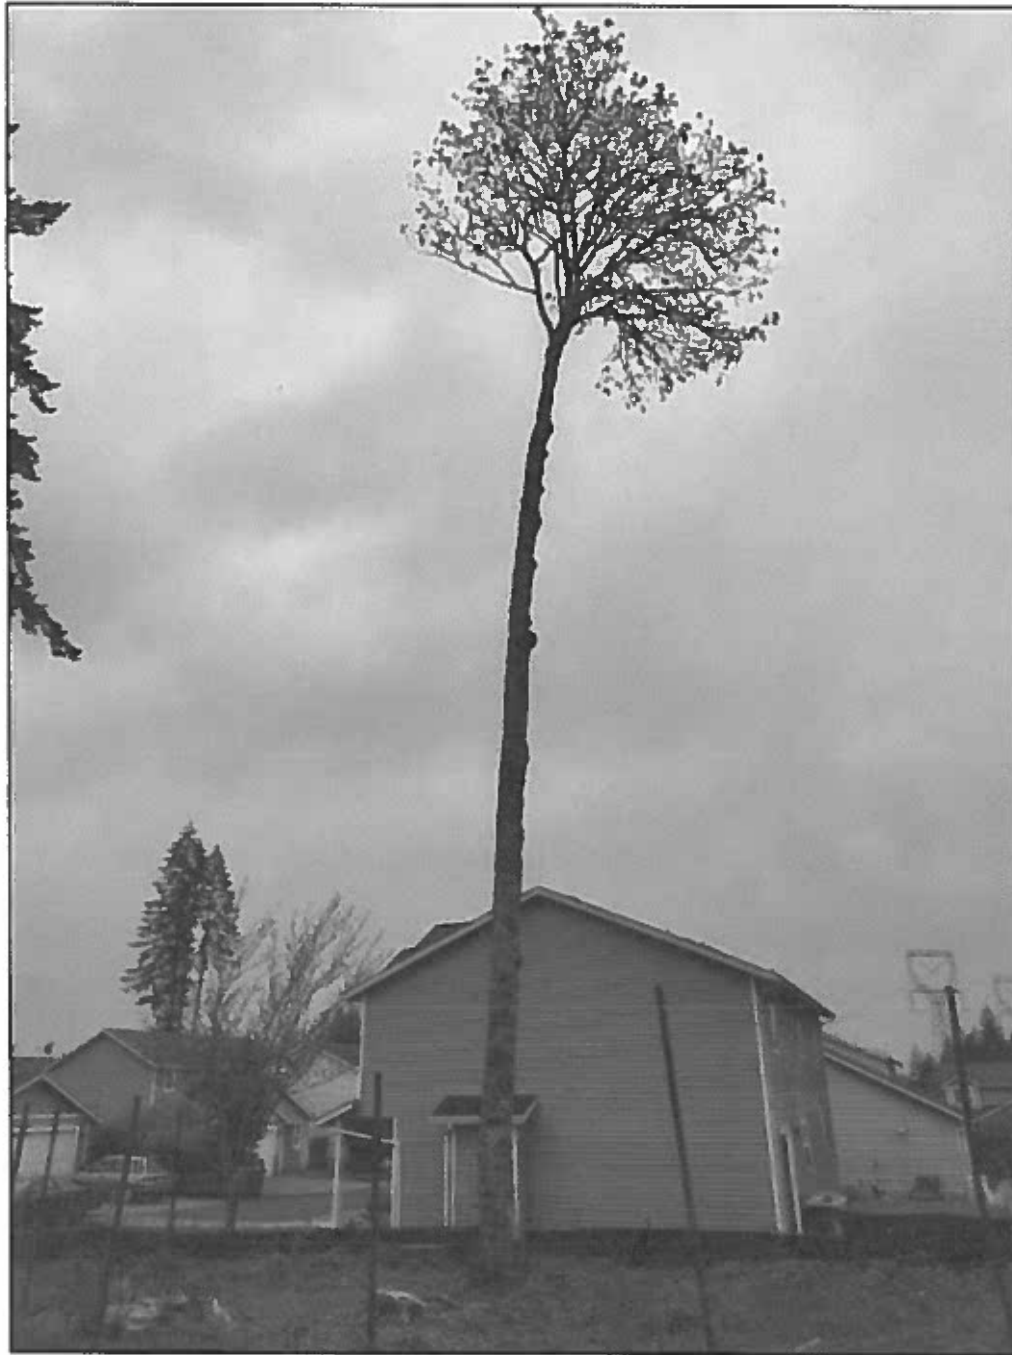
Tree #35 is also a 21" DBH bigleaf maple. The tree was not tagged and is assumed to be tree #35 based on distances to nearby structures. It is 70-75' tall. The tree is in poor health and poor structural condition. There are two injuries on the lower trunk. On the northwest side there is a decay cavity and seam that stretches from approximately 3' to 20' above ground level. On the east side there is a decay cavity at 3.5' above ground level. Soil has been piled on the north side of the trunk. Epicormic growth is present on all sides of the lower trunk. The live crown ratio is approximately 30%. The canopy is unbalanced to the west/northwest. Tree #35 is fully exposed to wind and nearby trees were recently removed. Piles of soil around the base of the trunk suggest that construction may have occurred close to this tree at one time. It is possible that some soil compaction has occurred near this tree prior to tree protection fencing being erected. A new(er) home (15262 Penny Ave) is 21' west of the tree and a retaining wall sits at the property line, approximately 20' west. Based on the proximity of the home and retaining wall to the tree, it is possible that this tree experienced root disturbance or damage, and/or loss of roots to accommodate the retaining wall and home. Photographs of tree #35 are located in Appendix 3, Figures 4-6.

In the next five years, the likelihood that tree #35 will fail due to decay in the lower trunk (decay cavity and seam on north side and decay cavity on east side) and possibly a compromised root system (suspected compaction and grade changes) interacting with a high and unbalanced canopy and recent exposure to wind is *probable*. The likelihood of tree #35 failing west or northwest onto 15262 Penny Ave is *high*. The home is within the dripline of the tree. Stem decay on the east and northwest sides of the tree in combination with the high and unbalanced canopy to the west and northwest creates a long lever arm with an imbalance of static and dynamic forces. It is difficult to predict the direction of failure of this tree due to the multiple defects, but the locations of lower stem defects and the unbalanced canopy are most likely to cause the tree to fail west, either northwest, west, or southwest. The consequence of failure of tree #35 falling on the home is *severe*. A 21" DBH tree failing onto a home would cause significant property damage. **Removal is recommended to mitigate for the high risk.**

Figure 4 Tree #35, 21” DBH bigleaf maple. This tree has a high risk rating. 4/18/2022.

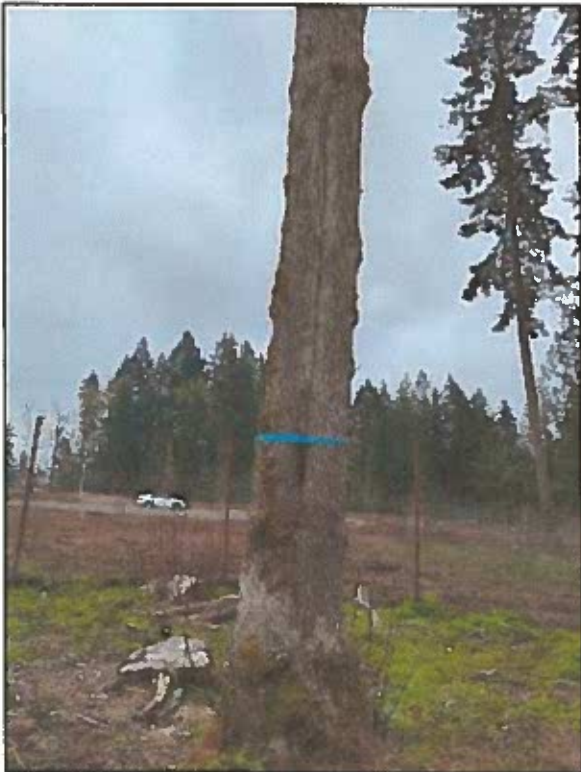
Figure 5 Tree #35, seam and decay cavity on northwest side of trunk. 4/18/2022

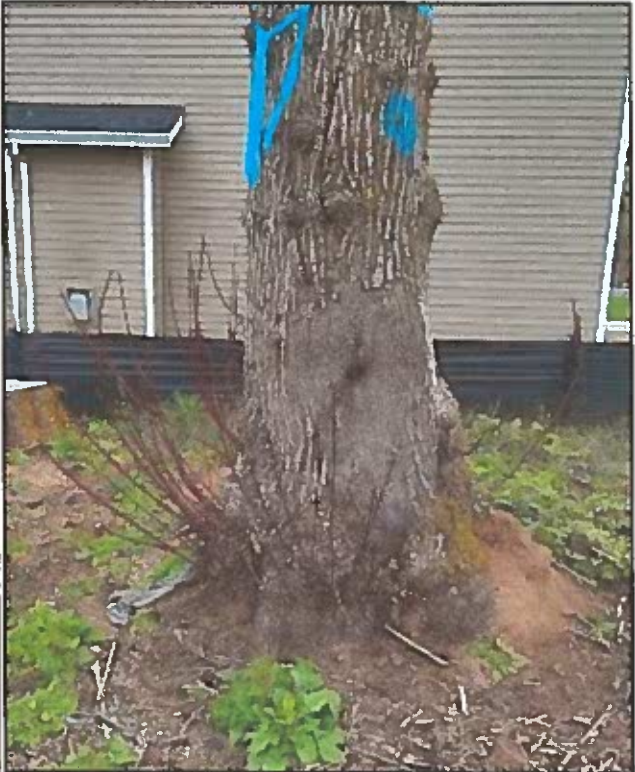
Figure 6 Tree #35, decay cavity and epicormic growth on east side of trunk. 4/18/2022.

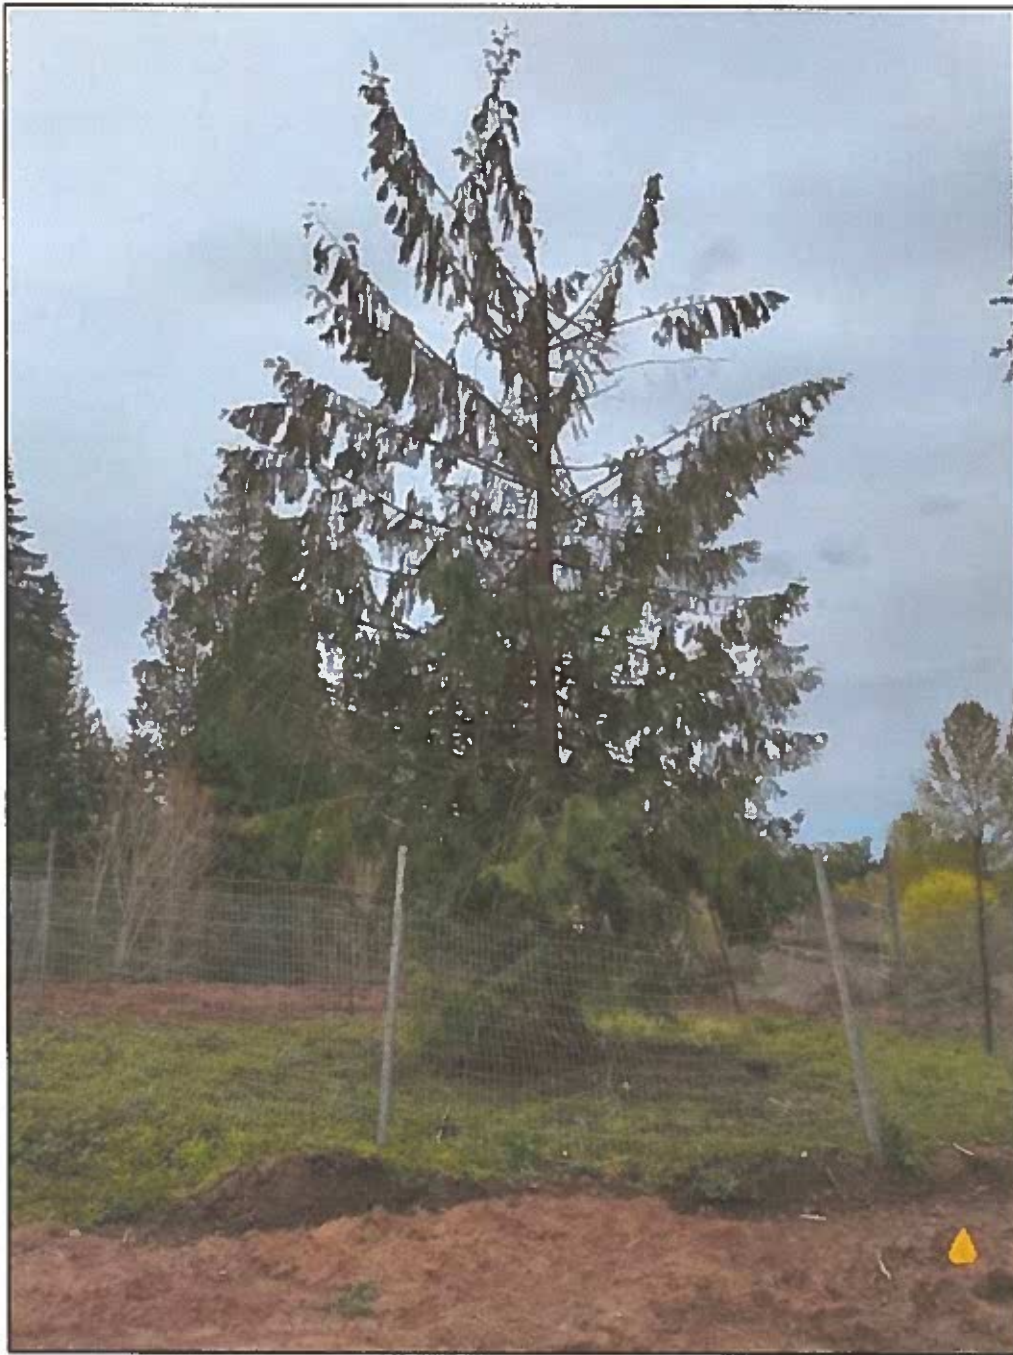
Tree #116 is a 14" DBH western redcedar (*Thuja plicata*). The tree was tagged. It is 30' tall. The tree is in poor health and poor structural condition. The central leader broke of natural causes several years ago and the tree is dying from the top down. Dead branches are present in the lower canopy. Foliage was thin, chlorotic, and uncharacteristically brown. There are no targets near the tree at this time, however a sidewalk and/or street will likely be within 14' of tree #116 with the proposed subdivision and a proposed home will be within 20'. Photographs of tree #116 are located in Appendix 3, Figures 7-9.

In the next five years, the likelihood that tree #116 will fail due to poor health is *improbable*. Tree #116 is dying, but it still has live branches. Over the next five years it will continue to decline standing. It is unlikely that it will uproot and fail. The likelihood of tree #116 failing west or northwest onto the proposed sidewalk/road and the proposed home on lot 6 is *low*. It is extremely hard to predict

the direction of failure of a dead tree. Since both targets are within 30' of the tree, either could be impacted. The consequence of failure of tree #116 falling onto the proposed sidewalk/home is *severe*. A 14" DBH tree could severely injure a person. If the sidewalk is not occupied by a pedestrian, then the consequence would be negligible. The consequence of failure of tree #116 falling onto the proposed home is minor. The top of the tree is dead so if it were to reach the house it would likely break on impact and cause some minor damage, but not structural damage. A gutter may be dented. Tree #116 is in an irreversible state of decline and will not recover. **The only mitigation to lower the low risk is removal.**

Figure 7 Tree #116, 14" DBH western redcedar. Notice the lost top, dead, dying, and thin foliage. 4/18/2022.

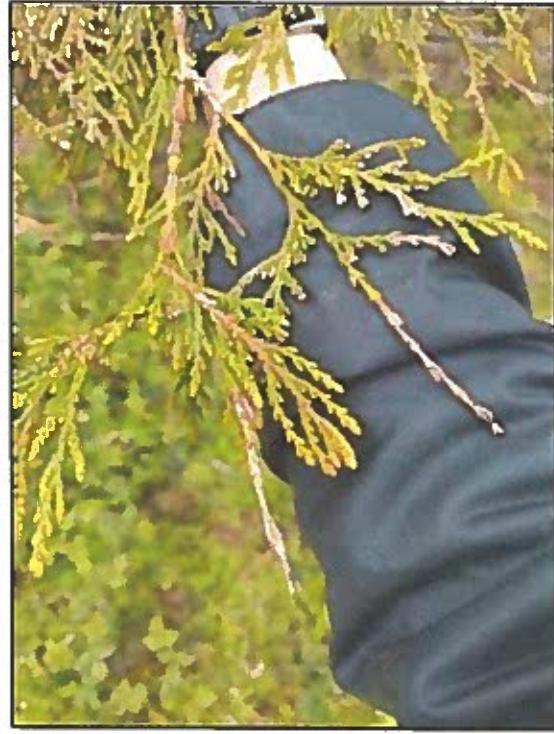
Figure 9 Tree #116, Dead and chlorotic foliage at the tips of branches. 4/18/2022.
