EXHIBIT K
TERAGAN
& ASSOCIATES, INC.
ARBORICULTURAL CONSULTANTS

MEMORANDUM

DATE: April 14, 2022
TO: Todd Hoffman
FROM: Todd Prager, RCA #597, ISA Board Certified Master Arborist
RE: Tree Plan for The Riffles Food Carts

This report includes tree removal, retention, and protection recommendations for the proposed The Riffles Food Carts project in Sandy, Oregon.

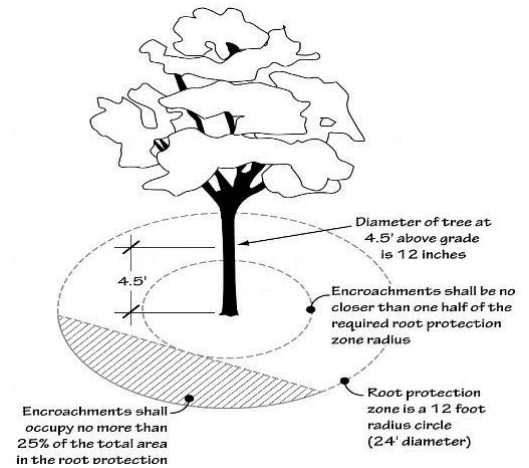
Figure 1: Alternative minimum protection zone

A typical alternative minimum protection zone allows encroachments no closer than a radius from a tree of .5 feet per inch of DBH if no more than 25 percent of the critical root protection zone area (estimated at one foot radius per inch of DBH) is impacted. Figure 1 illustrates this concept.

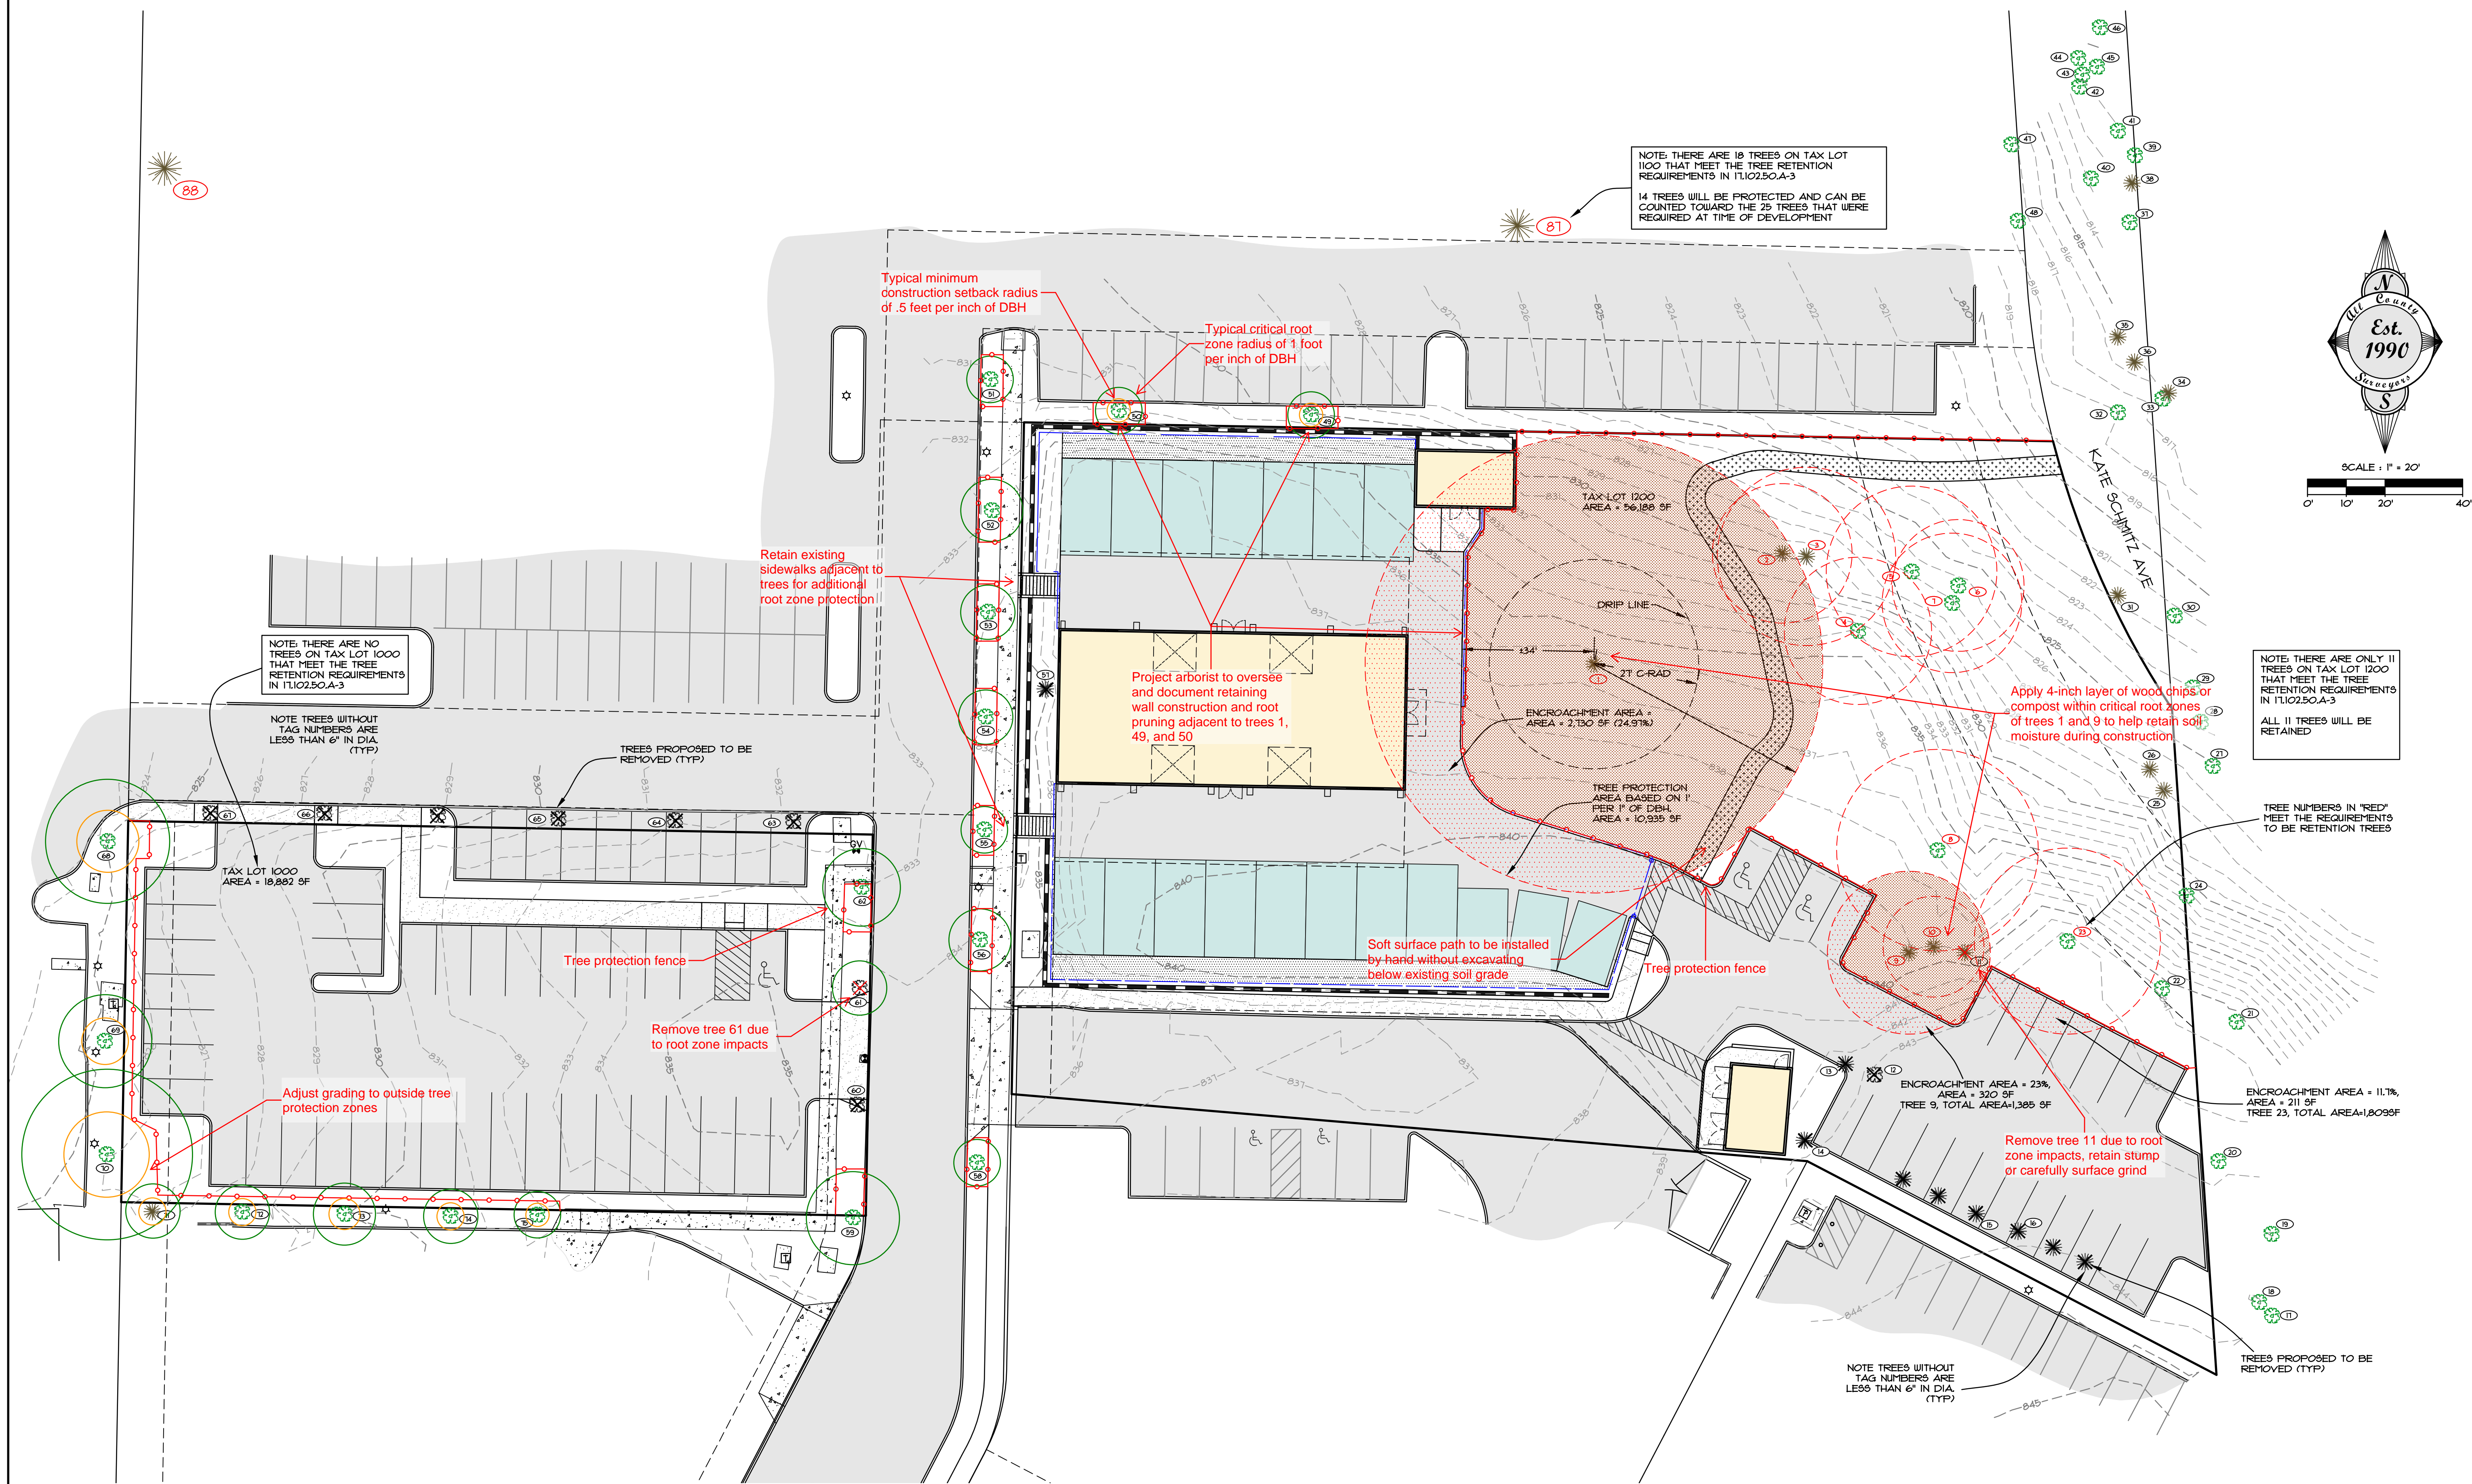
SHEET **C8** OF **10**

The tree numbers in the inventory in Attachment 2 correspond to the tree numbers on the tree plan sheet C8 in Attachment 1. The trees were also tagged with their corresponding numbers in the field.

- **Trees 11 through 16:** Parking lot construction at south-east portion of the site.
- **Tree 57:** Retaining wall and building construction.
- **Trees 60 and 61:** Driveway entry for new west parking lot.
- **Trees 63 through 67:** New west parking lot construction.

The trees to be retained can be adequately protected by placing tree protection fencing as shown in Attachment 1. The tree protection fencing will protect at least 75 percent of their critical roots zones and avoid any encroachments closer than a radius of .5 feet per inch of DBH to a tree to be retained. No grading, stockpiling, storage, disposal, or any other construction related activity shall occur in the tree protection zones unless specifically reviewed and approved by the project arborist.

- **Tree Protection Fencing:** Establish tree protection fencing in the locations shown in Attachment 1. Required fencing shall be a minimum of six feet tall supported with metal posts placed no farther than ten feet apart installed flush with the initial undisturbed grade. Fence installation may be delayed until immediately after tree removal is complete.

- *Arborist Oversight*: The project arborist shall be onsite to oversee the excavation of the retaining wall adjacent to trees 1, 49, and 50 to ensure the proper protection or pruning of roots.

- *Soil Treatment for Trees 1 and 9*: Four inches of wood chips or compost should be placed within the critical root zones of trees 1 and 9 prior to construction to help retain soil moisture and compensate for root removal with construction.

- *Sediment Fencing*: Shift sediment fencing to outside the tree protection zones. If erosion control is required inside the tree protection zones, use straw wattles to minimize root zone disturbance of the trees to be retained.
