City of Sandy - Emergency Tree Removals 12-29-2022  
39481 McCormick Dr  
Sandy, 97055  
Tiana Rundell  
Trundell@ci.sandy.or.us

**Retro Active Permit – Hazardous Grand Fir and Sweet Cherry**

**17670 Meinig Ave, Sandy Oregon 97005**

**Meinig Memorial Park**

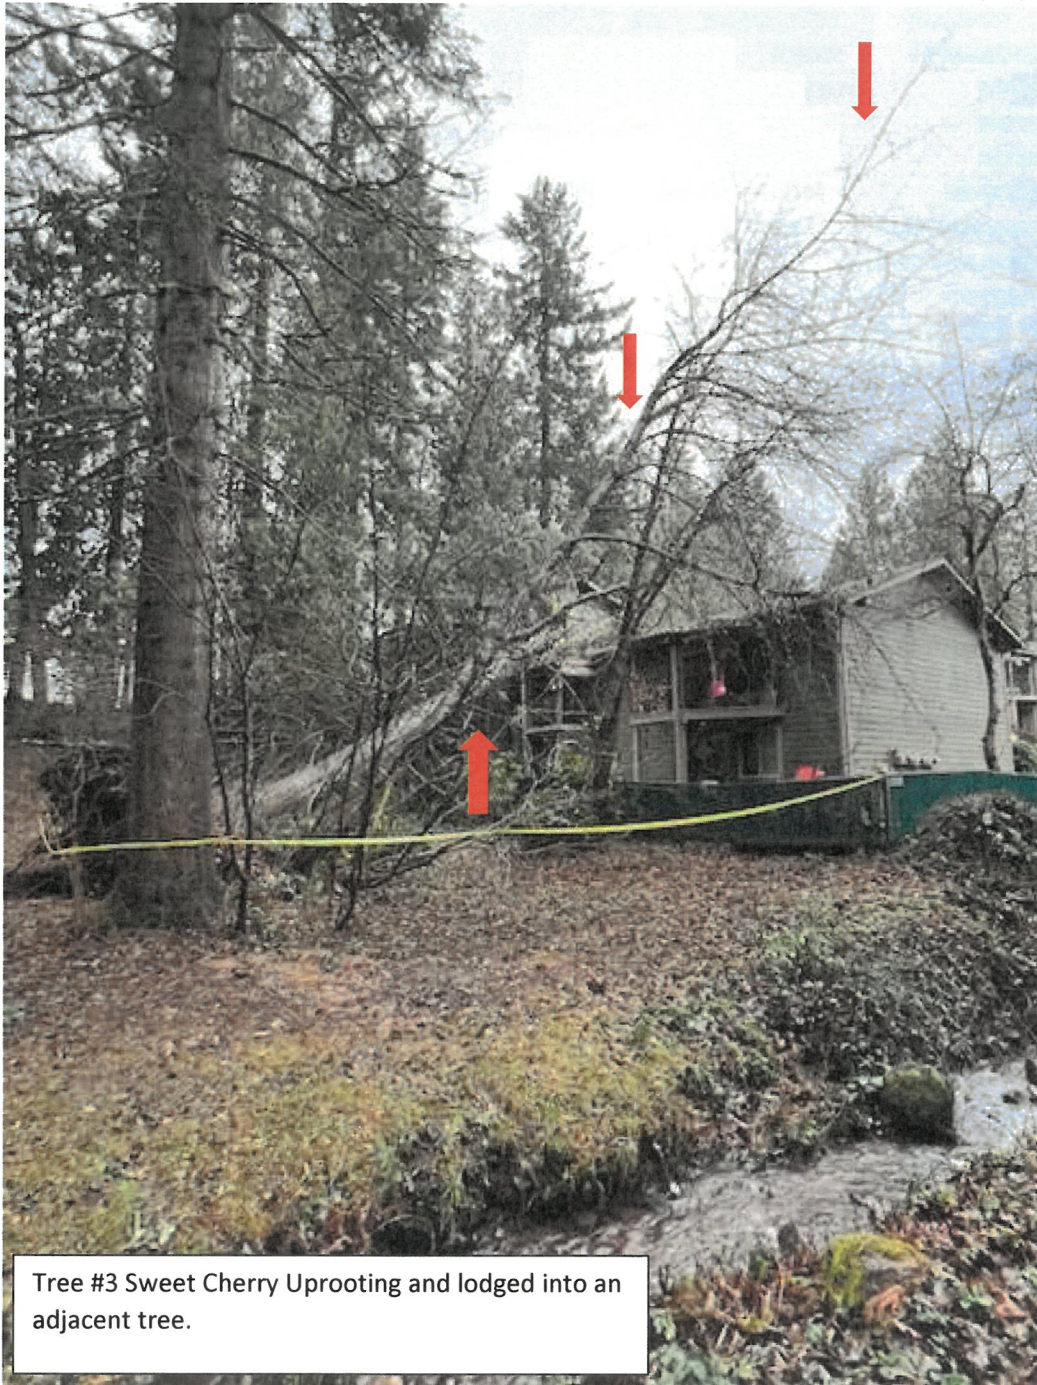
**During our recent storm we had in December of 2022, the park had one tree uproot into the adjacent apartment complex. When this tree uprooted, it had compromised the adjacent tree's root systems, #3 in it is actively failing, and is leaning into another tree and towards the building at the apartment complex which has multiple targets below. (See Picture).**

Tree #3 Sweet Cherry Uprooting and lodged into an adjacent tree.

**We are requesting the removal of (2) Hazardous trees, #1 being a Grand Fir, approx. 110' and tree #3 being a Sweet Cherry Tree (invasive species). (Please note each tree number on this is generated from our attached map)**

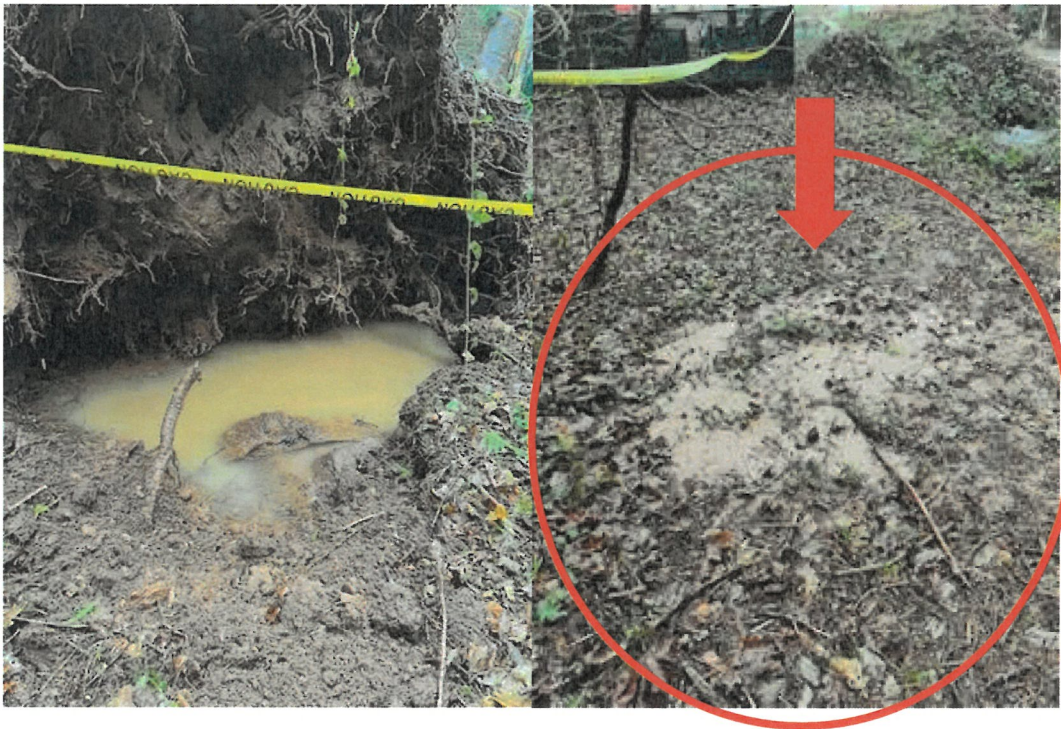
The larger tree in questions is a Grand Fir Tree #1, This fir tree's root system is very compromised, as we can see in the pictures of the standing water from the uprooted tree, has leached into this large standing grand fir, now this is creating water to flow from the root plate of the standing tree (see pictures), it's only a matter of time before this tree fails, especially coming into the winter/rainy months. We are seeking Immediate approval for the removal of this tree, as we have numerous targets in range, and don't want another tree to fail onto a unit.

Picture of the left is of the uprooted tree, this shows the amount of sitting water within the root plate of this tree, this root plate is withing 2-3' of tree #1's root system as well. Tree #1 is in the top right corner and this is showing the runoff of water coming from under this trees root system.

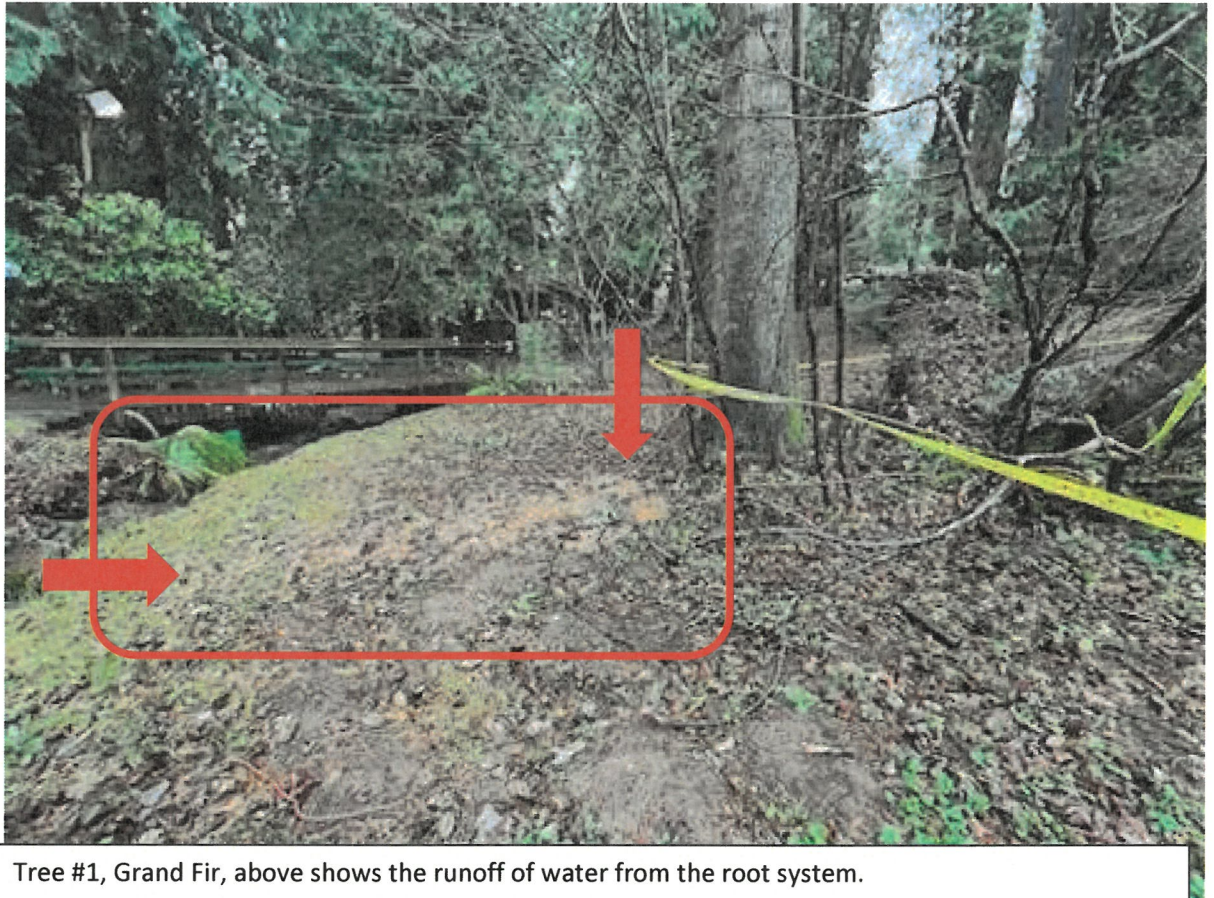
Tree #1, Grand Fir, above shows the runoff of water from the root system.

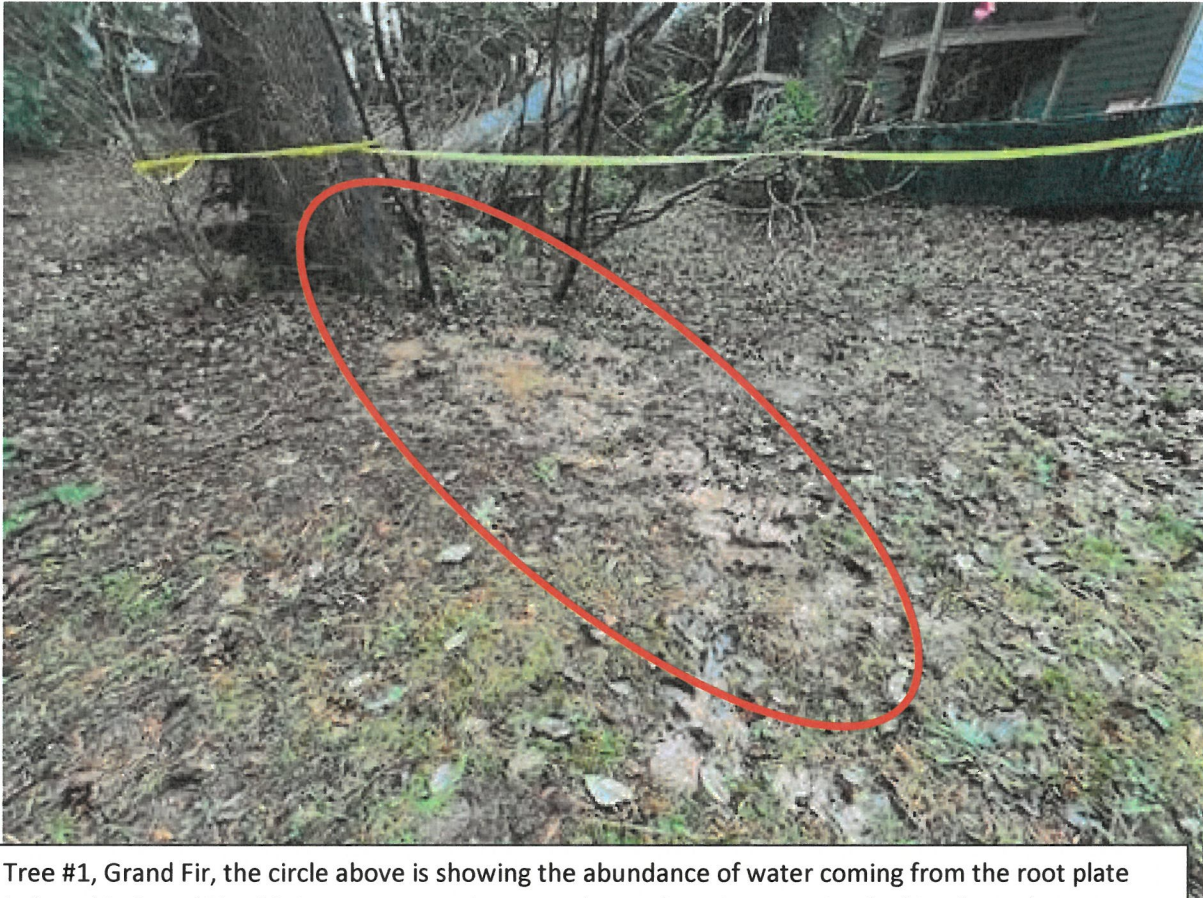
Tree #1, Grand Fir, the circle above is showing the abundance of water coming from the root plate below this Grand Fir, this is very concerning as we know there is saturation leaking from the root system that is holding this 110' tree up.

**As for mitigation, we can help facilitate in this, as this is a city park, I'll leave this portion of it up to Tiana and the rest of the team for the city of Sandy.**
