# TERAGAN & ASSOCIATES, INC. ARBORICULTURAL CONSULTANTS

**DATE:** January 10, 2018  
**TO:** Levi Levasa (Stafford Land Company)  
**FROM:** Todd Prager, RCA #597, ISA Board Certified Master Arborist  
**RE:** Tree Plan for Marshall Ridge Subdivision

PROJECT: MARSHALL RIDGE TREE INVENTORY, RETENTION, AND PROTECTION PLAN  
 LOCATION: 19525 SE BORNSTEDT RD, SANDY, OR

**MARSHALL RIDGE**  
 TREE MITIGATION PLAN AND  
 STREET TREE PLAN  
 19525 SE BORNSTEDT RD, SANDY, OR

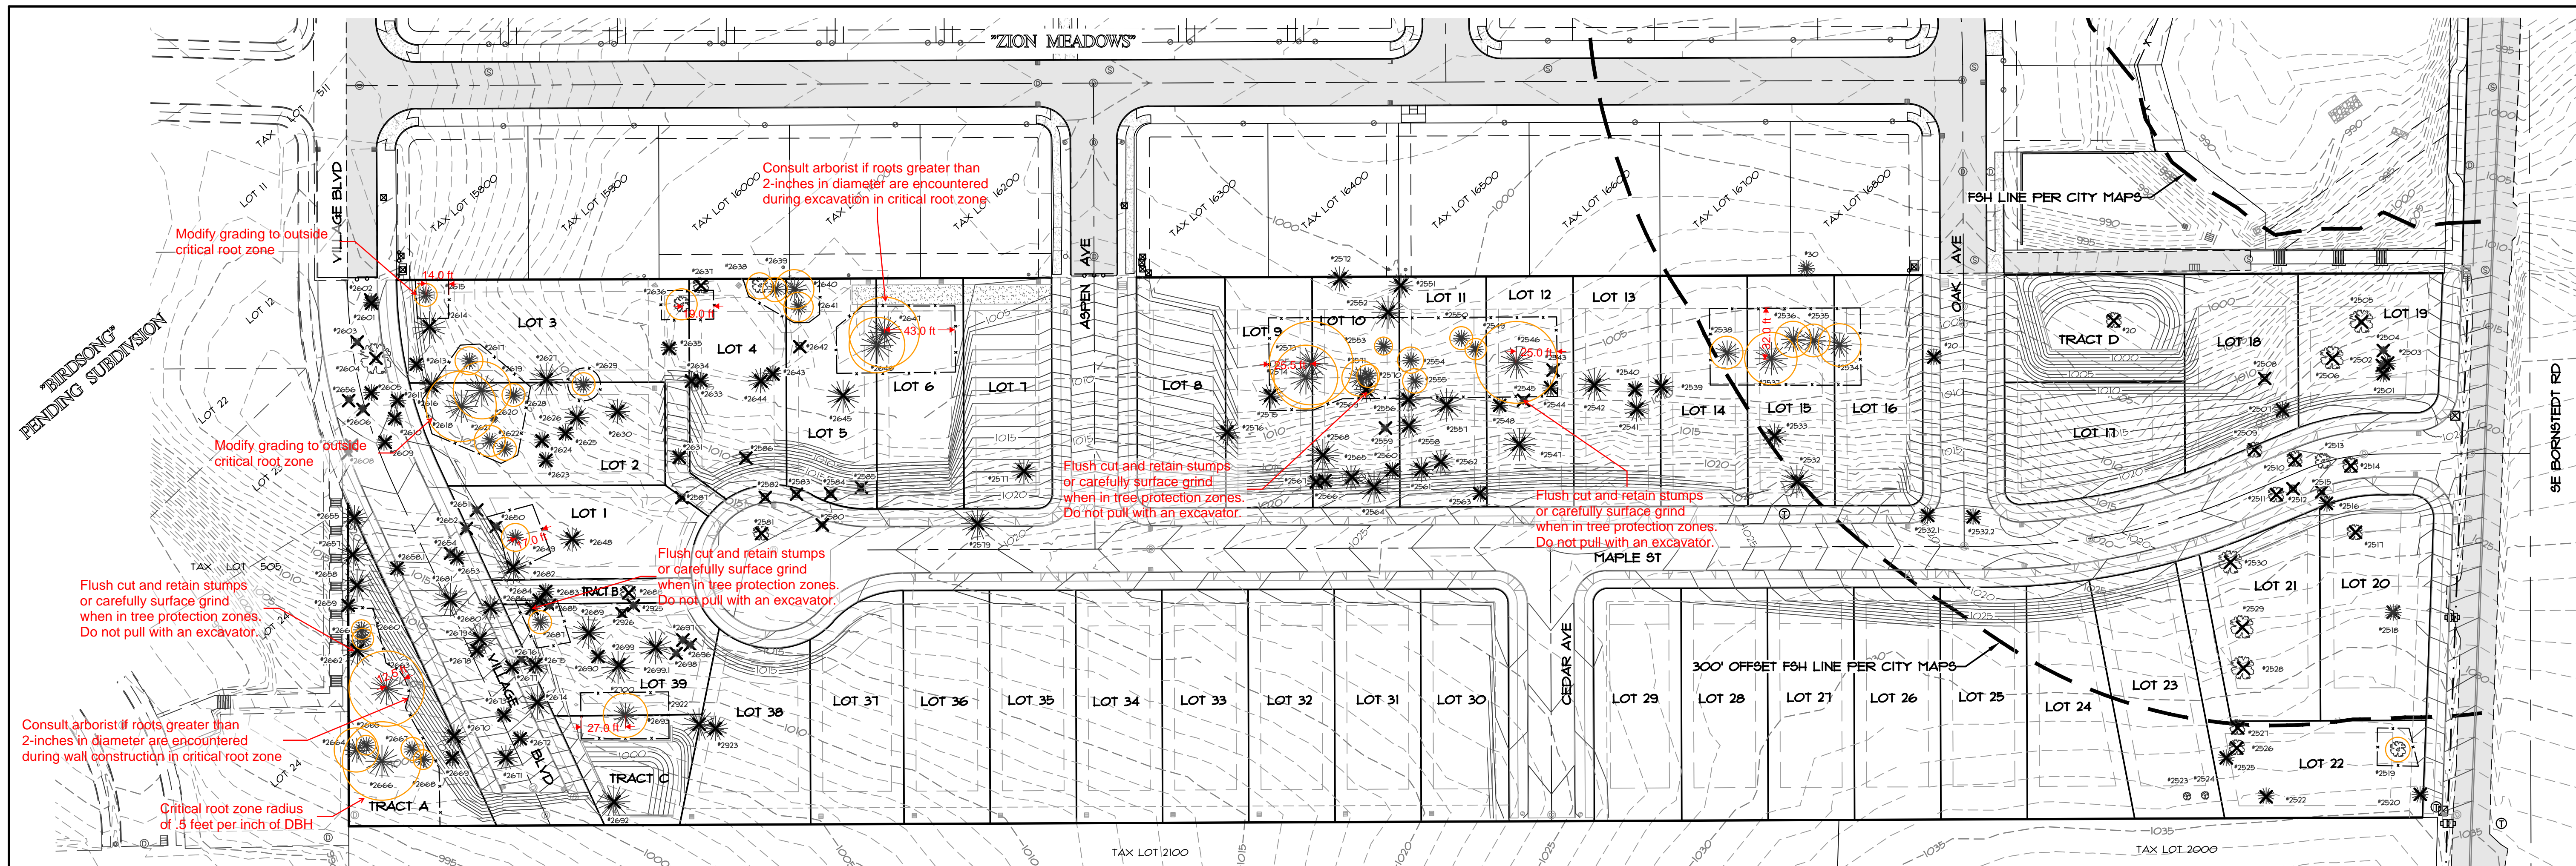
- *Construction Modifications*: Modify the grading so it is outside the tree protection zones of trees 2615 and 2618.

- *Excavation Adjacent to Tree 2647*: Excavation is proposed for a driveway within the critical root zone of tree 2647. The project arborist should be consulted if roots greater than 2-inches in diameter are encountered during excavation.

- *Fill Adjacent to Tree 2663*: A fill slope will encroach within the critical root zone of tree 2663. Based on the large size and good condition of the tree, the project team will attempt to retain it. The fill shall be held back from the tree as far as possible and not closer than 12.5 feet from the trunk as shown in Attachment 1. No vehicles or heavy equipment shall be permitted within the tree protection zone during the placement of fill materials. If a retaining wall is required to hold back the fill, the project arborist should be consulted if roots greater than 2-inches in diameter are encountered during construction of the wall.

- *Tree Protection Fencing*: Establish tree protection fencing in the locations shown in Attachment 1. Required fencing shall be a minimum of six feet tall supported with metal posts placed no farther than ten feet apart installed flush with the initial undisturbed grade.

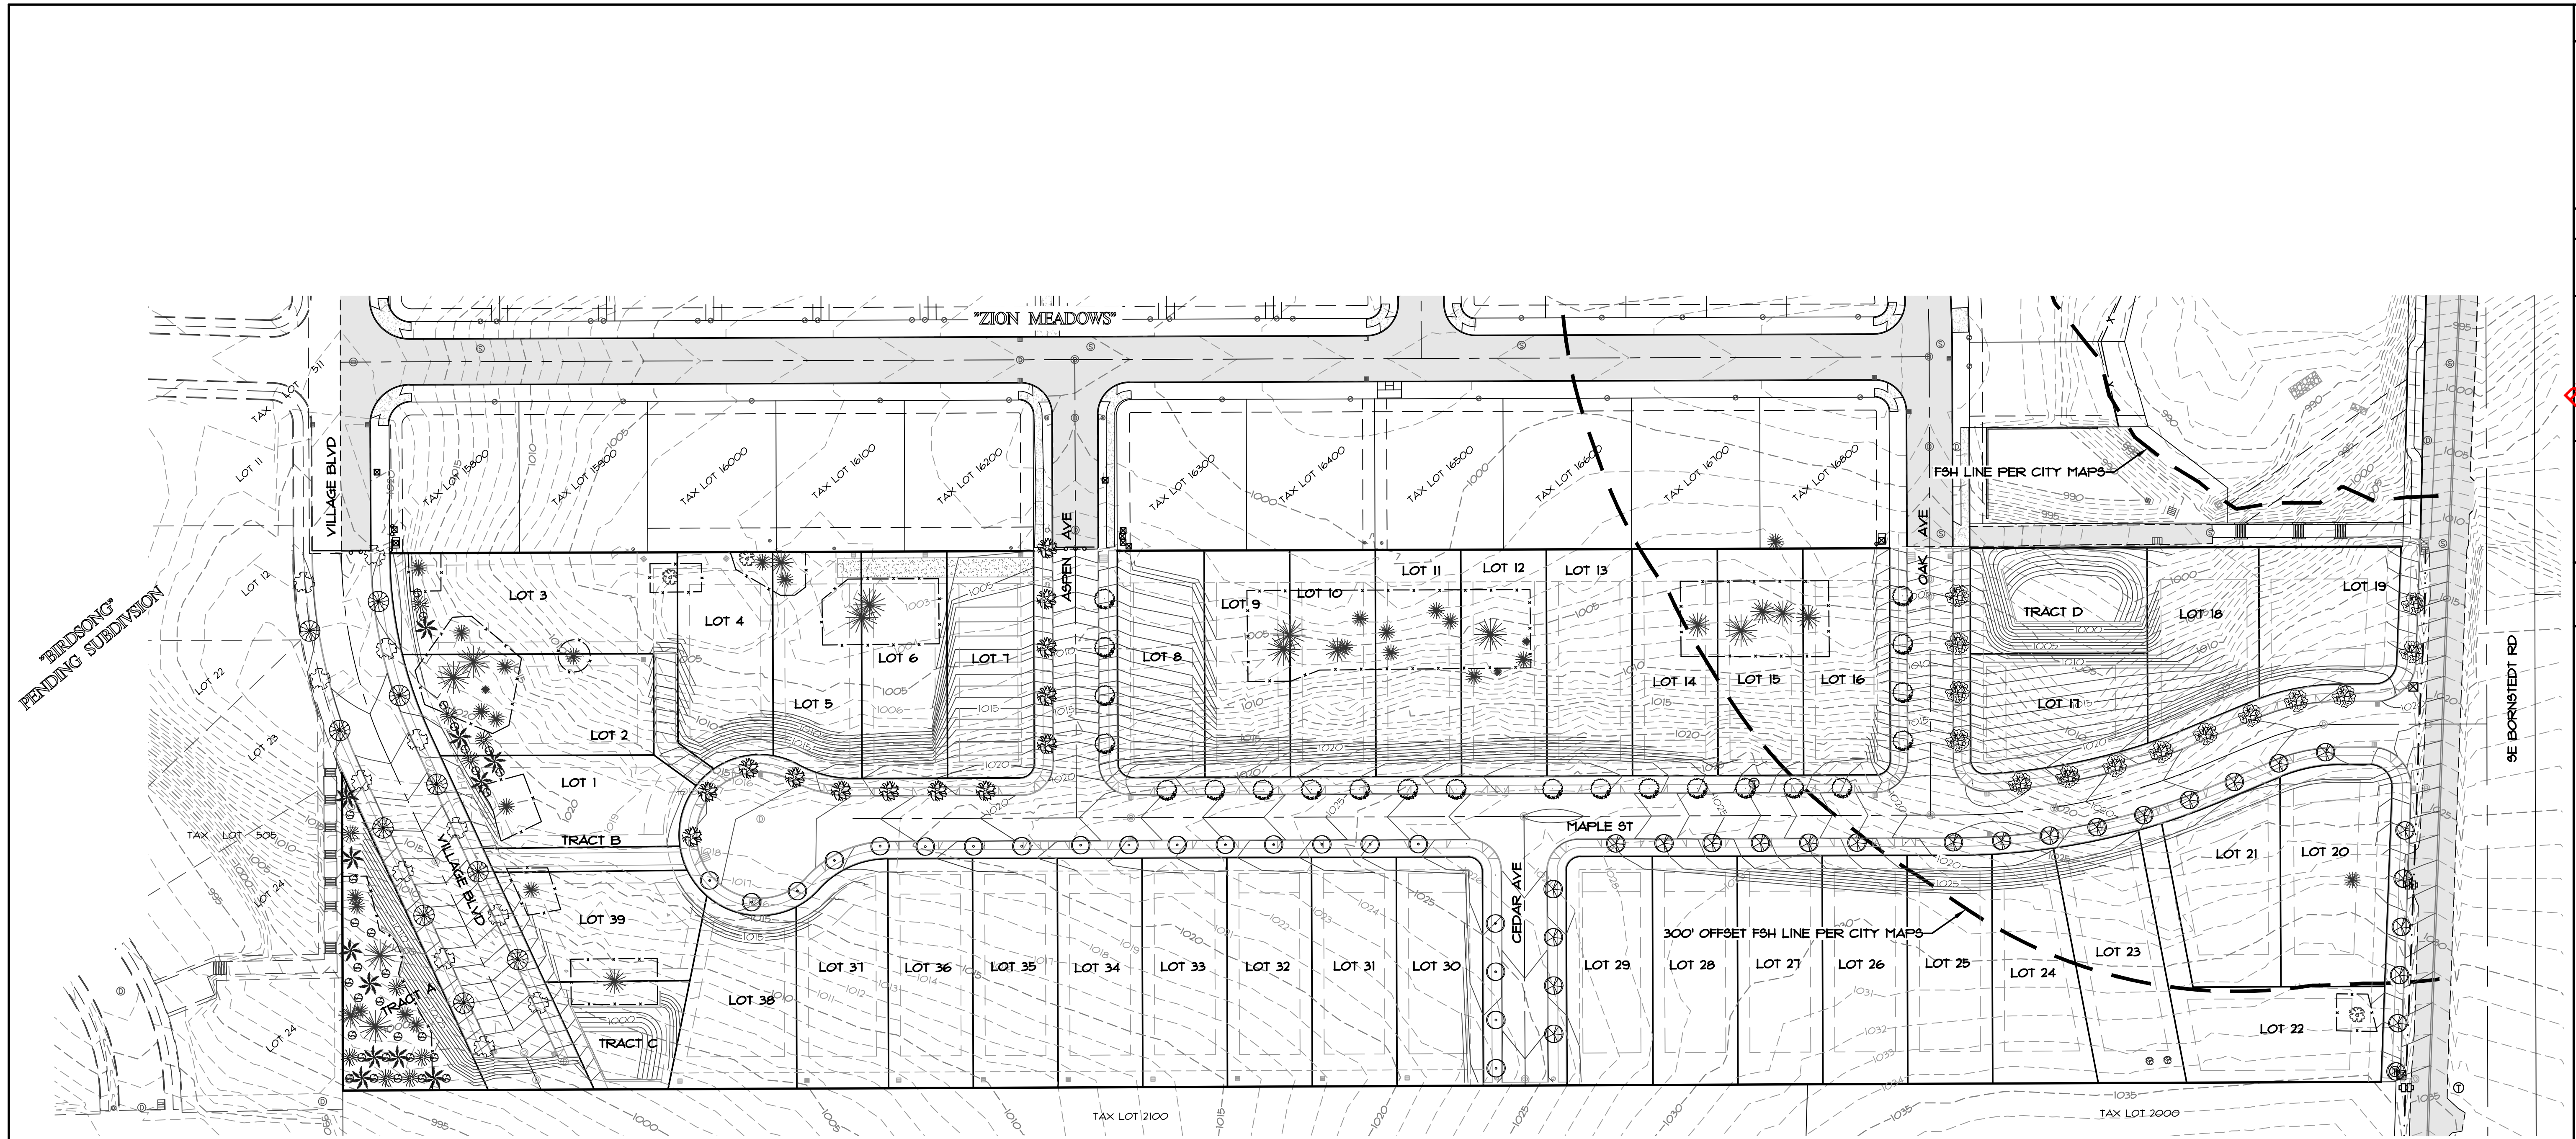
The proposed tree mitigation planting plan is provided in Attachment 2. Based on my recommendations, bigleaf maples (*Acer macrophyllum*) and western red cedars (*Thuja plicata*) are spaced a minimum of 15 feet on center. Vine maples (*Acer circinatum*), which are shade tolerant understory trees, may be spaced as close as six feet on center from existing and proposed trees. This species mix and planting arrangement is sustainable and will allow for the long term growth of the proposed mitigation trees.
