July 14, 2025

RE: Addendum for Riffles Food Carts tree preservation and protection plan at 37133 Highway 26, Sandy, OR.

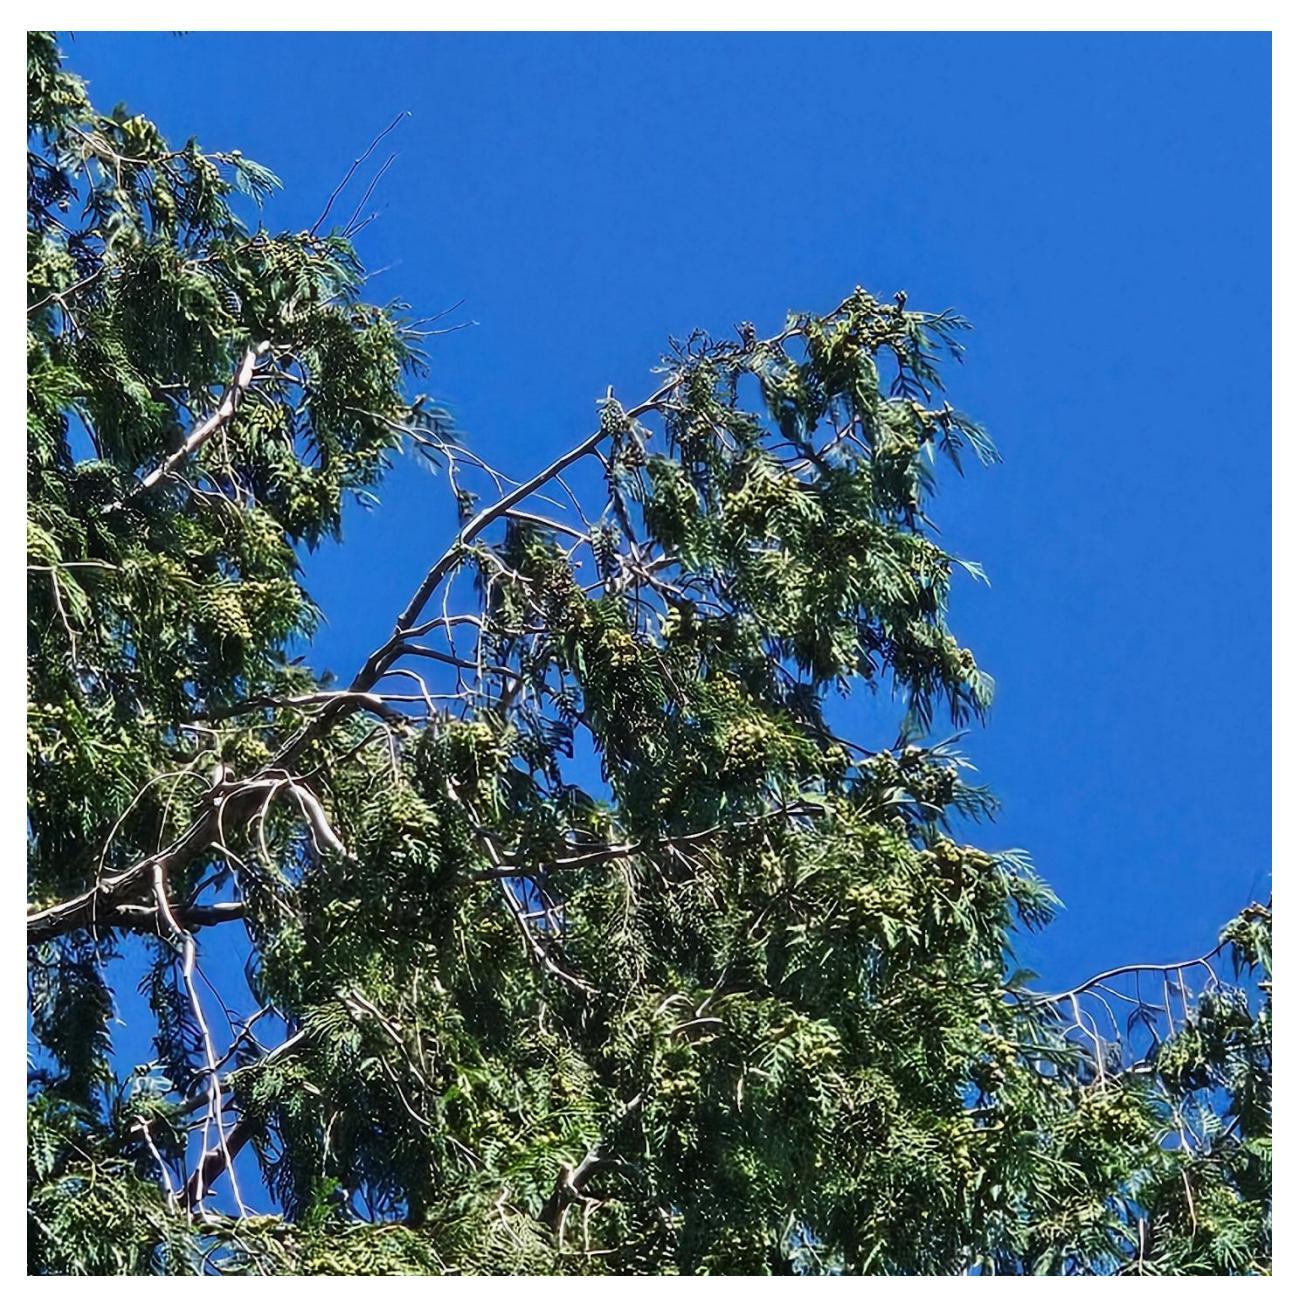
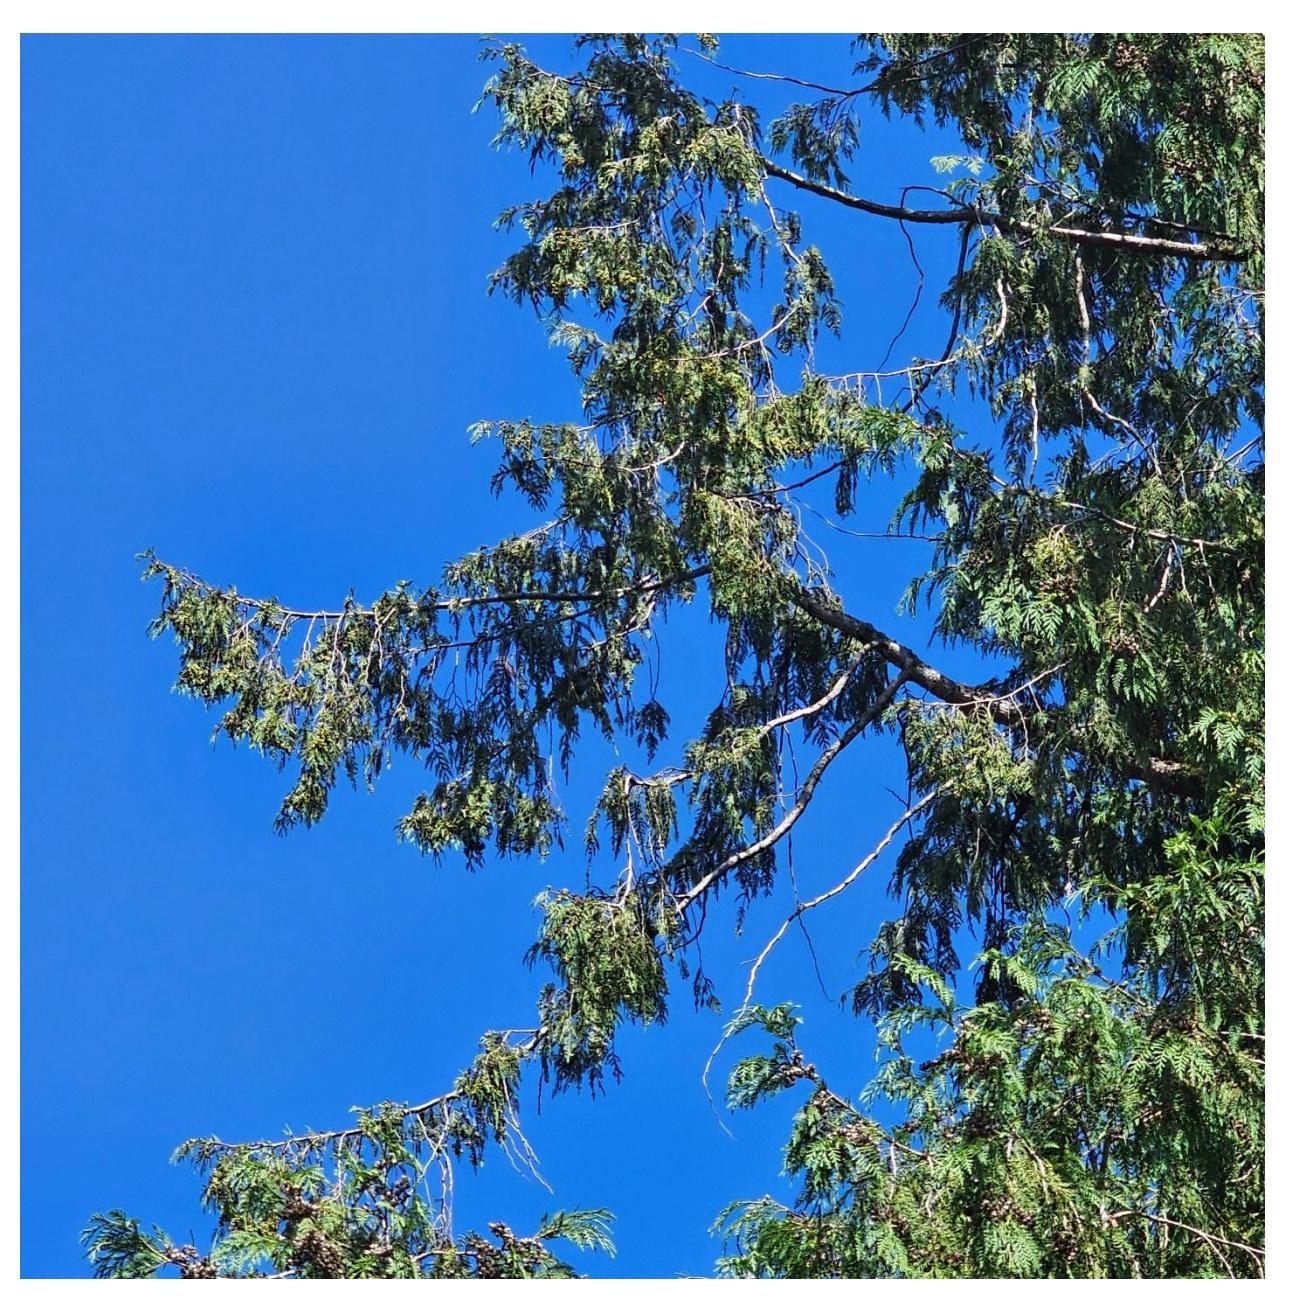
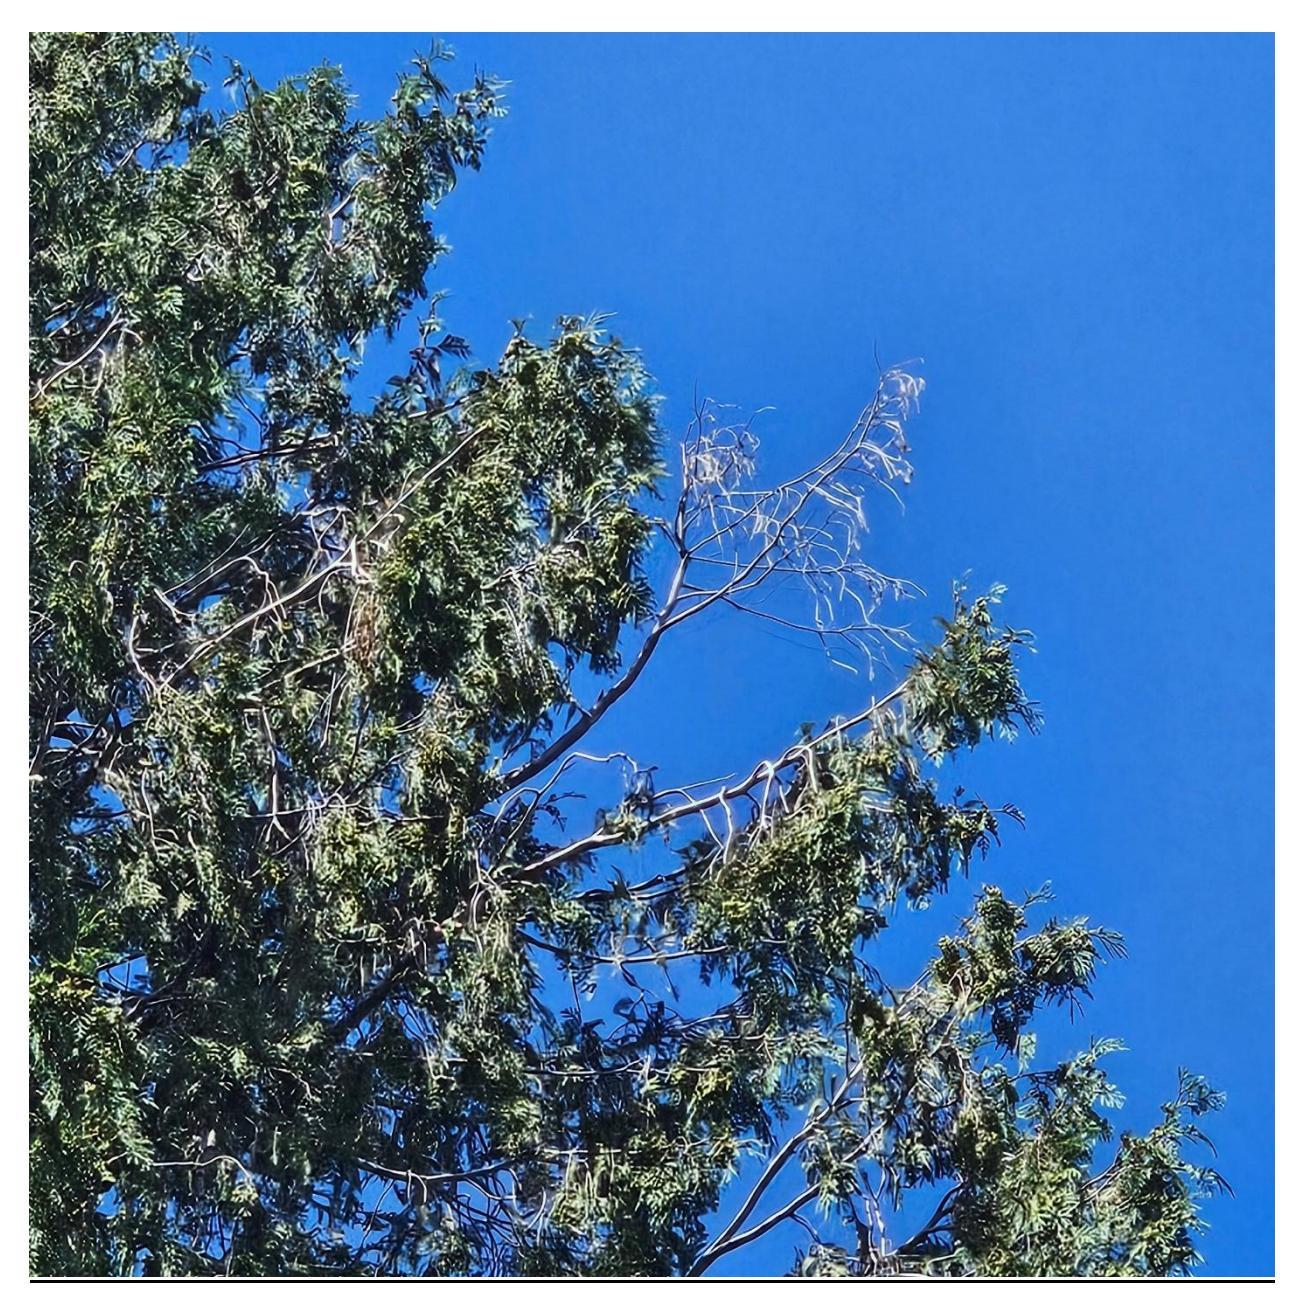
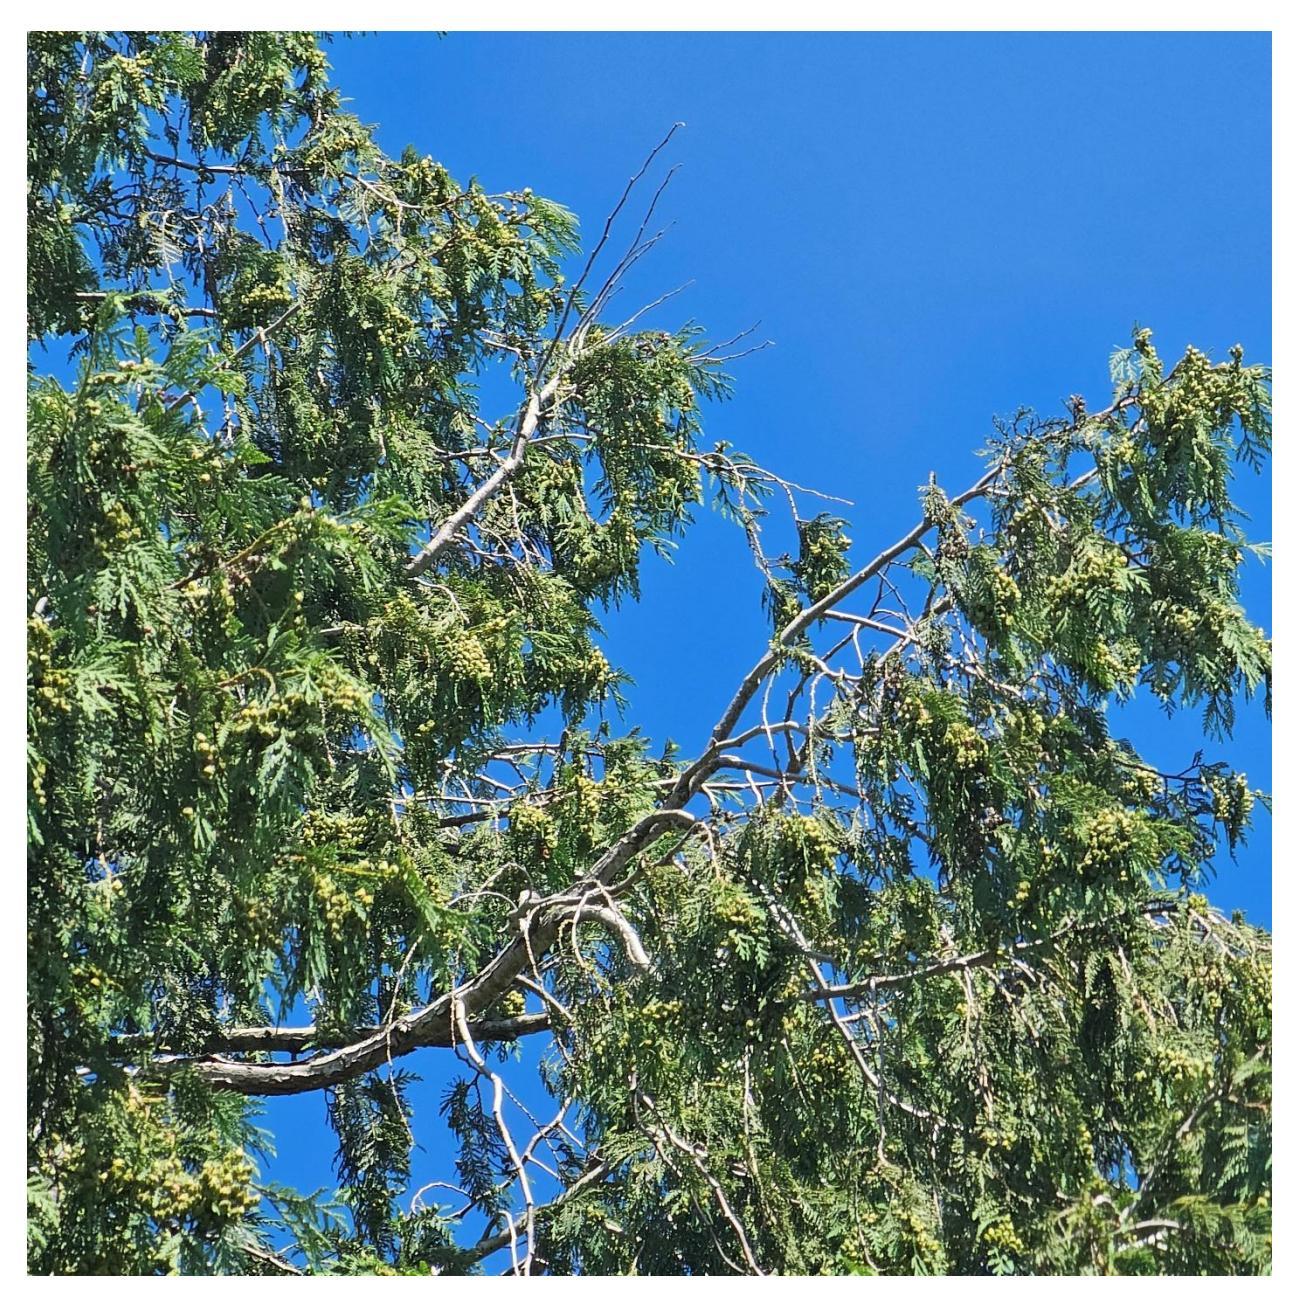
Symptoms of stress related to age, heat and urban environment were observed onsite. These include early stages of canopy and branch tipdieback (Attachments 1-4), and sap bleeding from boring insects. The structure of the tree is defined by a codominant trunk union at 8-feet height and a codominant top with multiple leaders. The codominant trunk union has multiple seams of included bark that extend to near the base of the tree (Attachments 5-9). The secondary trunk leader leans south approximately 15-degrees. The tree has an approximate height of 90-feet and is located on an elevated grade with a high degree of wind exposure. In the event of tree decline and/or windthrow, these features indicate an increased probability of failure. The close proximity of the tree (within the fallzone) to a high-traffic pedestrian area of food carts indicates that the consequences of failure should be considered hazardous.

considering tree health, maturity, structure, species, and site factors described above, the subject tree is not considered sustainable for retention and is recommended for removal.

The forgoing report records observations and recommendations concerning the Riffles Food Carts project. The mature western red cedar marked tree #1 in the 2022 and present report is recommended for removal. (2) native, nursery-grown trees will be planted as mitigation. No other changes to the siteplan or tree plan are advised.
