Todd Prager & Associates
LLC

MEMORANDUM

DATE: May 10, 2023
TO: Kelly O’Neill Jr. (City of Sandy)
FROM: Todd Prager, RCA #597, ISA Board Certified Master Arborist
RE: Tree Variance Review for Cascade Creek Apartments

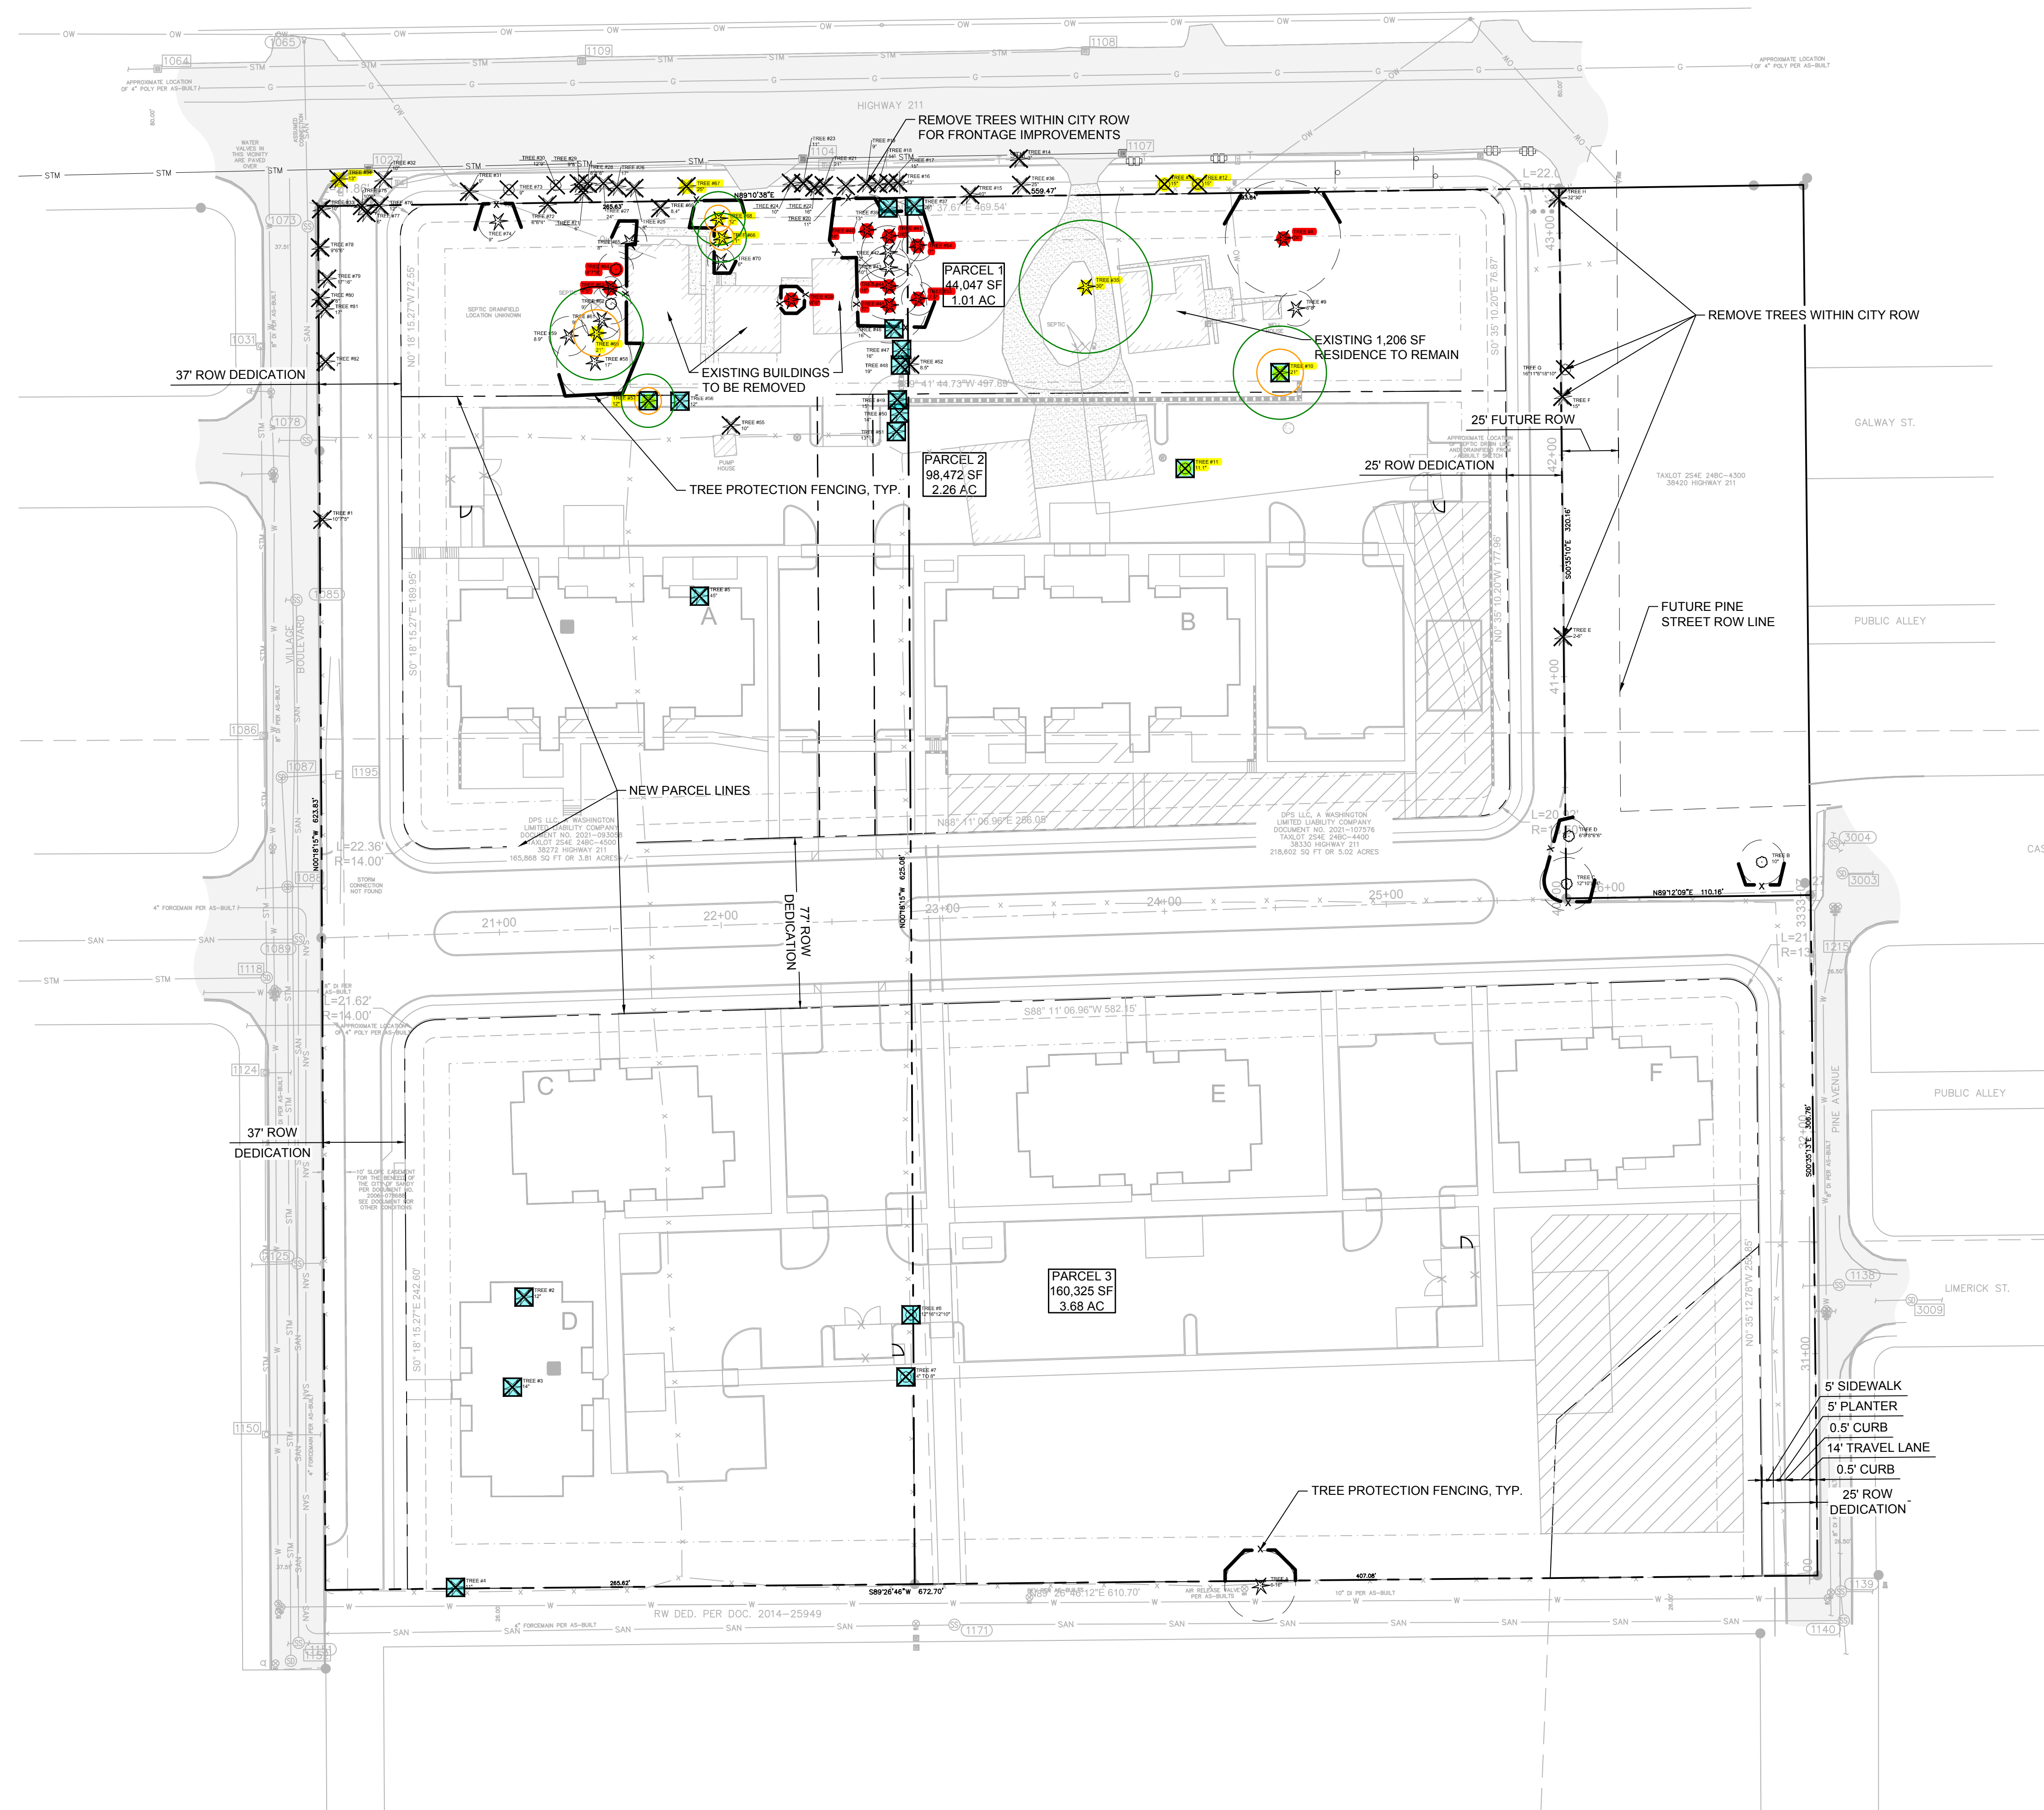
C-102
LAND-USE

The City of Sandy's administrative practice is to require preservation trees to be in good health condition. In reviewing Table 3 of the arborist report, there are 11 potential preservation trees at the site (trees 10, 11, 12, 13, 34, 35, 57, 60, 66, 67, and 68, which I highlighted in yellow in Attachment 1). Four of these trees (trees 35, 60, 66, and 68) are proposed for preservation while the remaining seven trees will be removed. Of the seven trees proposed for removal, four are not practicable to retain because they are within the footprint of right-of-way improvements along Highway 211 (trees 12, 13, 34, and 67) and one is not practicable to retain because it is near the center of a proposed parking lot (tree 11). Two of the trees may be practicable to retain because they are at the edges of a proposed parking lot (trees 10 and 57). These trees should be further evaluated by the applicant for retention with a modified site design which could include reducing adjacent parking stall depth, eliminating adjacent parking stalls, and/or shifting or adding parking lot islands so they are adjacent to the trees.

Ten of the trees to be retained are currently in poor condition. These trees are highlighted in red in Attachment 1. The applicant team should coordinate with the

Tree 35 is proposed to be retained but does not have tree protection fencing shown for its root protection zone. In reviewing sheet C-501 from the civil plan set, there is a new sanitary sewer service line proposed within its root protection zone. Based on the potential impacts to the tree, tree protection fencing should be provided for tree 35. The applicant team should also coordinate with the project arborist to determine if an alternate route for the sanitary sewer service line is possible to better protect the tree.

Findings and Recommendations: Tree 35 does not have tree protection fencing and there is a sanitary sewer service line proposed within its root protection zone. Tree protection fencing should be provided for tree 35. The applicant team should determine if an alternate route for the sanitary sewer service line is possible to better protect the tree.

Findings and Recommendations: The gross site acreage is 8.83 acres and the BVO standards require the preservation of six trees per acre. Therefore, a total of 53 preservation trees are required to be retained. There are 11 possible preservation trees at the site. Four are proposed for retention, five are not practicable to retain based on their locations relative to right of way and parking lot improvements, and two may be practicable to retain with minor design changes. The applicant should further evaluate design options to retain trees 10 and 57.

Findings and Recommendations: Ten trees to be retained are in poor condition and eligible for removal. The applicant team should coordinate with the project arborist to evaluate whether trees in poor condition should be retained or if they should take the opportunity to remove them with proposed construction.

- Further evaluate design options to retain trees 10 and 57;
- Coordinate with the project arborist to evaluate whether trees in poor condition should be retained;
- Provide protection fencing for tree 35 and determine if an alternate route for the sanitary sewer service line to avoid the tree's root zone is possible;
- Require the project arborist to be onsite and document the proper protection of tree 70 during demolition work in its root zone for it to receive credit as a mitigation tree; and
- Provide 37 to 41 additional native replacement trees and ensure a minimum spacing of at least 15 feet on center for all replacement trees.
