## EXHIBIT L

### PACIFIC HABITAT SERVICES, INC.

**Subject: Third-Party Review of Streamflow Assessment Report prepared for 19618 SE Bornstedt Road, Sandy, Oregon PHS #74178**

Photo Documentation  
19618 SE Bornstedt Road, Sandy, Oregon

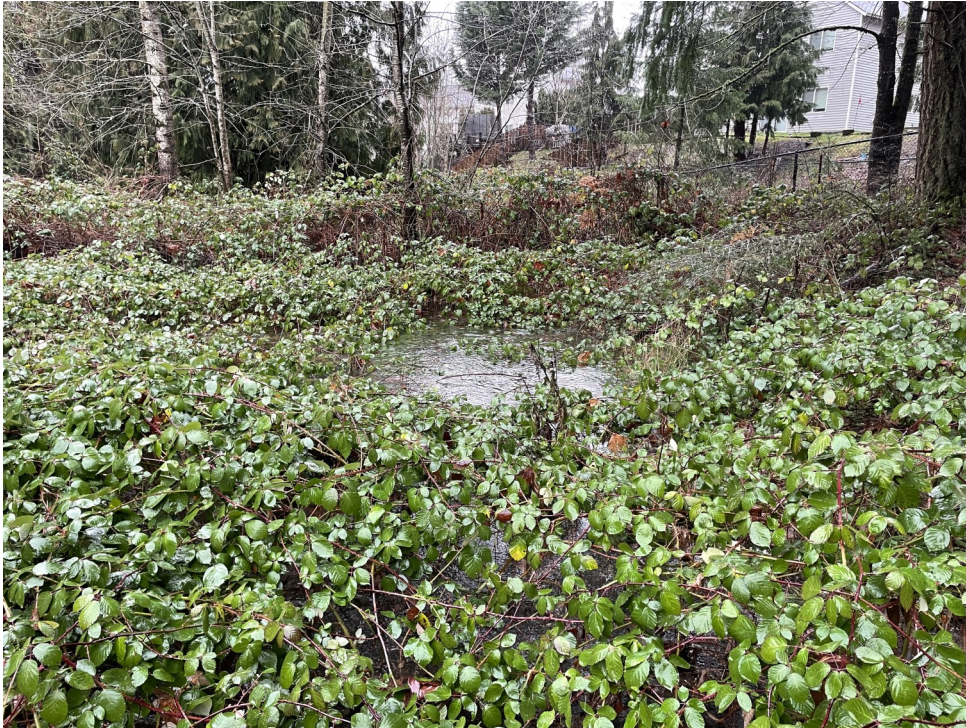
**Photo 2**

Looking southwest along  
the stream.

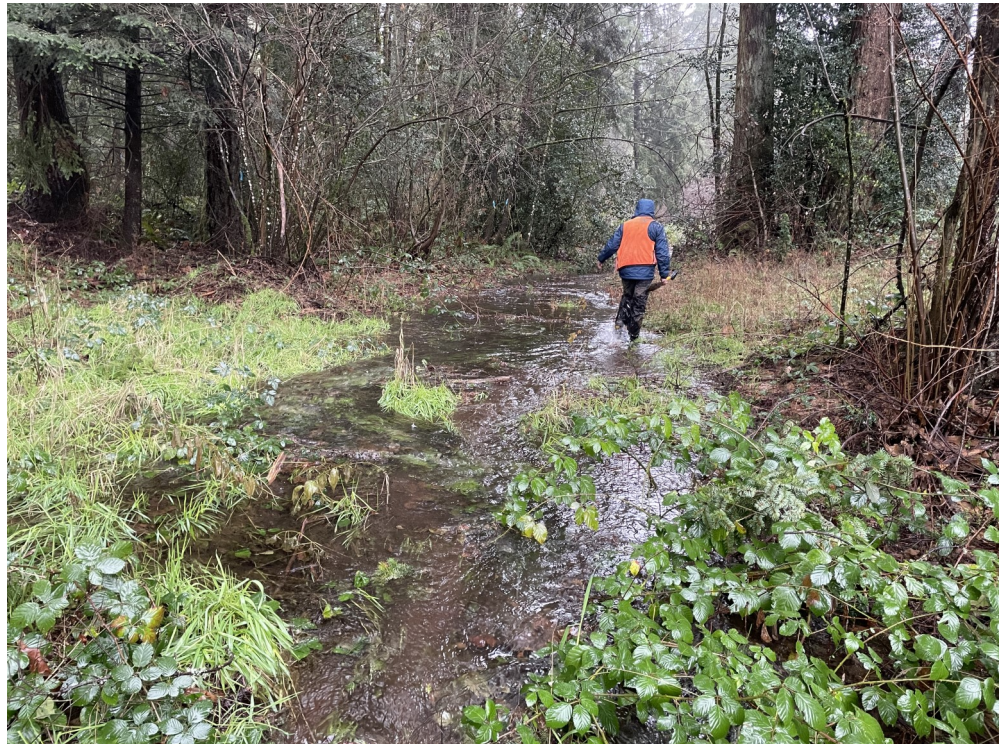
**Photo 3**

Looking southwest along the stream.

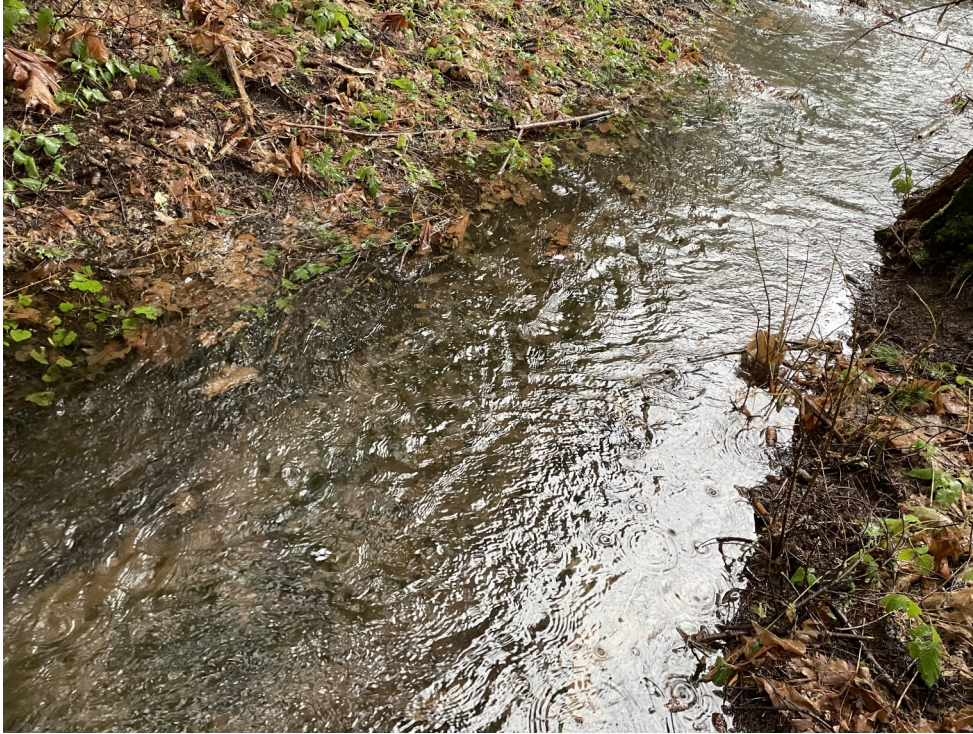
**Photo 4**

Looking southwest along the stream.

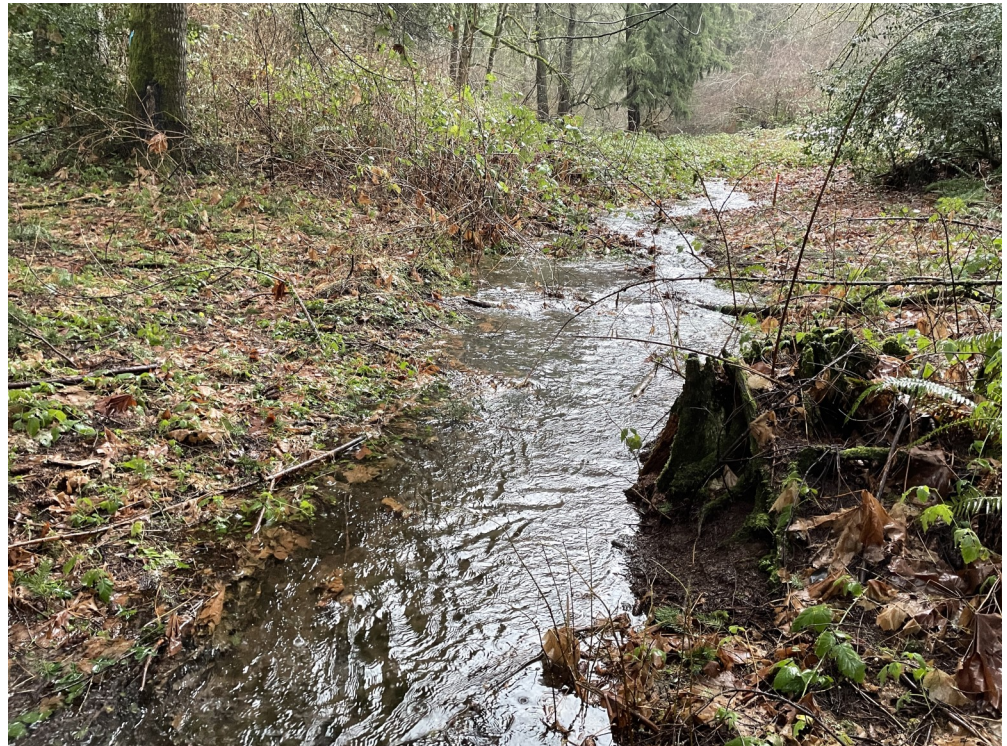
**Photo 5**

Based on the presence of wetland plants with a FACW indicator status in portions of the stream channel and the presence of soils meeting hydric soil indicators within the drainageway, it is PHS's opinion that the stream may be intermittent rather than ephemeral. By definition, ephemeral streams flow only in direct response to precipitation. The streambed is always above the water table, and stormwater runoff is the primary source of water. Intermittent streams contain water for only part of the year, typically during the winter and spring when the streambed is below the water table and/or snowmelt from surrounding uplands provides sustained flow. Because the original streamflow assessment was conducted in September 2021 (a time of year when an intermittent stream might be expected to be dry) and because PHS's site visit was conducted during winter after a period of higher-than-average precipitation (a time of year when it can be extremely difficult to distinguish between intermittent and ephemeral streams), PHS recommends that the stream be observed and reassessed during the late spring after a precipitation event and again after a period with no precipitation to determine if flow persists and if stream flows are truly ephemeral rather than intermittent.

Hydric soils from wetland area in the northern portion of the site.

Additionally, NWI mapping depicts wetland on the site, and PHS's observation of hydric soils within a hydrophytic plant community indicate that wetlands subject to jurisdiction under the Oregon Removal-Fill Law and/or Section 404 of the Clean Water Act may be present on the site. A wetland delineation of wetlands is recommended to document the location and extent of wetlands on the site.

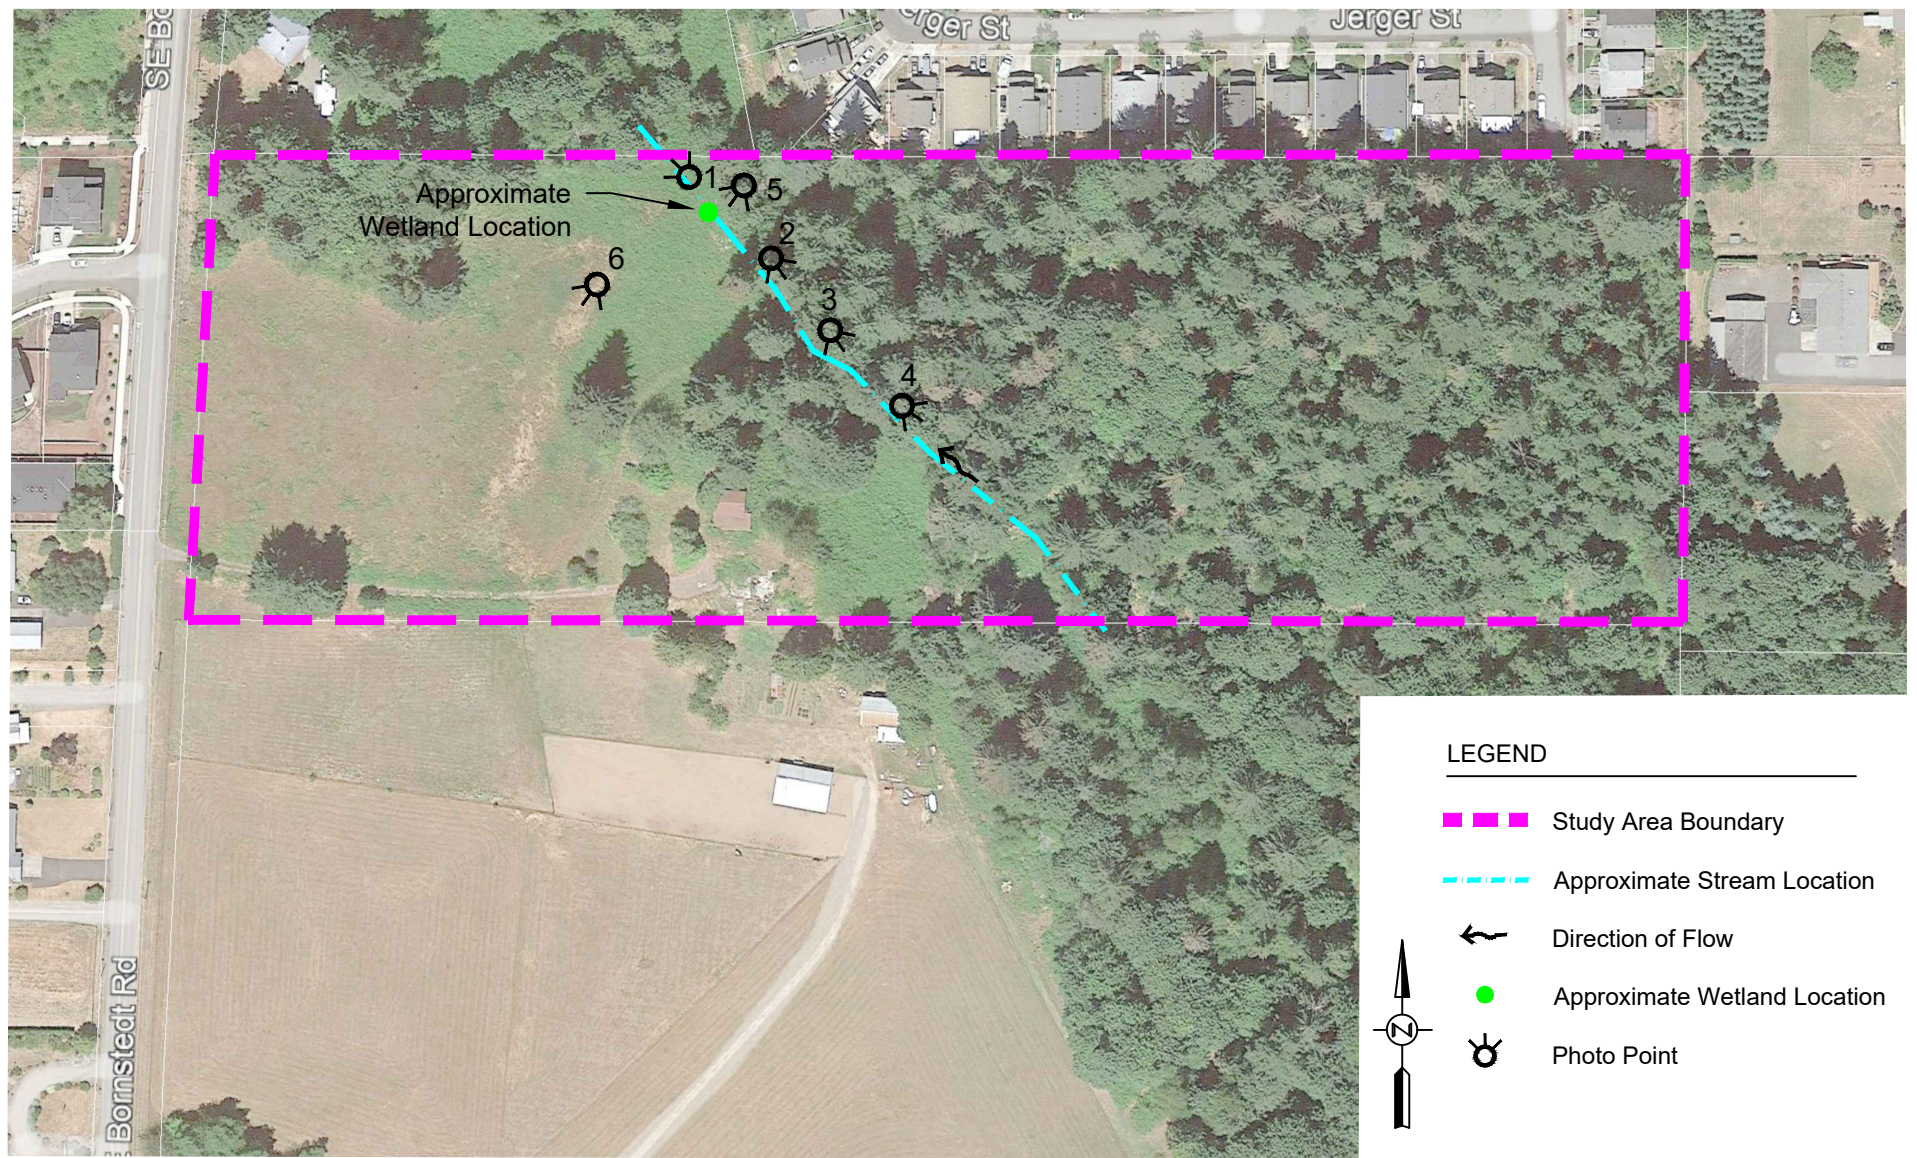
**Figure**

Photos of existing conditions at the time of PHS’s site visit are included in Attachment A. A figure showing the location of the photos and the approximate location of wetland, and the mapped stream
