Name of Project:	Knollwood Mobile Estates
Location or Address:	37600 sunset St. #58, Sandy, OR 97055

Request:	Removal of 1 alder & 1 maple that are hazard trees.

DATE: October 5, 2021
TO: Allison Hanson, Knollwood Estates
FROM: Christine Johnson, ISA Certified Arborist, PN-8730A
RE: 2021 Knollwood Estates Tree Inventory

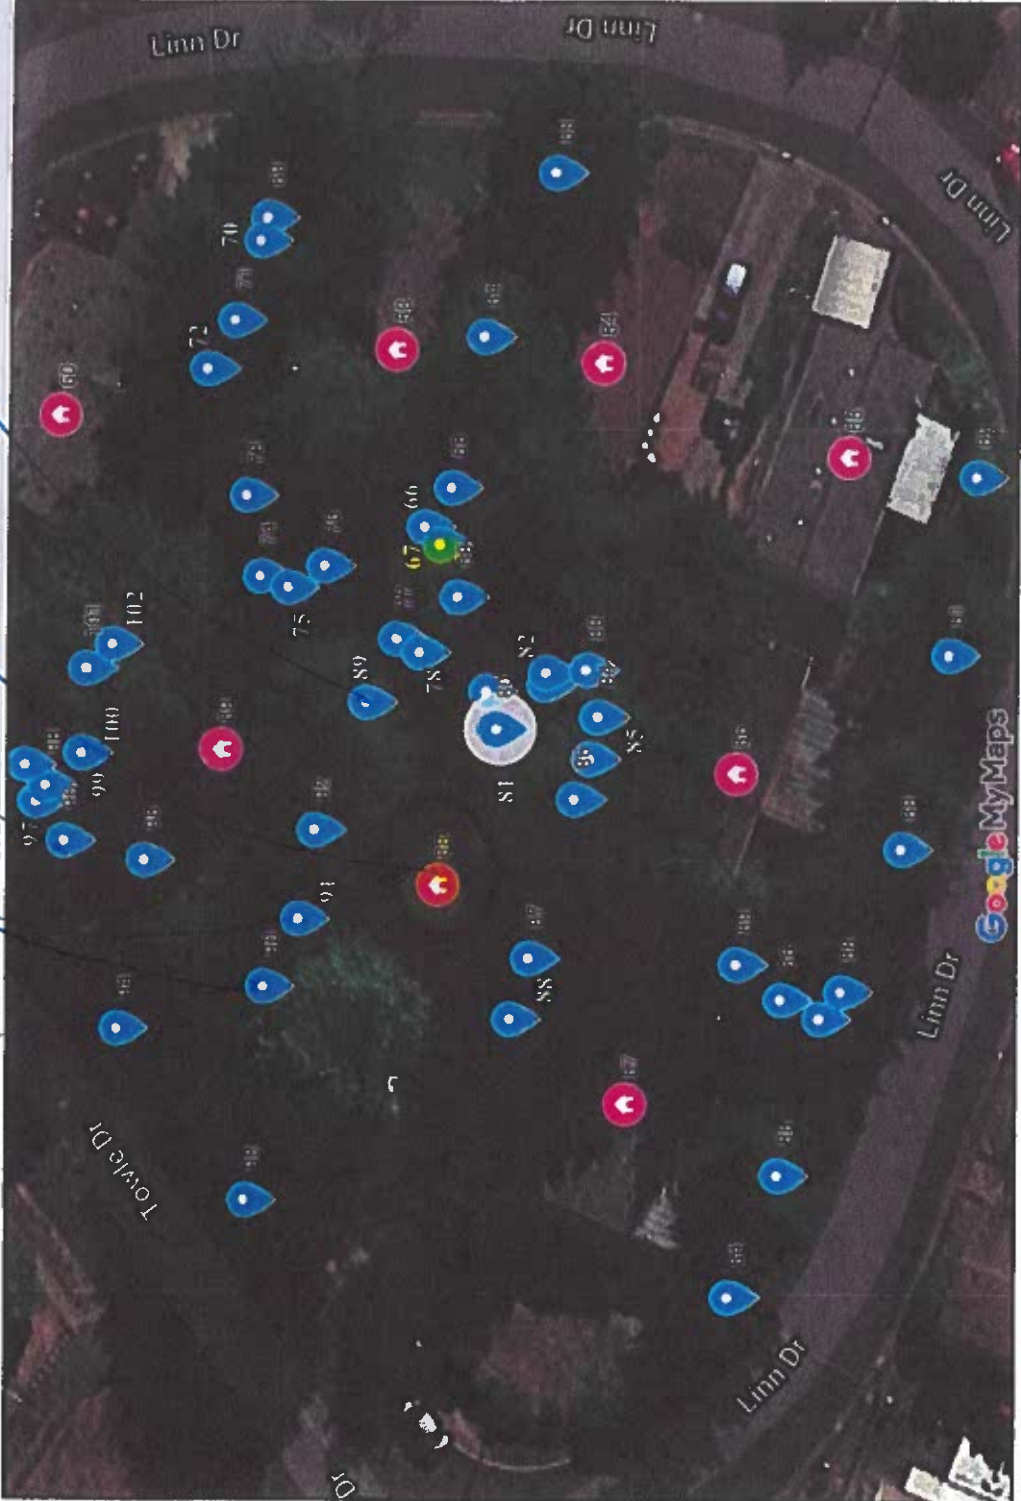
Figure 5 Linn Dr. Trees 54-102.

90
Home # 95
p 8 # 98

Tree #89 on inventory list

Tree #90 on inventory list
