# General Land Use Application

| Location or Address: | 15212 Jewelberry |

**Basic Visual Tree Assessment Summary for  
RMH Bartels Construction  
15212 Jewelberry Ave  
Sandy, OR**

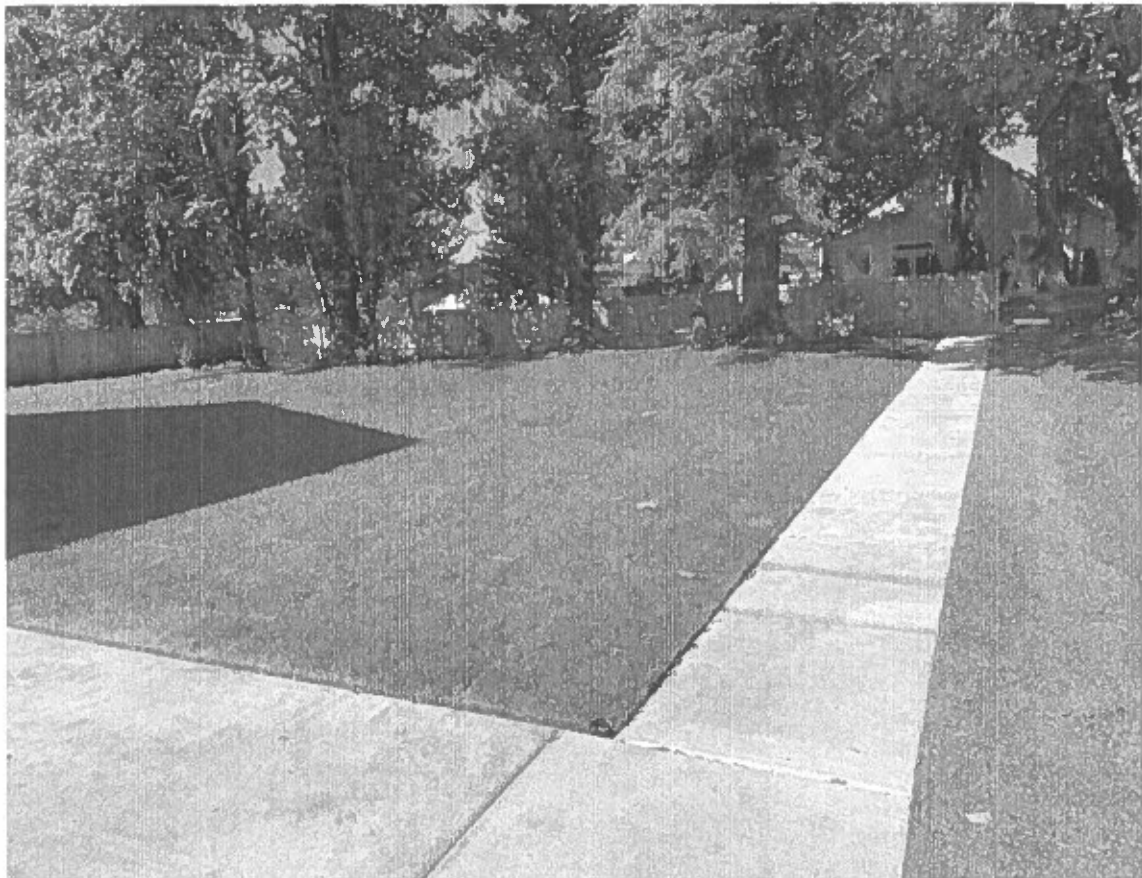
**Figure 1. Tree locations**

A new concrete walk to Jewelberry Ave was constructed along the north side of the property, north of Tree #5. No evidence of root cutting was observed. The yard has new sod and bark mulch covering the ground. The walk provides access to Jewelberry Ave. through a gate in the fence. There is no parking permitted on Jewelberry Ave. which has one lane with curbs and a vegetated median strip.

Tree #2 is located directly between the front door of the residence and Jewelberry Ave. The grade of the site is fairly level with a slight drop as the site approaches the sidewalk along Jewelberry Ave. It is estimated that constructing a sidewalk from the front door straight west to Jewelberry Ave. would likely involve a 12 to 16-inch excavation near the location of the trees to accommodate the grade change, concrete walk, and gravel base.

Constructing a sidewalk directly west from the front door to Jewelberry Ave. would require the removal of Tree #2, a bigleaf maple tree 41" in diameter. Some root damage would also occur to Tree #1 and Tree #3 in the standard root protection zone around the trees of 1-foot radius per inch of trunk diameter, and near the limits of their critical root zones of .5-foot radius per inch of trunk diameter. The current walk construction appears to serve the same access function while preserving the trees.

1. I recommend requesting a variance to the standard walk location to preserve and protect the existing trees located along the west side of the property.
2. If a variance is not granted, I recommend removing Tree #2 and positioning the new walk at least 6 feet away from Tree #1 and at least 10 feet away from Tree #3, if possible.
