#### WETLAND DELINEATION / DETERMINATION REPORT COVER FORM

#### DELINEATION REPORT WD2018-0656 FOR PERMITS NWP2018-473 AND 61489-RF 37090 SE Kelso Road Boring, OR

- Figure 1: Figure 2: Figure 3: Figure 4: Figure 5:
- Figure 6A Figure 6B
- Location Map (Streamnet) Tax Map NWI Map Soil Map Aerial Photo (Google Earth 2017) Wetlands (Entire Study Area) Wetlands (Detail of Olson Road Area)

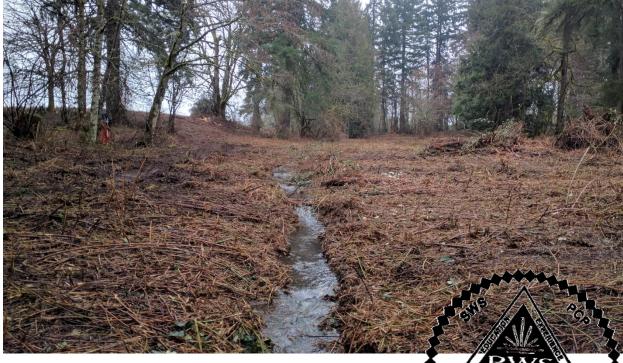
## Cover Photo.

Photo of stream on property shortly after blackberries were mowed. ETC Photo 3/13/2017

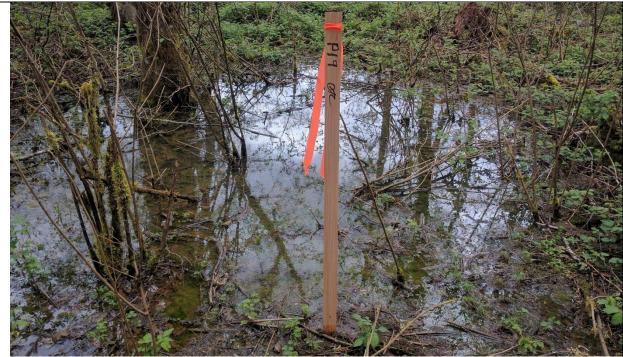
Photo 3. Wetland "B", a small depressional wetland in a forested area adjacent to Stream 2 in a forested area near where Stream 2 enters the subject property on the East border. ETC Photo 4/28/2017

**Wetland "B", 2,225 SQFT, 0.051 Acres**. Wetland "B" is a small depressional wetland next to Stream #1. Some water enters from the property to the East as part of the same basin that Stream #2 runs through. Most of the wetland appear to be caused by high groundwater tables. Although the lower end connects to Stream #1, water exchange is mostly subsurface, and from the wetland to the stream. Areas of the wetland that are inundated or saturated to the surface have little vegetation. The area is densely shaded by trees rooted both in and outside of the wetland area. The Cowardin classification is Palustrine, Unconsolidated Bottom, Mud, Seasonally flooded/saturated. HGM classification is depressional wetland.

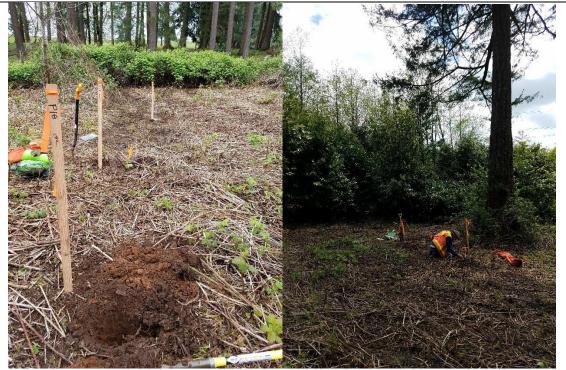
Photo 4, (left) and 5 (right). Wetland "C". Photo 4 looks down toward the stream, and 5 looks up from the stream. P18 had dry non-hydric soils, and saturated hydric soils were found at P17 which is slightly lower and closer to the stream.

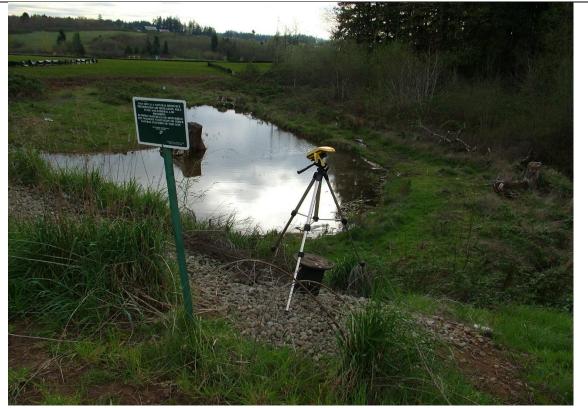
Photo 7 Track "E" mitigation area in April 2007. Olson Road had not been constructed, it would be later be built along the far side of the pond. ETC Photo 4/4/2007.

A small shallow horse shoe shaped pond about 4,267 SQFT in area was excavated in about the middle of Track "E", and the hydrology monitoring study conducted in 2007 found it to be flooded to a depth of about 6".

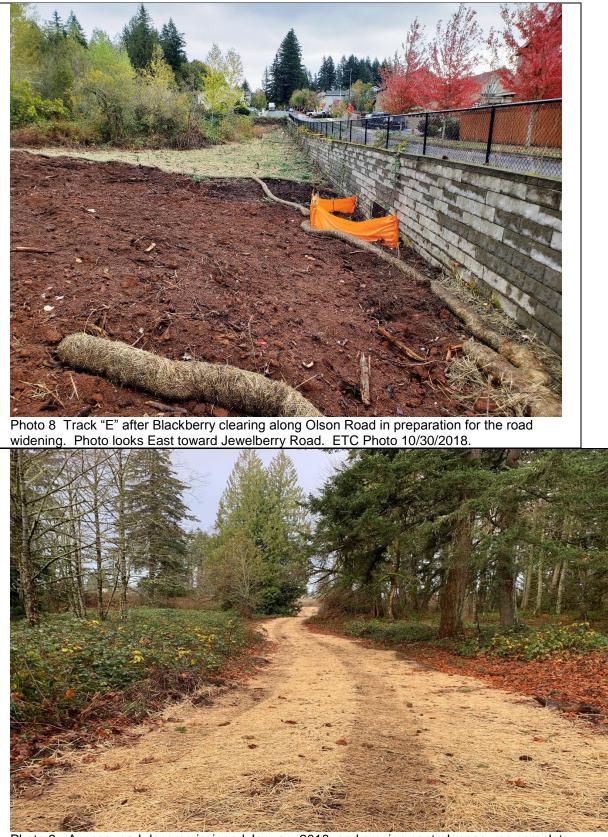
Photo 9 - Access road decommissioned January 2018, and erosion control measures complete.
