WETLAND DELINEATION / DETERMINATION REPORT COVER FORM Exhibit H

Project Name: 37090 SE Kelso Road	Latitude: N 45.245314	Longitude: W -122.165512
Proposed Use: New Subdivision (Sandy Woods)	Tax Map # 032S4E11	
Project Street Address (or other descriptive location): 37090 SE Kelso Road	Township T2S Range R4E Section 2 QQ AC Tax Lot(s) 24E1102200, 24E11AC00828 & 24E11AC00832	
City: Boring, OR County: Clackamas	Waterway: No name River Mile: _____ NWI Quad(s): Sandy, Oregon

DELINEATION REPORT WD2018-0656
FOR PERMITS NWP2018-473 AND 61489-RF
37090 SE Kelso Road
Boring, OR

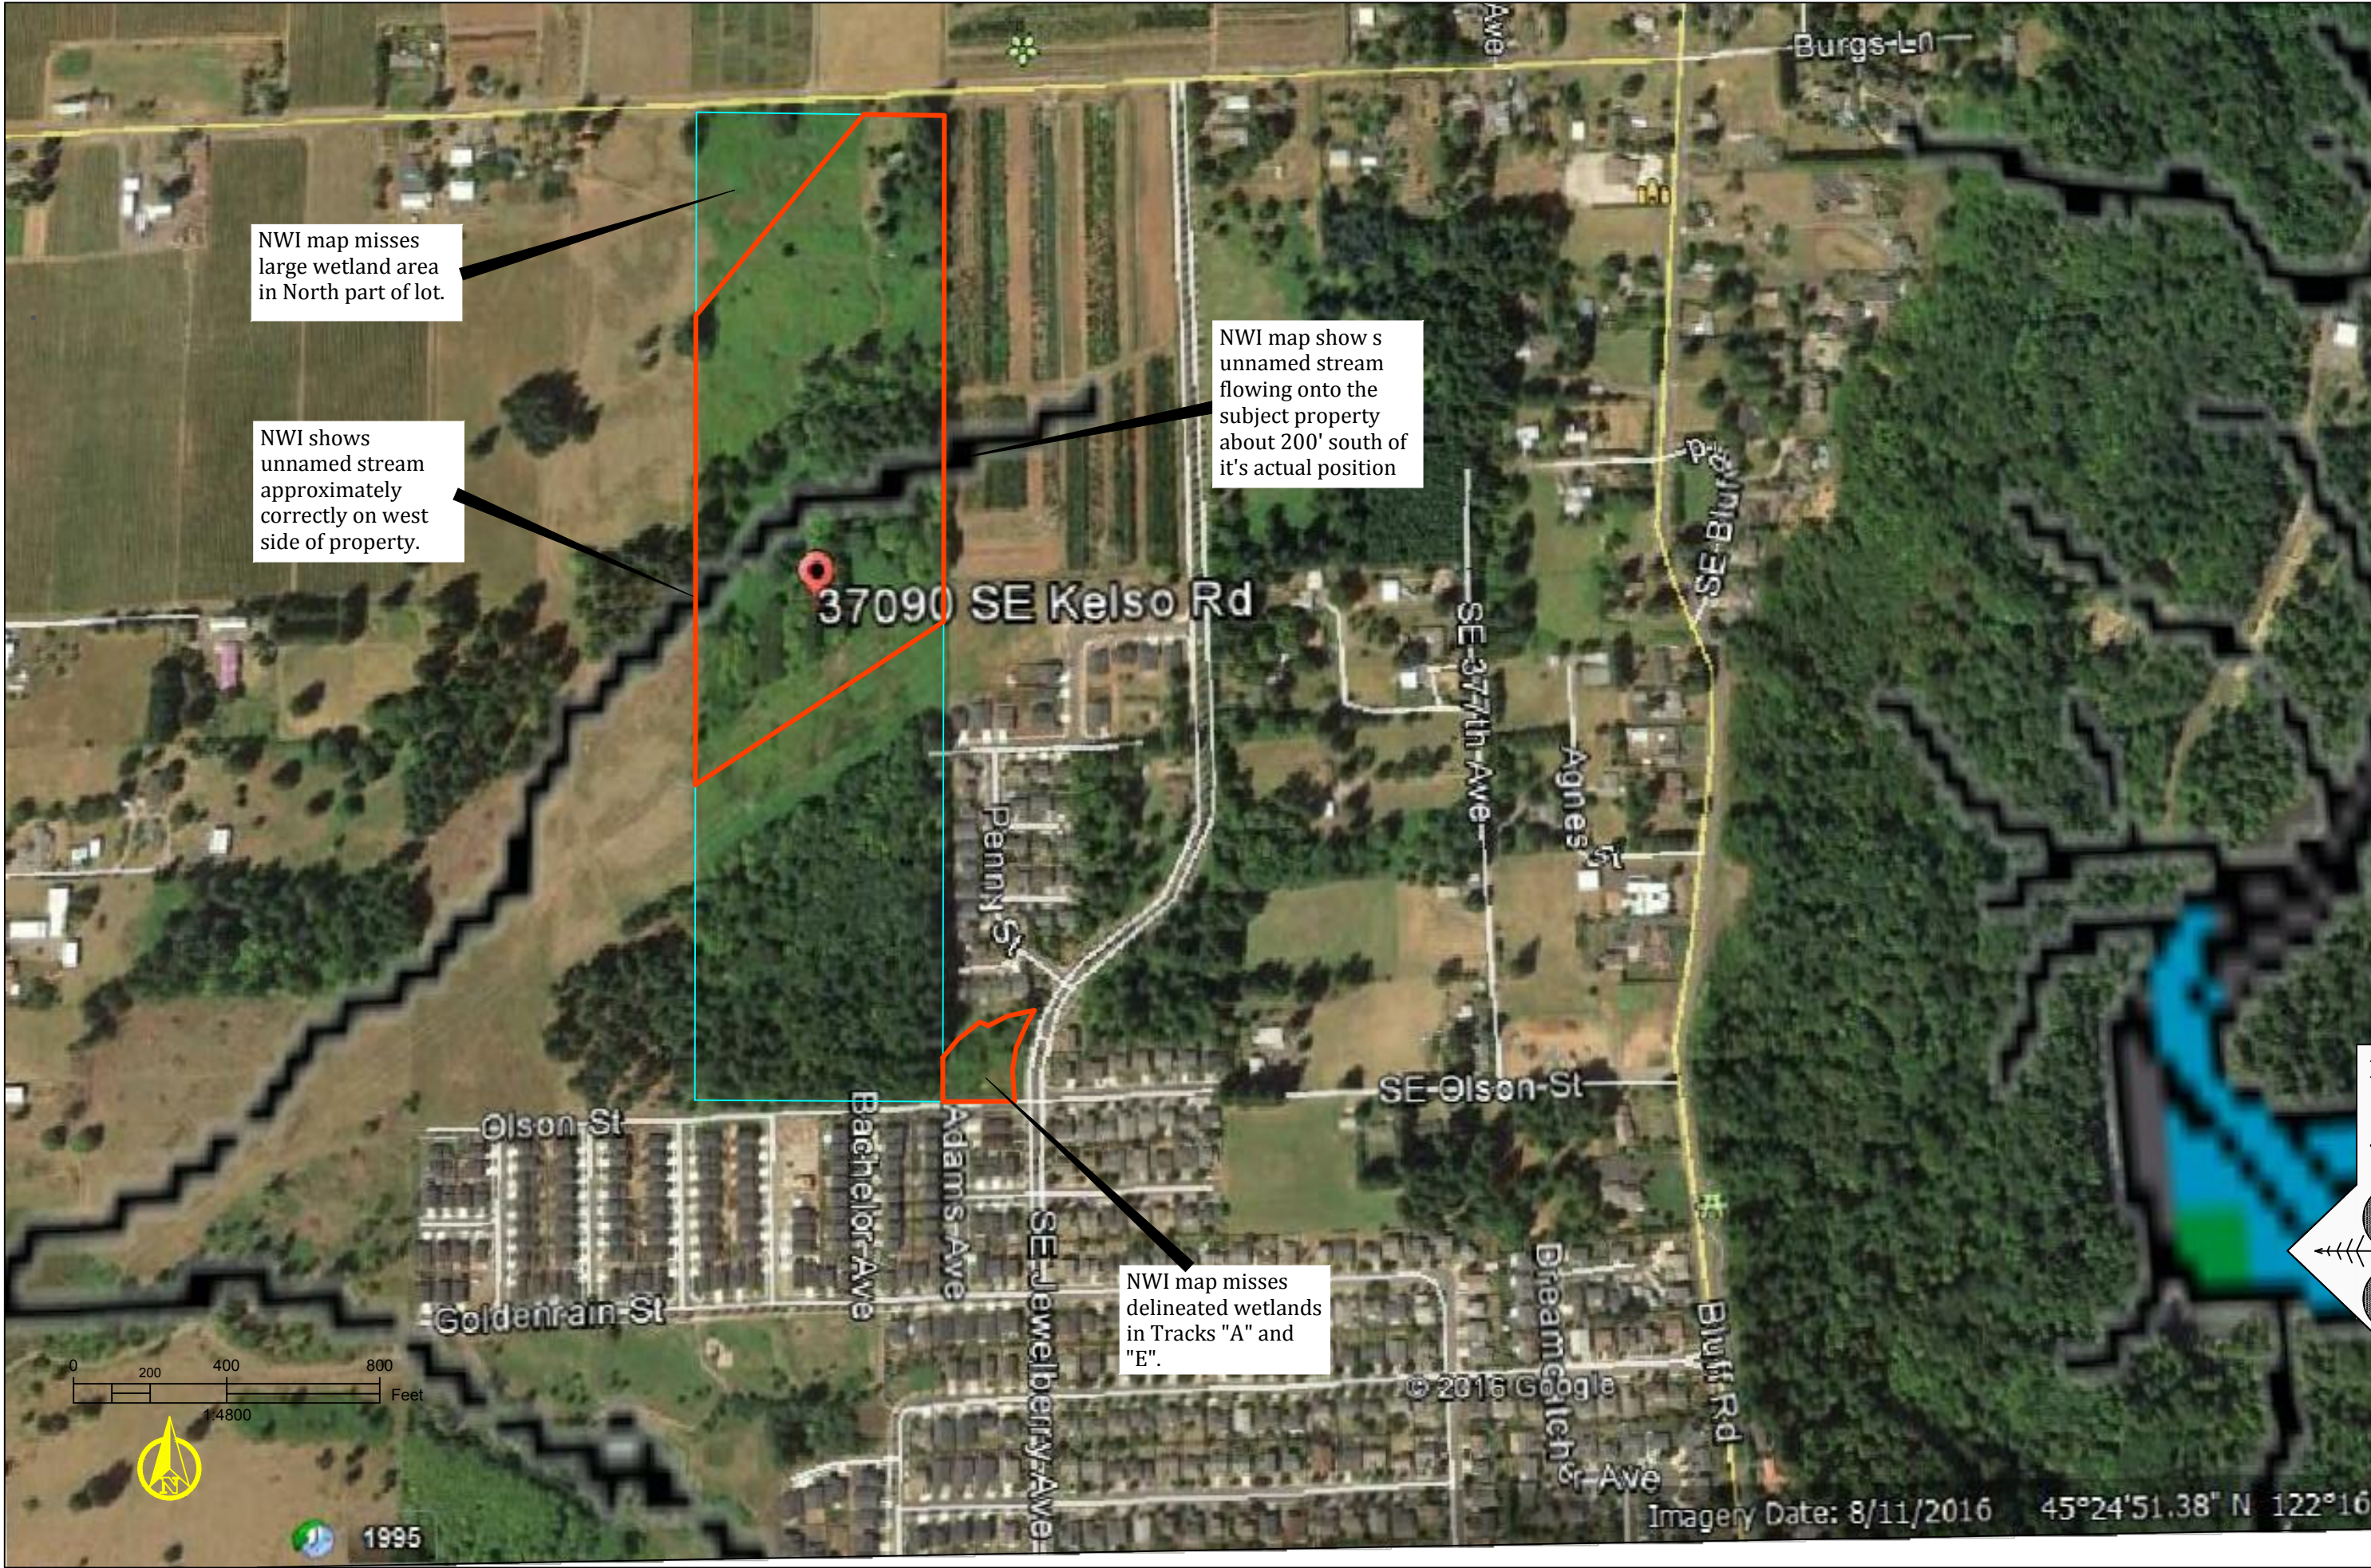
NWI map misses large wetland area in North part of lot.

NWI shows unnamed stream approximately correctly on west side of property.

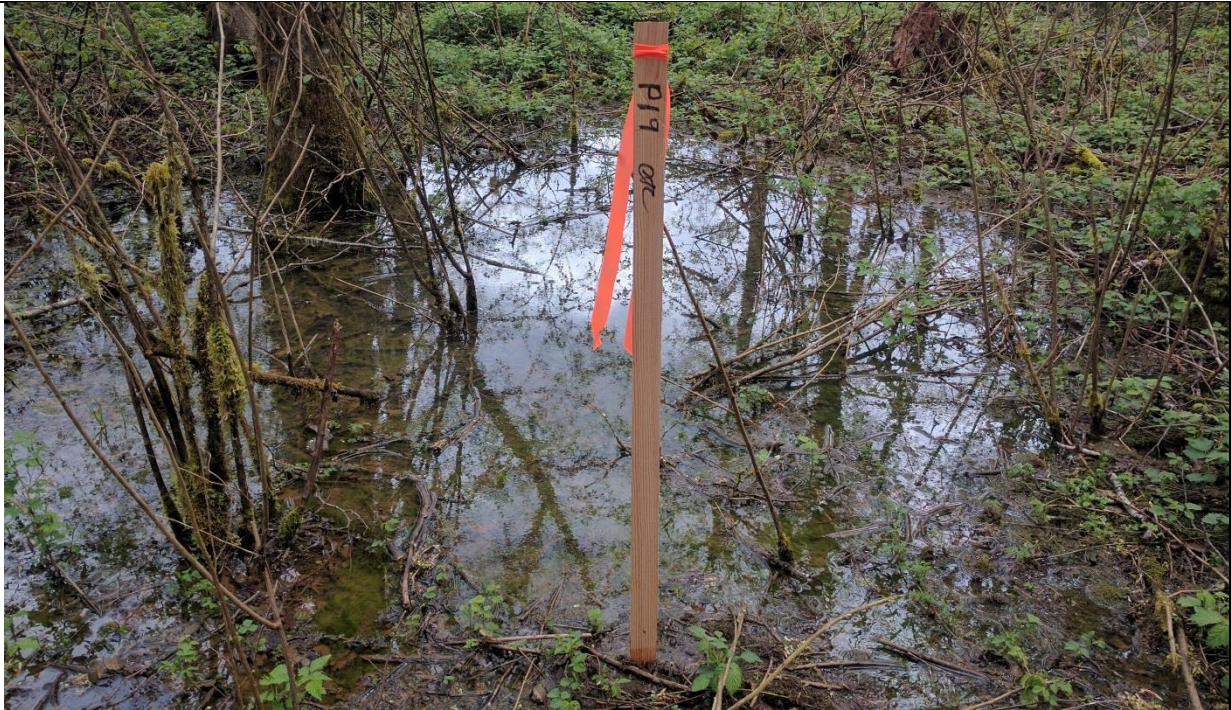
Photo 2. REMOVED Lower portion of Wetland "A" showing excessive algal growth due to fertilizers washed down from farms and nurseries upslope. ETC Photo 4/28/2017

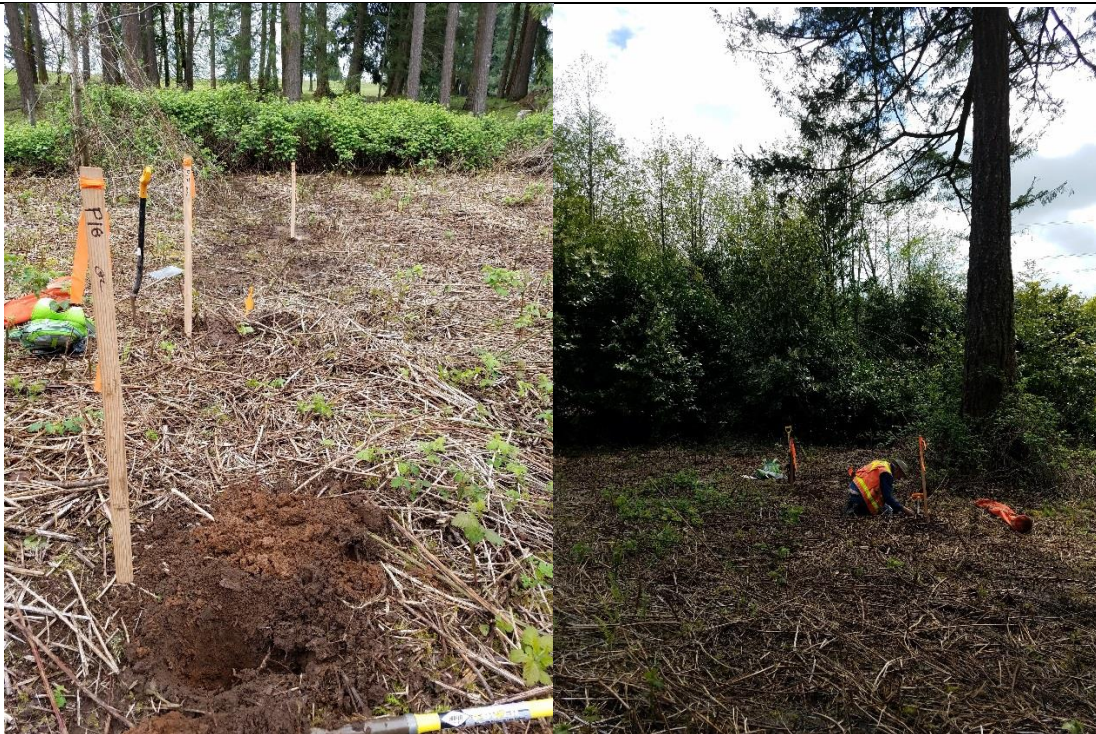
Photo 3. Wetland "B", a small depressional wetland in a forested area adjacent to Stream 2 in a forested area near where Stream 2 enters the subject property on the East border. ETC Photo 4/28/2017

Wetland "B", 2,225 SQFT, 0.051 Acres. Wetland "B" is a small depressional wetland next to Stream #1. Some water enters from the property to the East as part of the same basin that Stream #2 runs through. Most of the wetland appear to be caused by high groundwater tables. Although the lower end connects to Stream #1, water exchange is mostly subsurface, and from the wetland to the stream. Areas of the wetland that are inundated or saturated to the surface have little vegetation. The area is densely shaded by trees rooted both in and outside of the wetland area. The Cowardin classification is Palustrine, Unconsolidated Bottom, Mud, Seasonally flooded/saturated. HGM classification is depressional wetland.

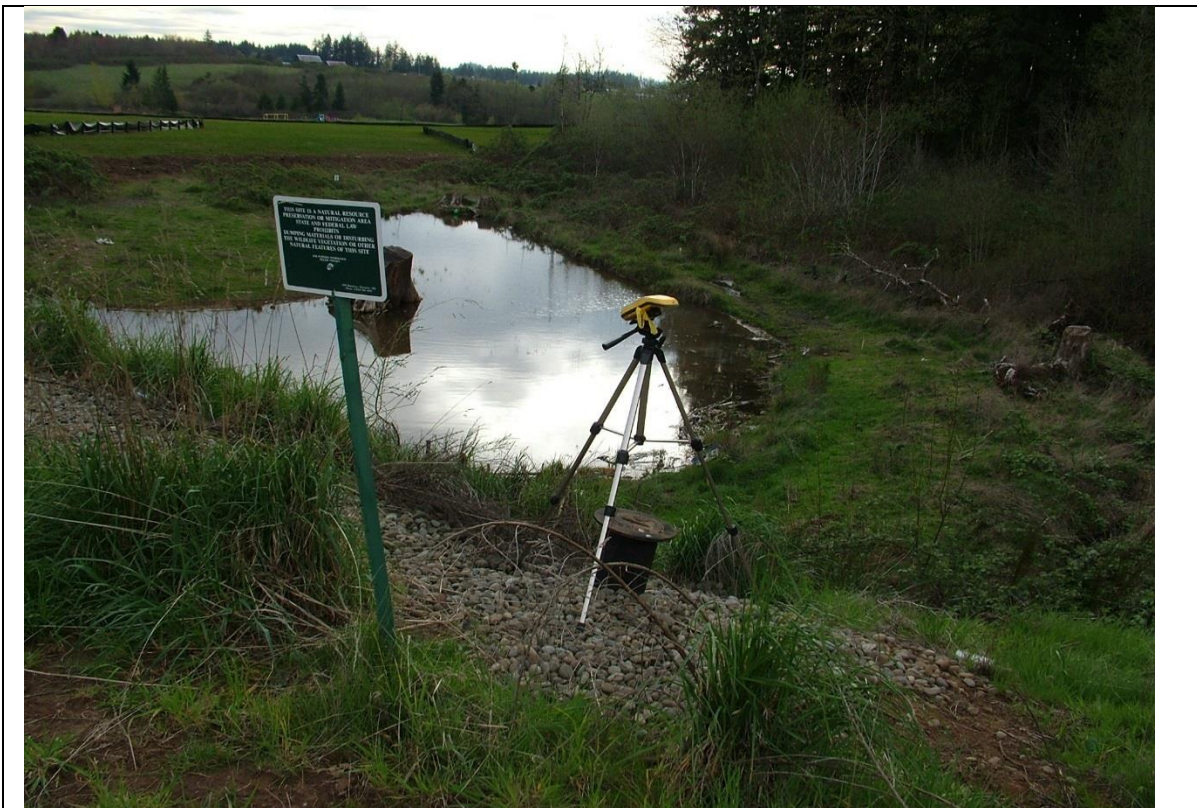
Photo 6. The wetland creation area in Track "E", as seen from Olson Road. ETC Photo 3/30/2017.

A small shallow horse shoe shaped pond about 4,267 SQFT in area was excavated in about the middle of Track "E", and the hydrology monitoring study conducted in 2007 found it to be flooded to a depth of about 6".

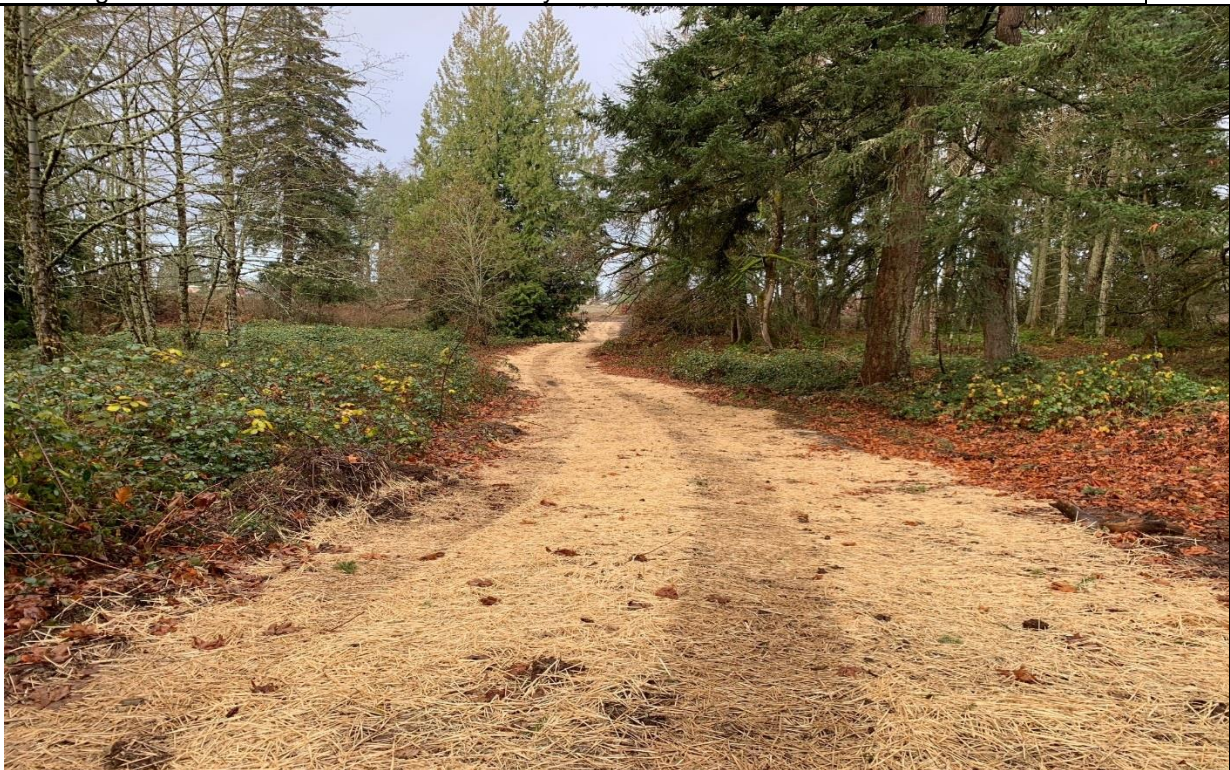
Photo 8 Track "E" after Blackberry clearing along Olson Road in preparation for the road widening. Photo looks East toward Jewelberry Road. ETC Photo 10/30/2018.
