Attention: Zac Baker
Subject: Geotechnical Report
Bornstedt Village
38272 SE Highway 211
Sandy, Oregon
Gill Project No. ET237V1028

Date: May 4, 2021
To: Jake Epperson, P.G.
Gill Group
From: Nathan M. Villeneuve, C.E.G.
Timothy J. Pfeiffer, P.E., G.E.
Subject: Preliminary Geotechnical Investigation - DRAFT
Project: Sandy Housing Development
Project No. 2211038

We have completed the requested preliminary geotechnical investigation for the above-referenced project in Sandy, Oregon. This report provides a description of our work and a discussion of site conditions.

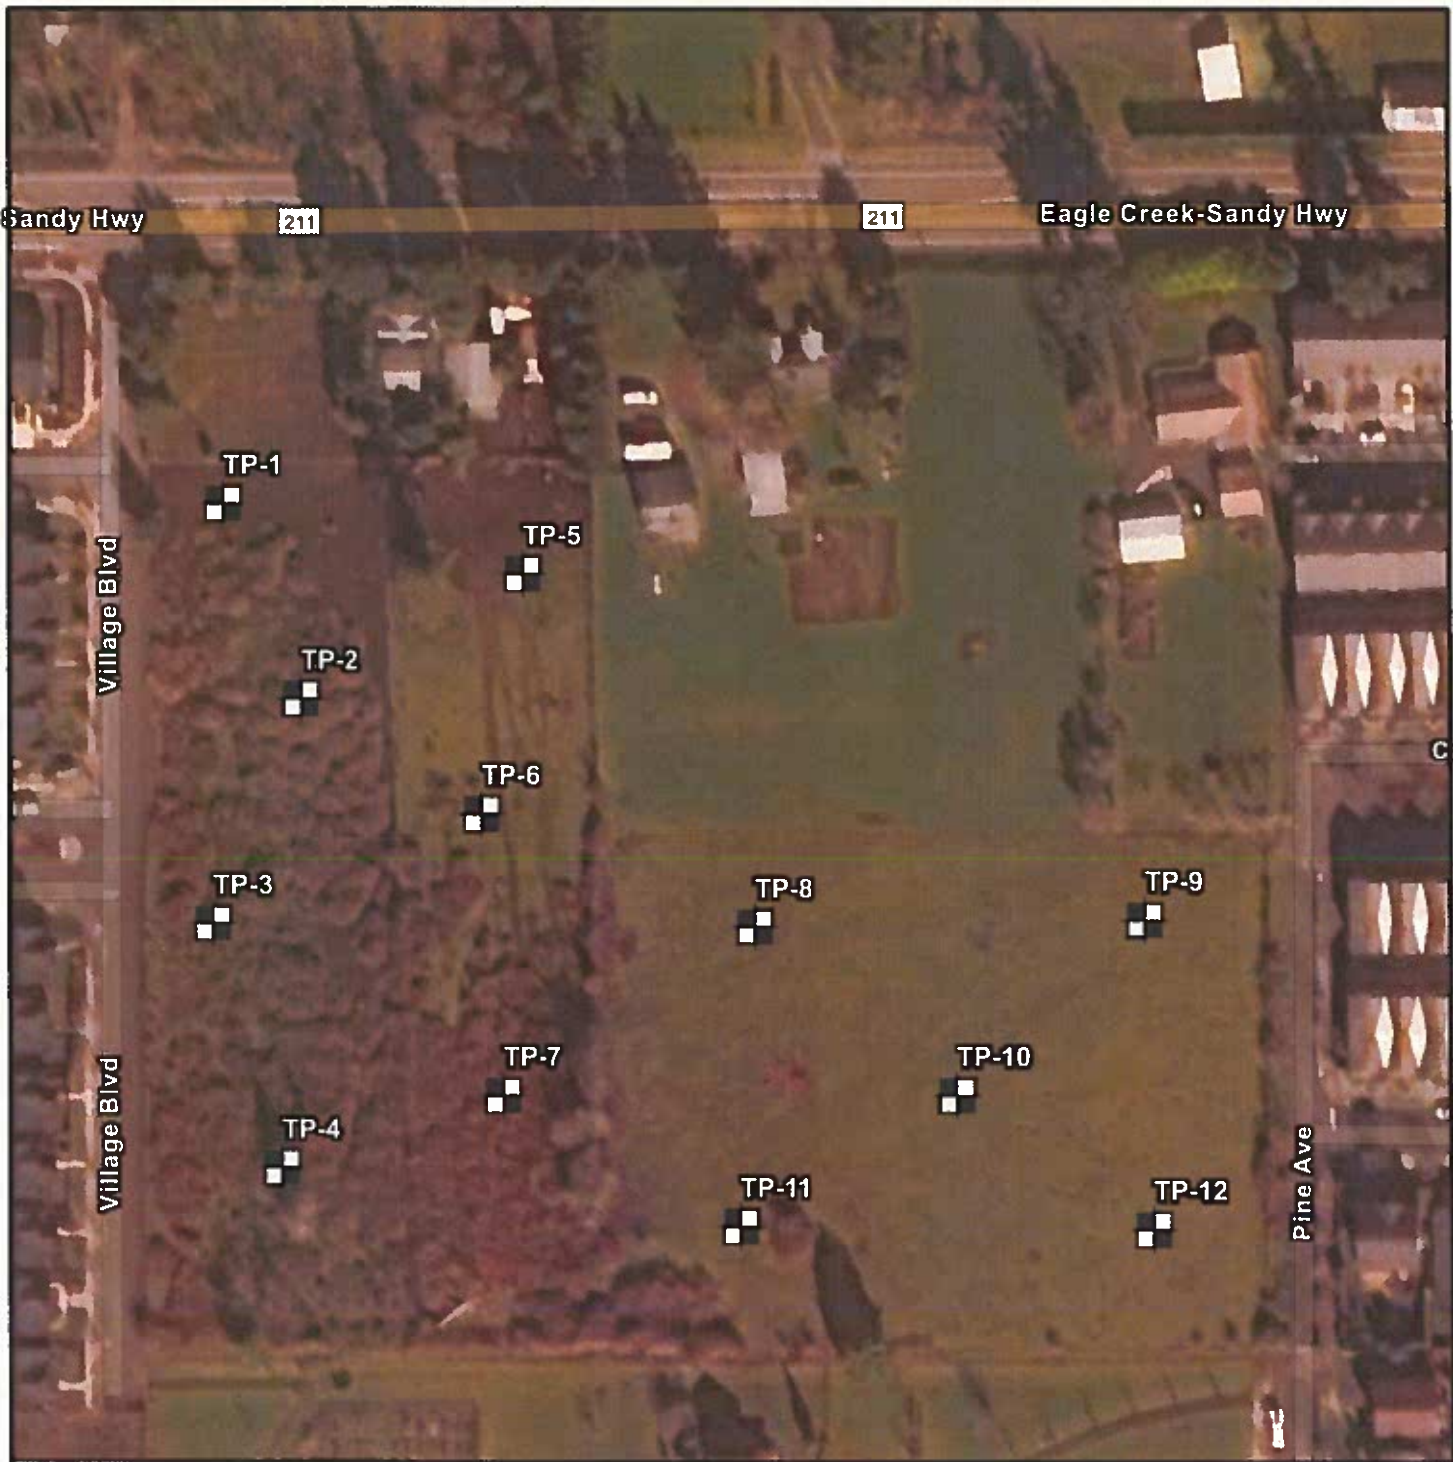
We excavated twelve (12) exploratory test pits (TP-1 through TP-12) at the site on April 27, 2021 using a CAT 306 excavator provided and operated by Wapiti Pacific Construction. The northwest quadrant of the site was not accessible during the preliminary investigation, so test pits were not excavated in this area. The approximate locations of the test pits are shown in Figure 2A (Appendix A) The test pits extended to maximum depths ranging from ± 6 to 10 feet.

SITE PLAN

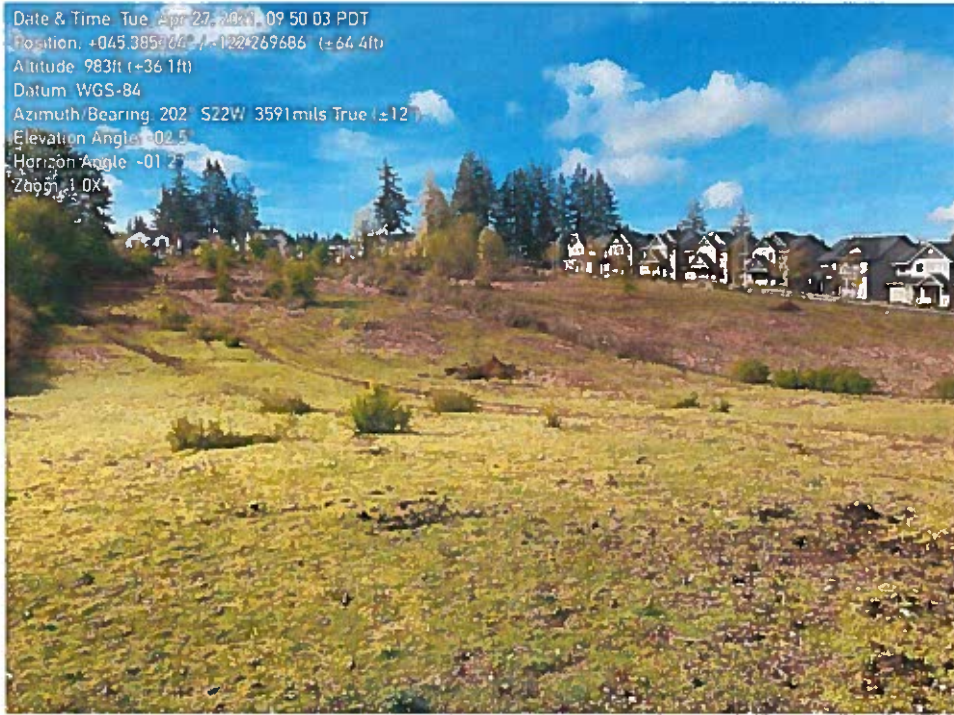
The site consists of sloping topography with the high elevations to the north and south and lowest elevations in the middle of the properties. The low elevations form a small drainage to the west where it intersects a road embankment. The lots are bordered on the north by Highway 211, on the east by Pine Avenue, on the south by Bornstedt Park, and on the west by Village Boulevard. Surface conditions at the time of our field exploration are shown in Photos 1 and 2 (Appendix A).

Photo 1: West side of the property, looking southwest.

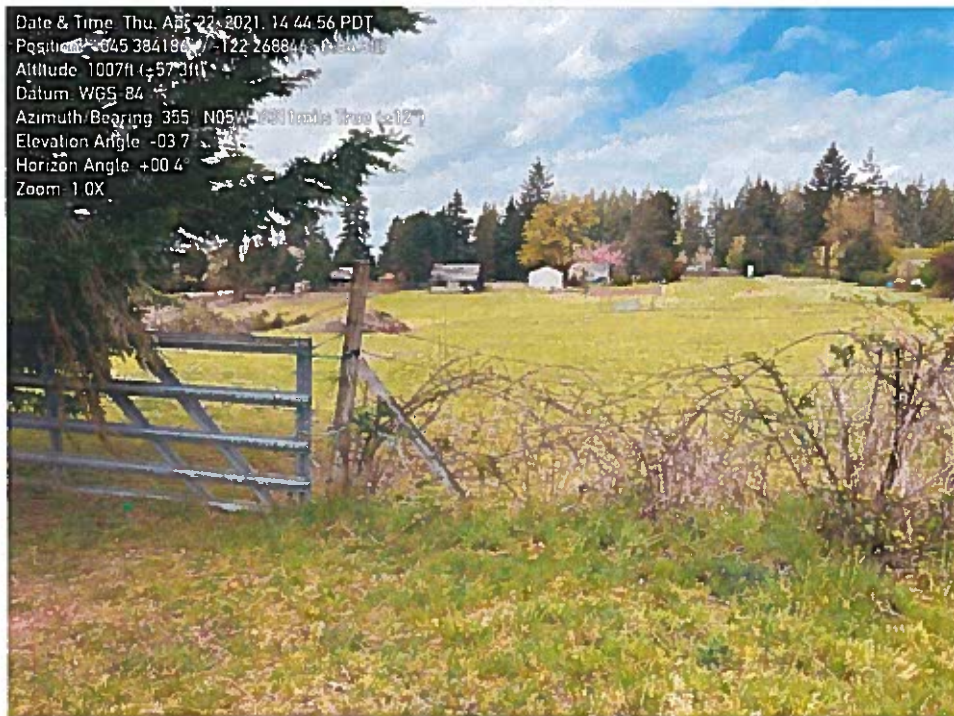
Photo 2: East side of the property, looking north.
