Project Name: 37090 SE Kelso Road	Latitude: N 45.417907	Longitude: W -122.2831
Proposed Use: SUBDIVISION, SINGLE FAMILY HOMES	Tax Map # 24E11 Lot 24E11 02204 Parcel Number 05034843	
Project Street Address (or other descriptive location): No Situs Address (Formally known as 37090 SE Kelso Road)	Township T2S Range R4E Section 11 QQ Tax Lot(s) 24E1102204	
City: Sandy, OR County: Clackamas	Waterway: No name River Mile: _____ NWI Quad(s): Sandy, Oregon

WETLAND DELINEATION REPORT
Tax Lot 24E11 02204
Formally 37090 SE Kelso Road
Sandy, OR

Evaluated by:
Annakate Martin, NRS
John McConnaughey PWS# 2009
May, 2017 and August 2020

LOT 2204, SE KELSO RD
 Rosemont Development
 10117 SE Sunnyside Rd
 Clackamas, OR 97015

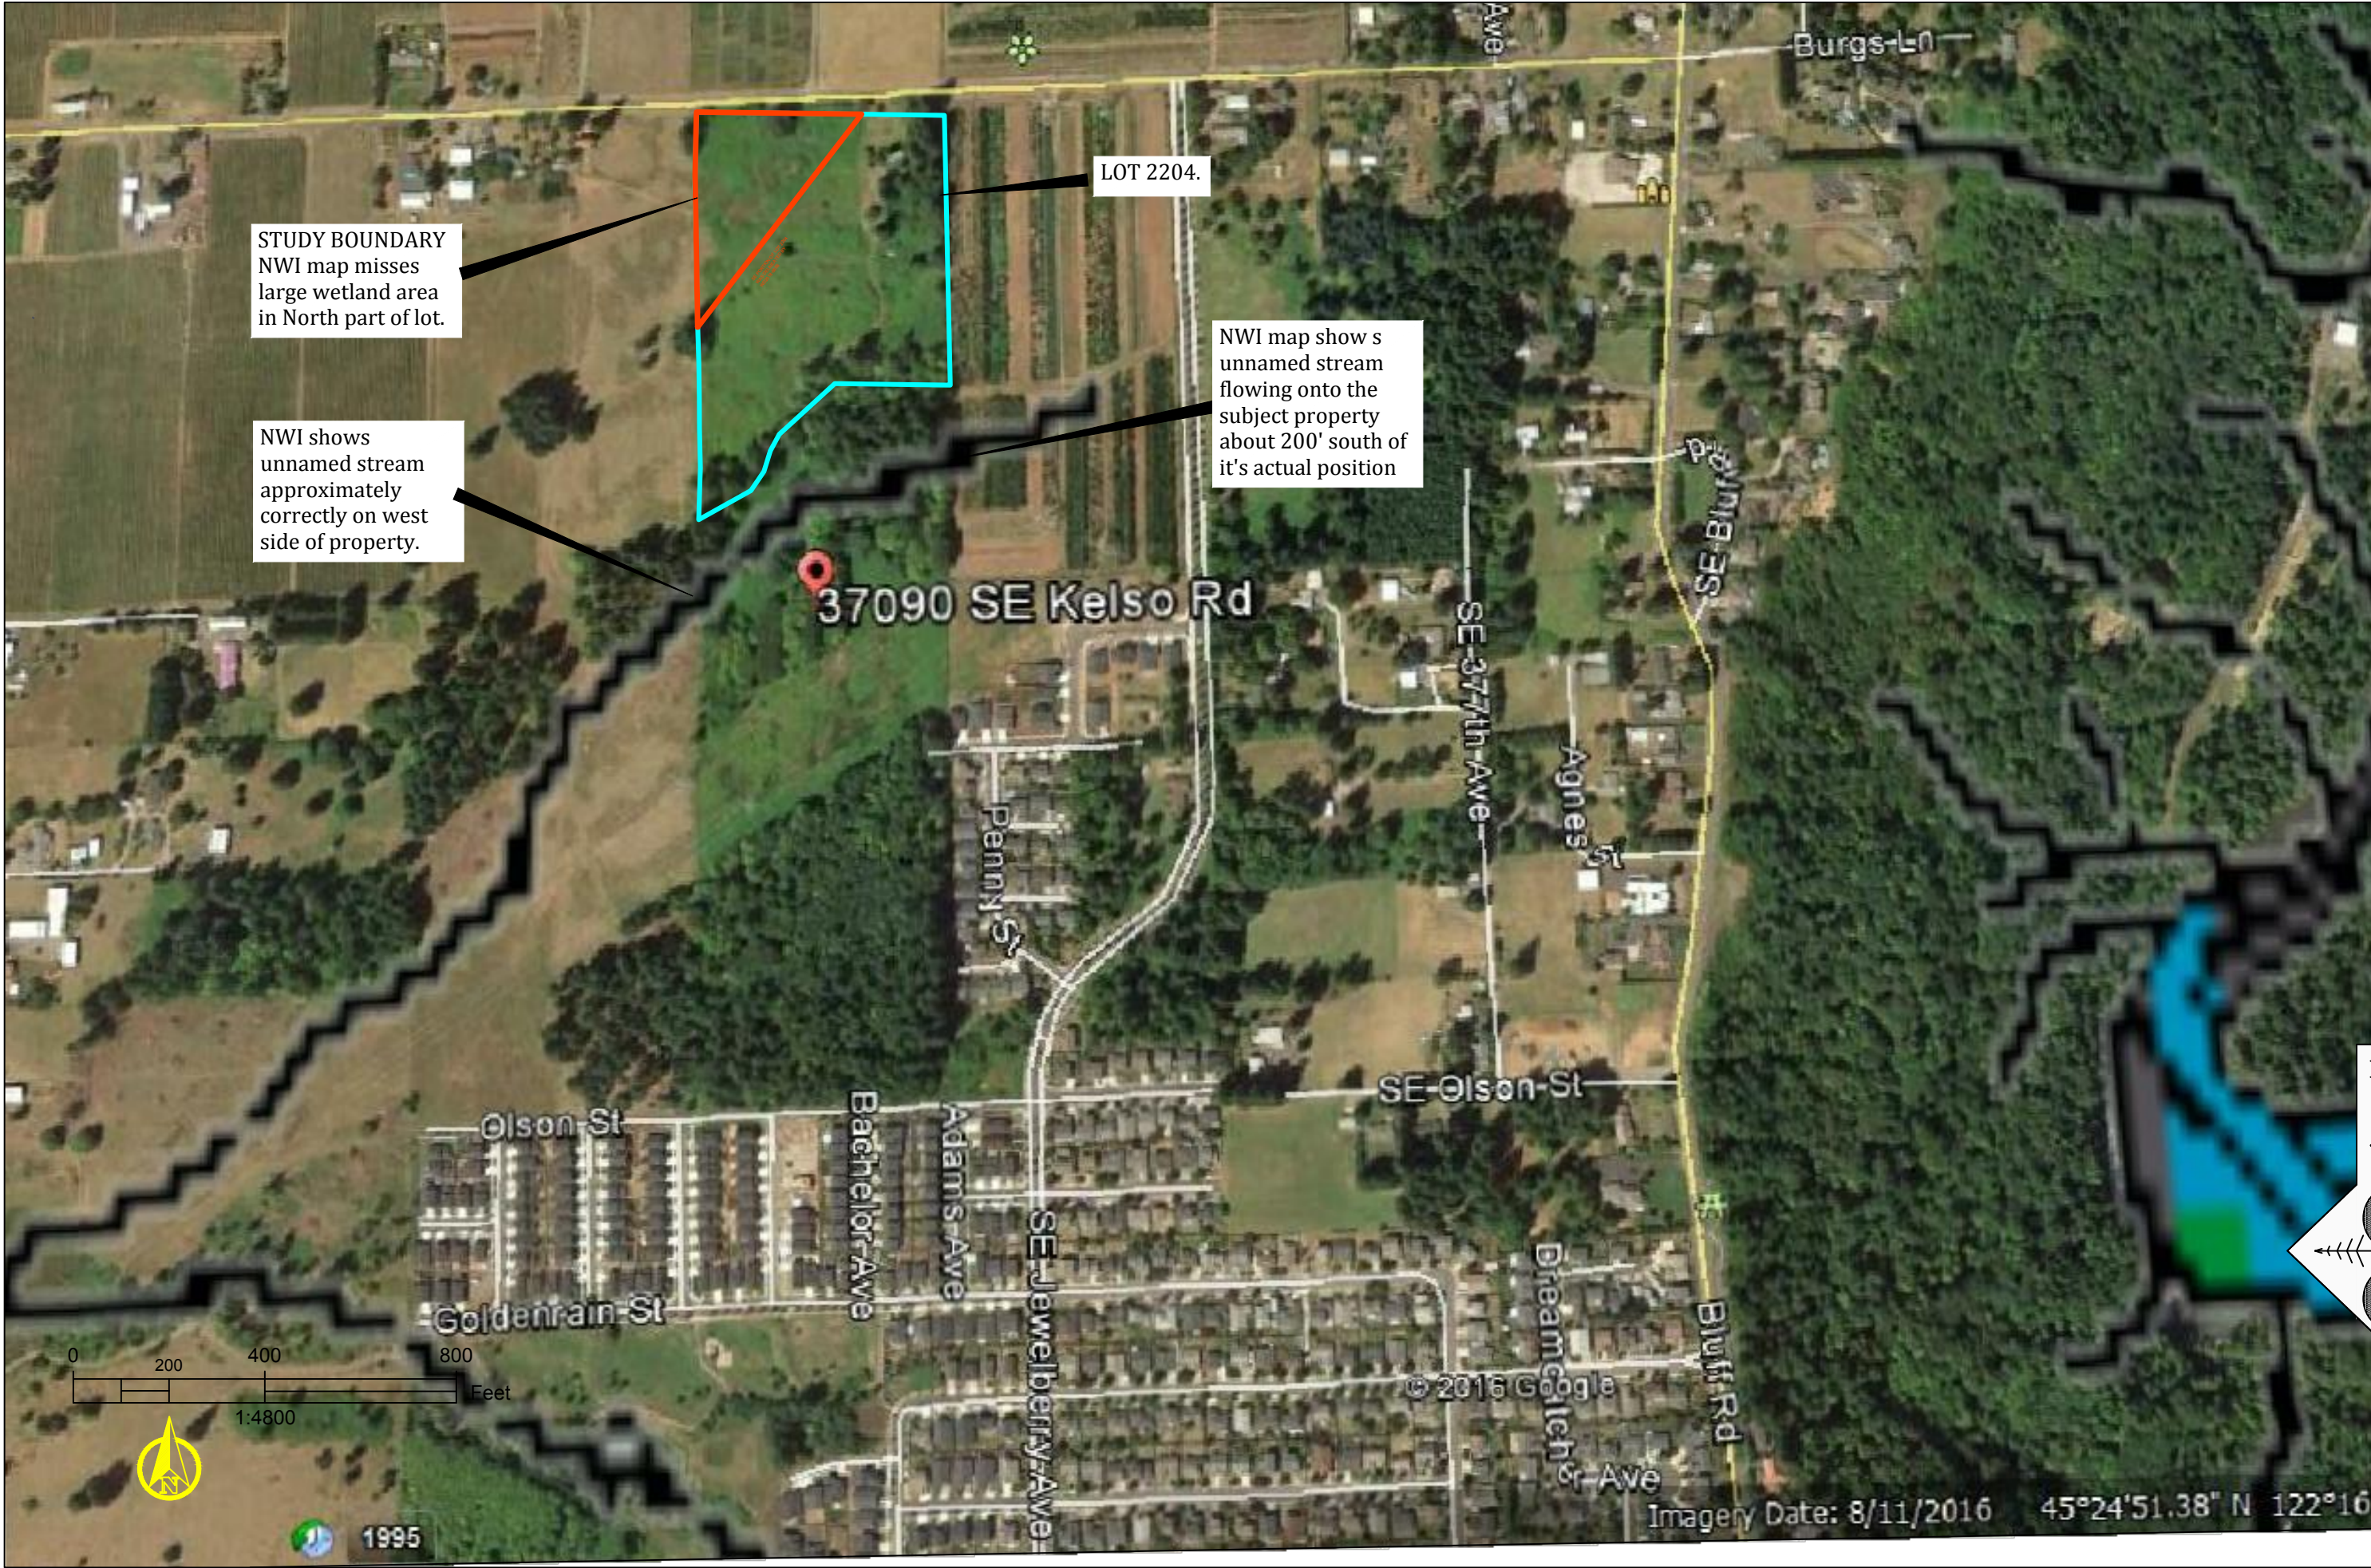
STUDY BOUNDARY
NWI map misses
large wetland area
in North part of lot.

NWI shows
unnamed stream
approximately
correctly on west
side of property.

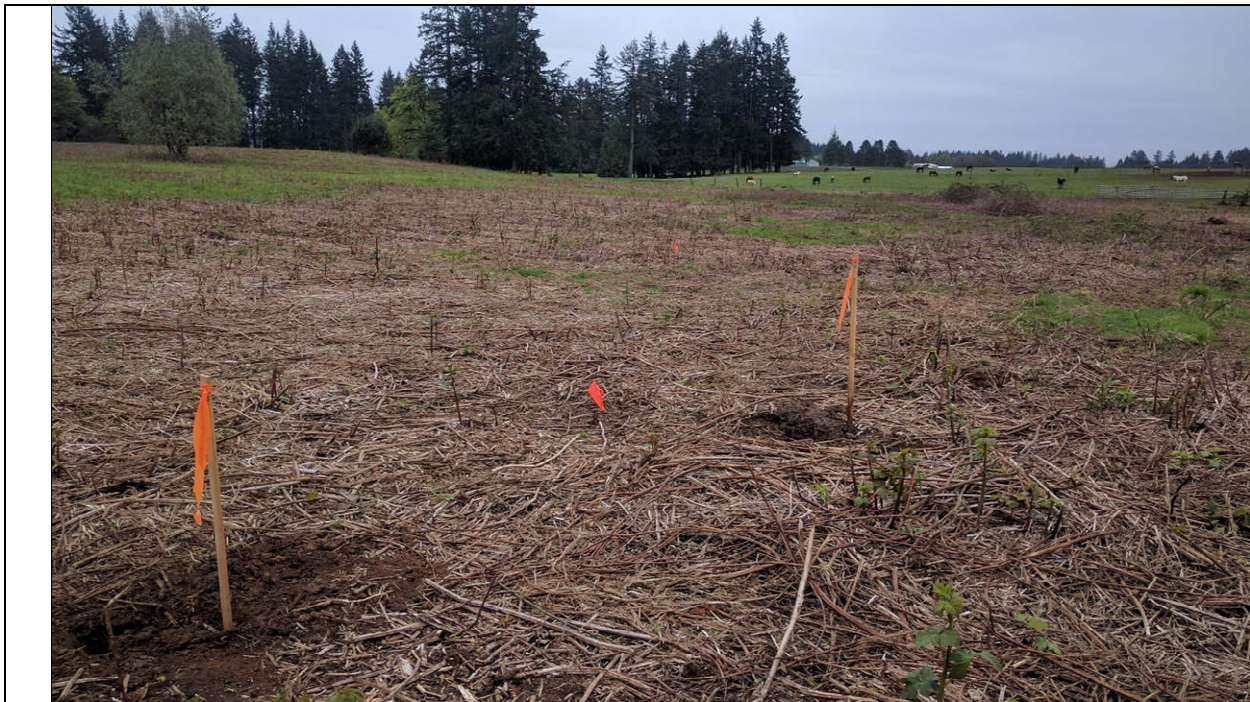
Photo 1. Wetland "A" data plots P1 Upland (left), and P2 Wetland (right). The blackberries had been recently mowed to give surveyors access. The wetland determination was based on soils and hydrology. ETC Photo 4/28/2017.

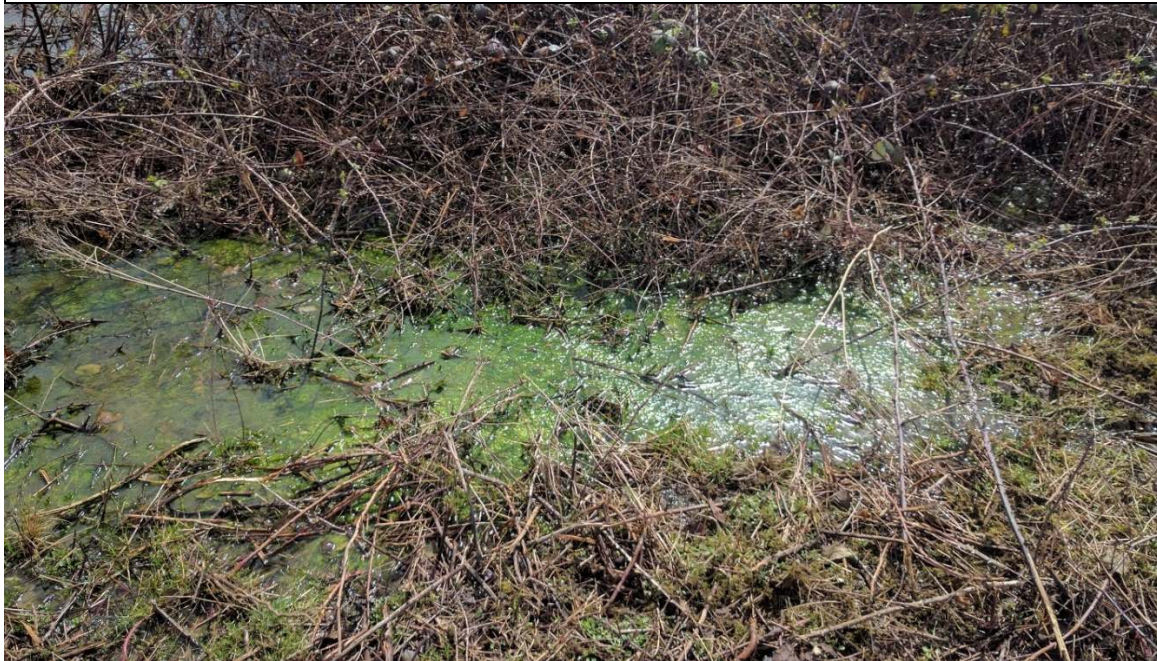
Photo 2. Lower portion of Wetland "A" showing excessive algal growth due to fertilizers washed down from farms and nurseries upslope. ETC Photo 4/28/2017

The middle of the wetland has some shallow ponding created by the shallow ditch that runs through the center of the wetland becoming clogged with blackberry rubble and tire ruts from the mowing of the blackberries. In these puddles we observed bright green bubbly algae, the vigorous growth of which suggested fertilizer enrichment, probably fertilizer runoff from the nursery on the North side of SE Kelso Road.

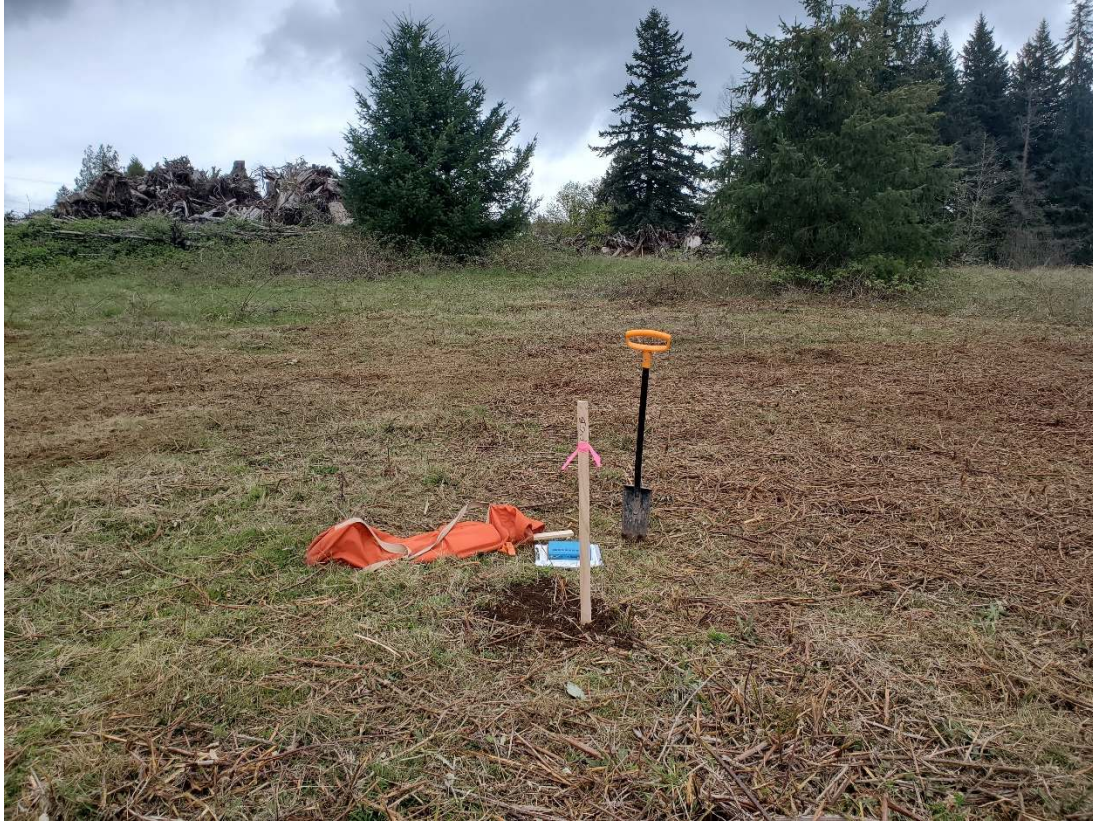
Photo 3. New P5B upland plot, photo looking into upland to the southeast. ETC Photo 4/15/2020

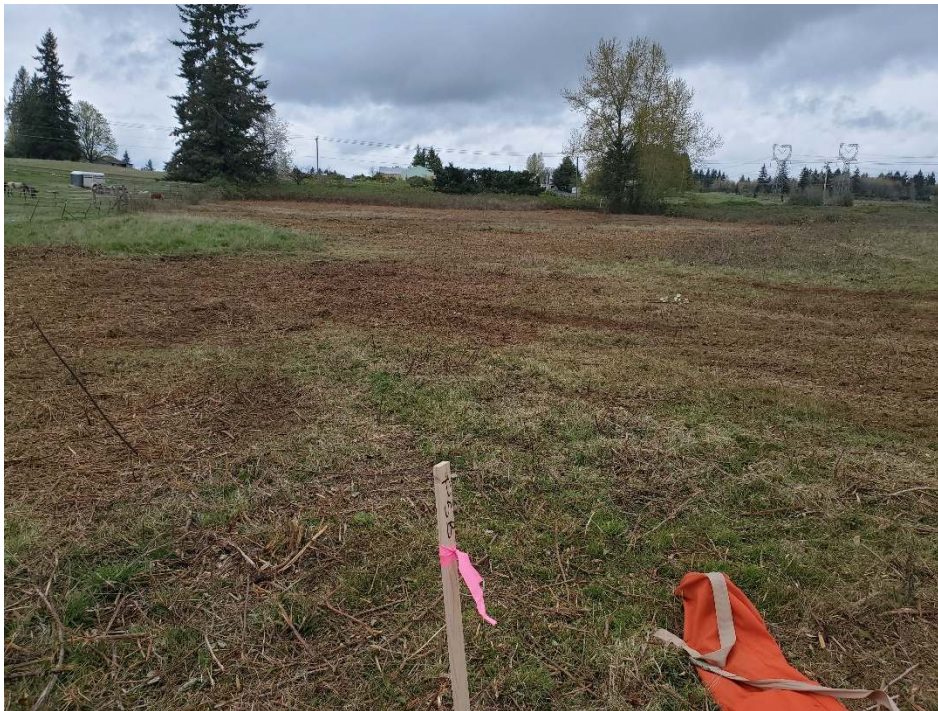
Photo 4: Looking the south at P5B into Wetland "A". ETC Photo 4/15/2020
