CITY OF SANDY
**DOWNTOWN
WALKABILITY
ASSESSMENT**

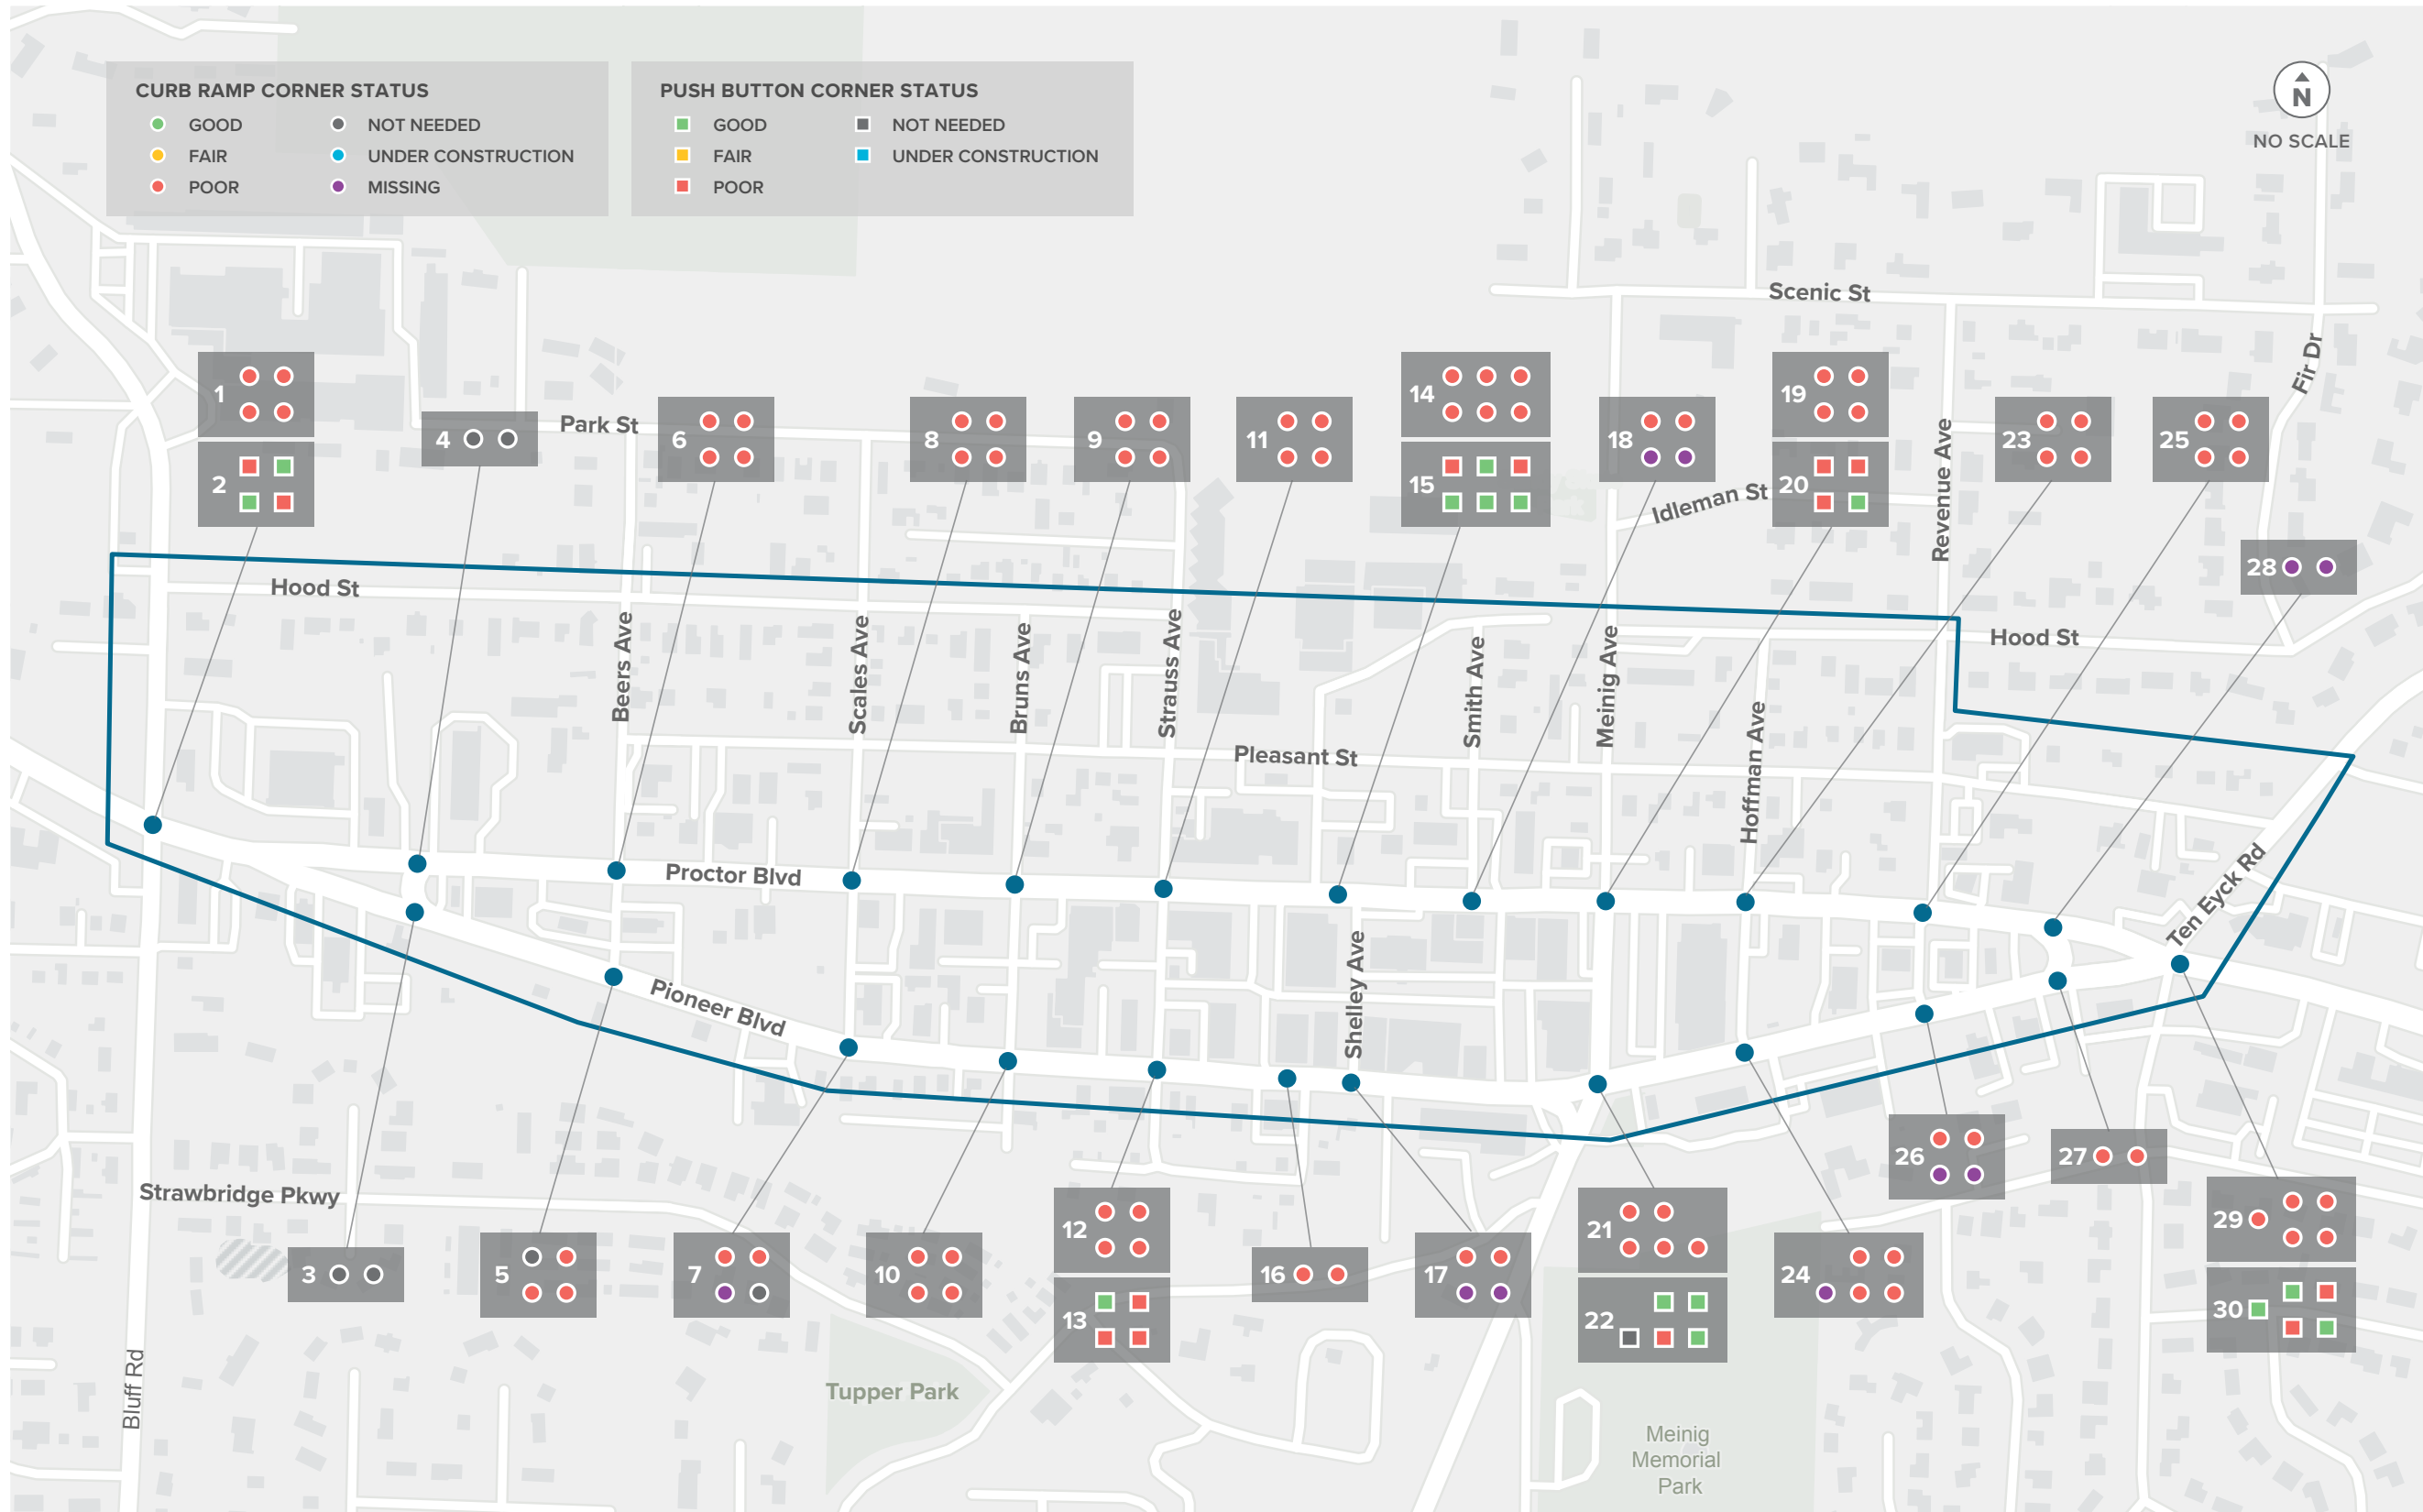
FIGURE 7. CURB RAMP AND PUSH BUTTON ACCESSIBILITY CONDITIONS

on all state highways, within incorporated cities, and other developed areas. A “Good-Fair-Poor” rating was developed to determine the physical conditions of these ramps, as defined further in the design recommendations in *Public Right-of-Way Accessibility Guidelines*. A “Good” rating indicated curb ramps met the ADA guidelines and the ramp was usable by most, if not all, people with disabilities. A “Fair” rating indicated that curb ramps met ADA guidelines but lacked a detectable warning, such as a truncated dome. A “Poor” rating described curb ramps that did not meet one or more ADA guidelines, making the ramp a barrier for all people with disabilities.

ADA accessibility conditions in downtown Sandy currently meet some standards, but are not adequate for people with certain disabilities. Some efforts and evaluations have been made but further analysis is needed. Additionally, while certain conditions are deemed compliant or up to standards by governing agencies, the community has expressed that an extra step should be taken to ensure safety and accessibility.
