TENTATIVE PLANS FOR SANDY WOODS 2

CITY OF SANDY, CLACKAMAS COUNTY, OREGON

JUNE, 2021

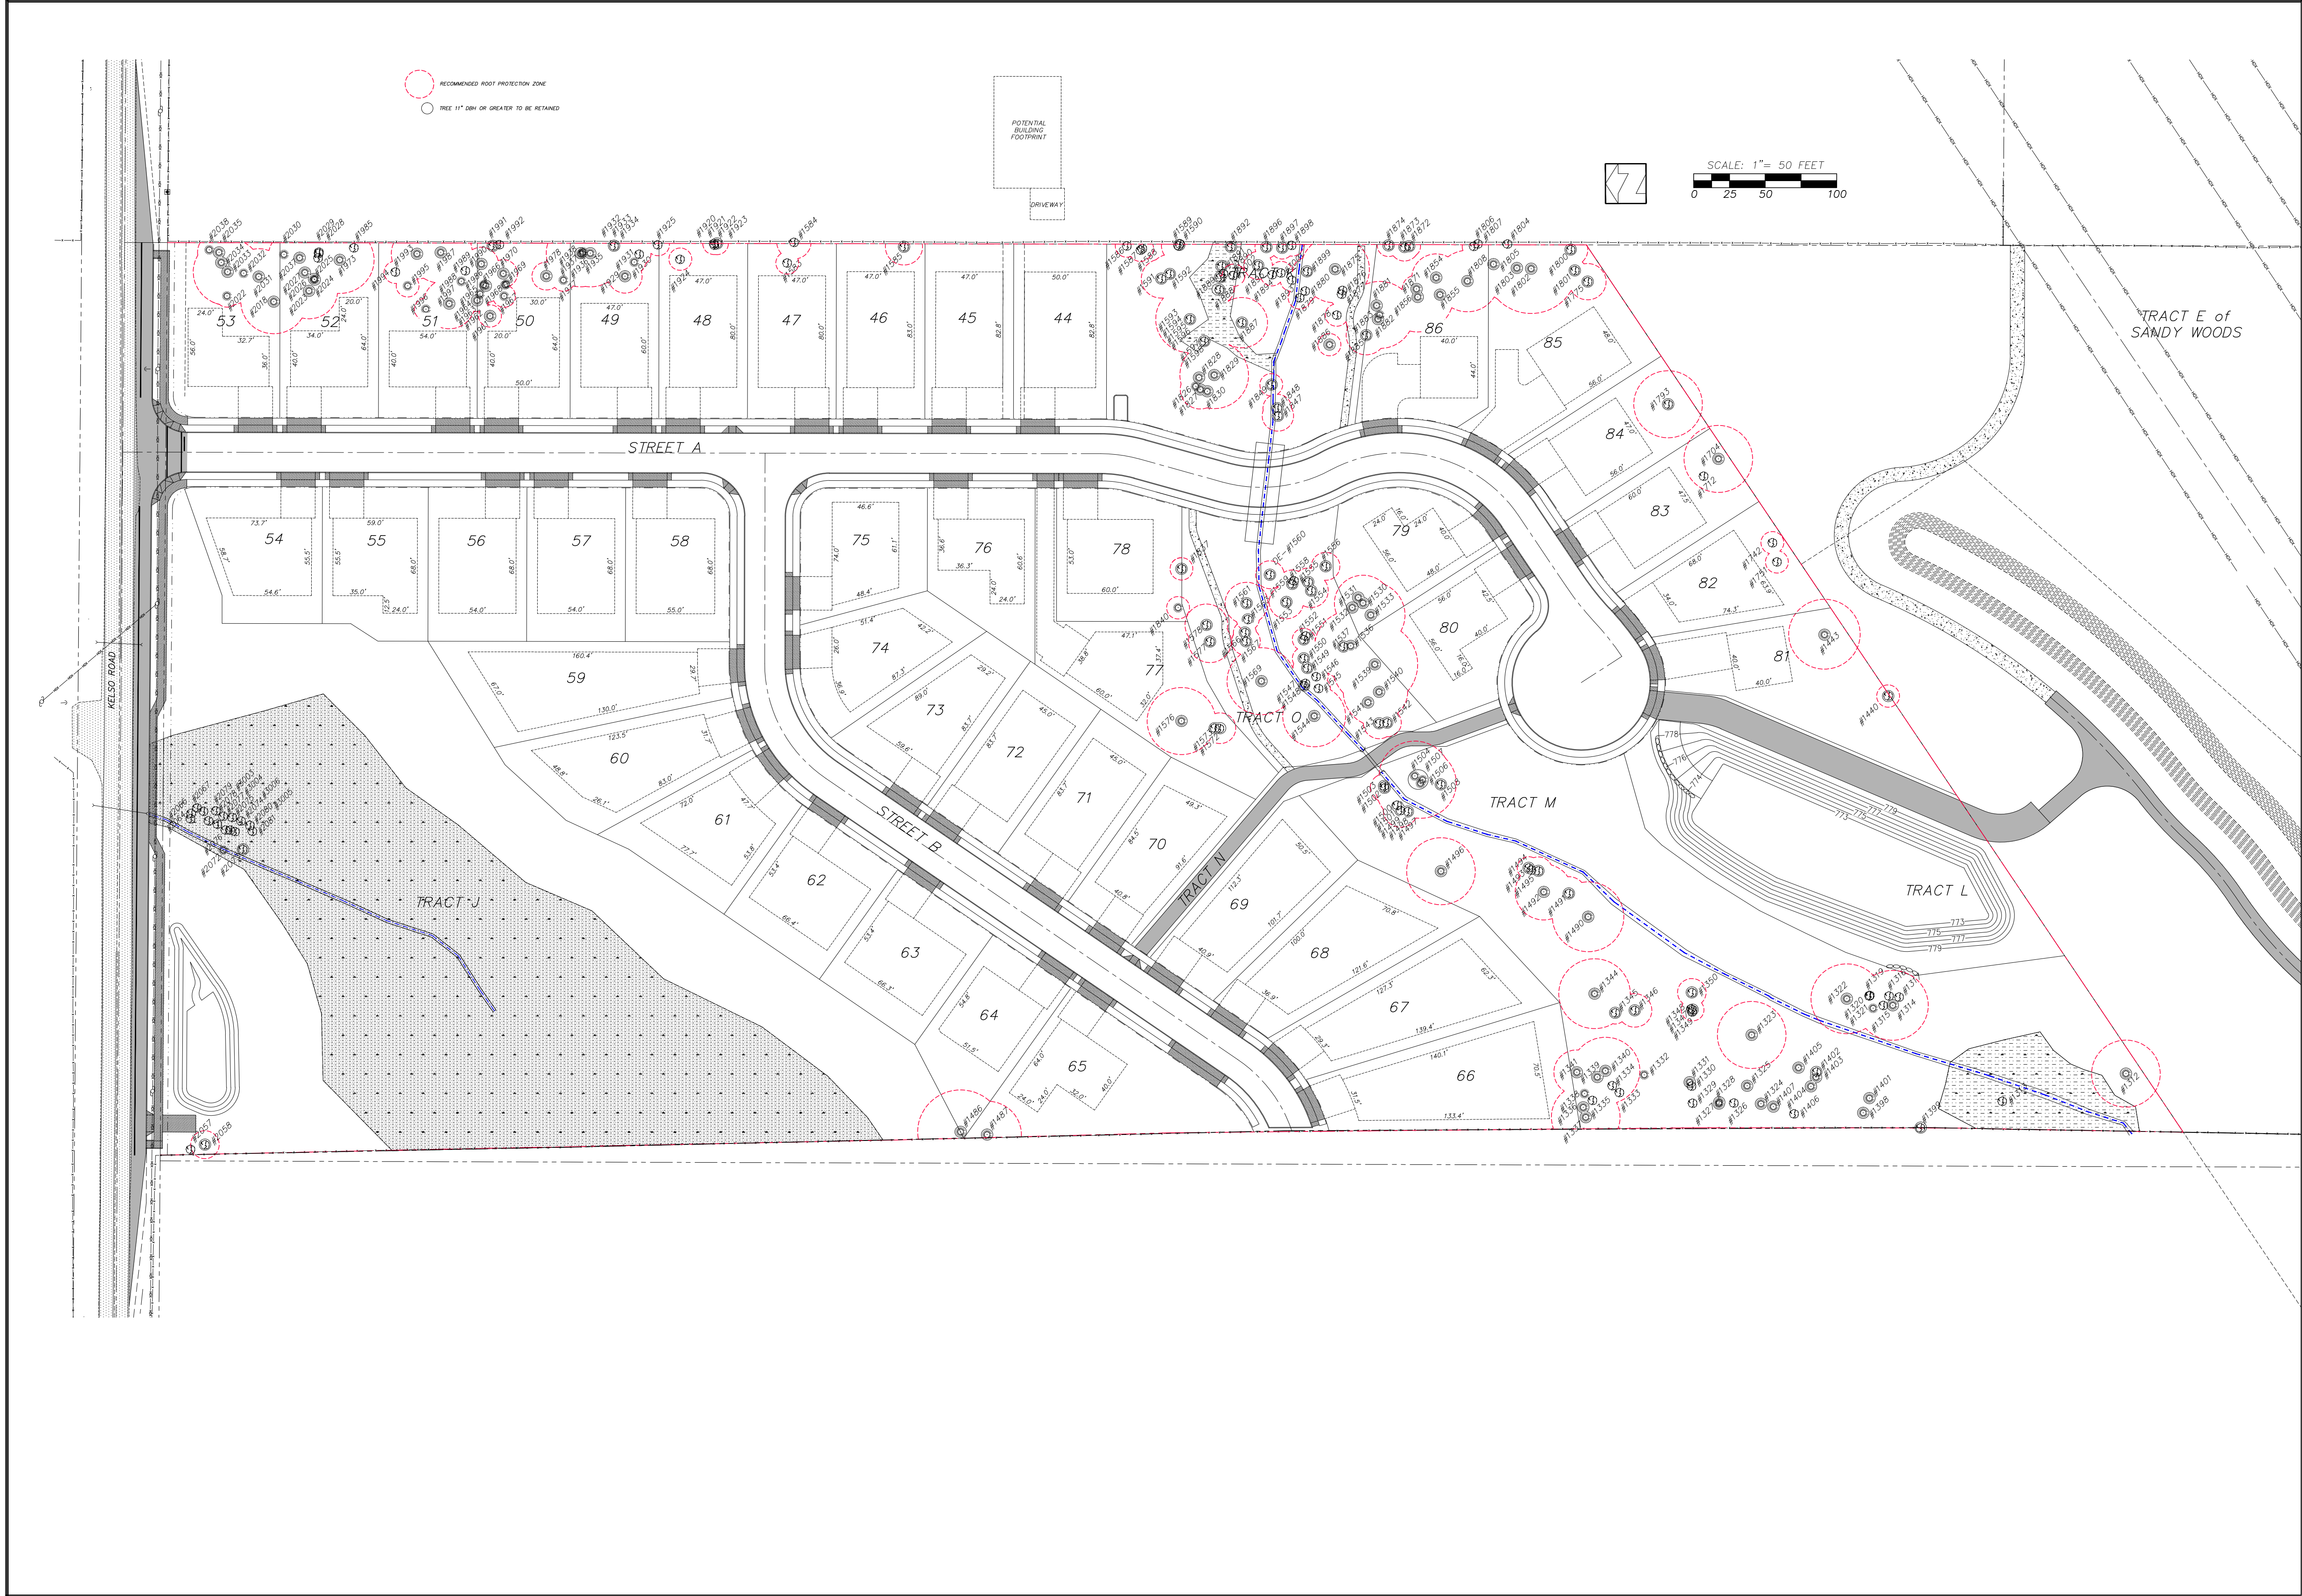
DATE	JUNE, 2021
SCALE	1" = 50'
DRAWN	PS
JOB	SCL19-042
SHEET	2
OF 15 SHEETS

Site Plan with Retention Trees,
RPZ's and Building Footprints

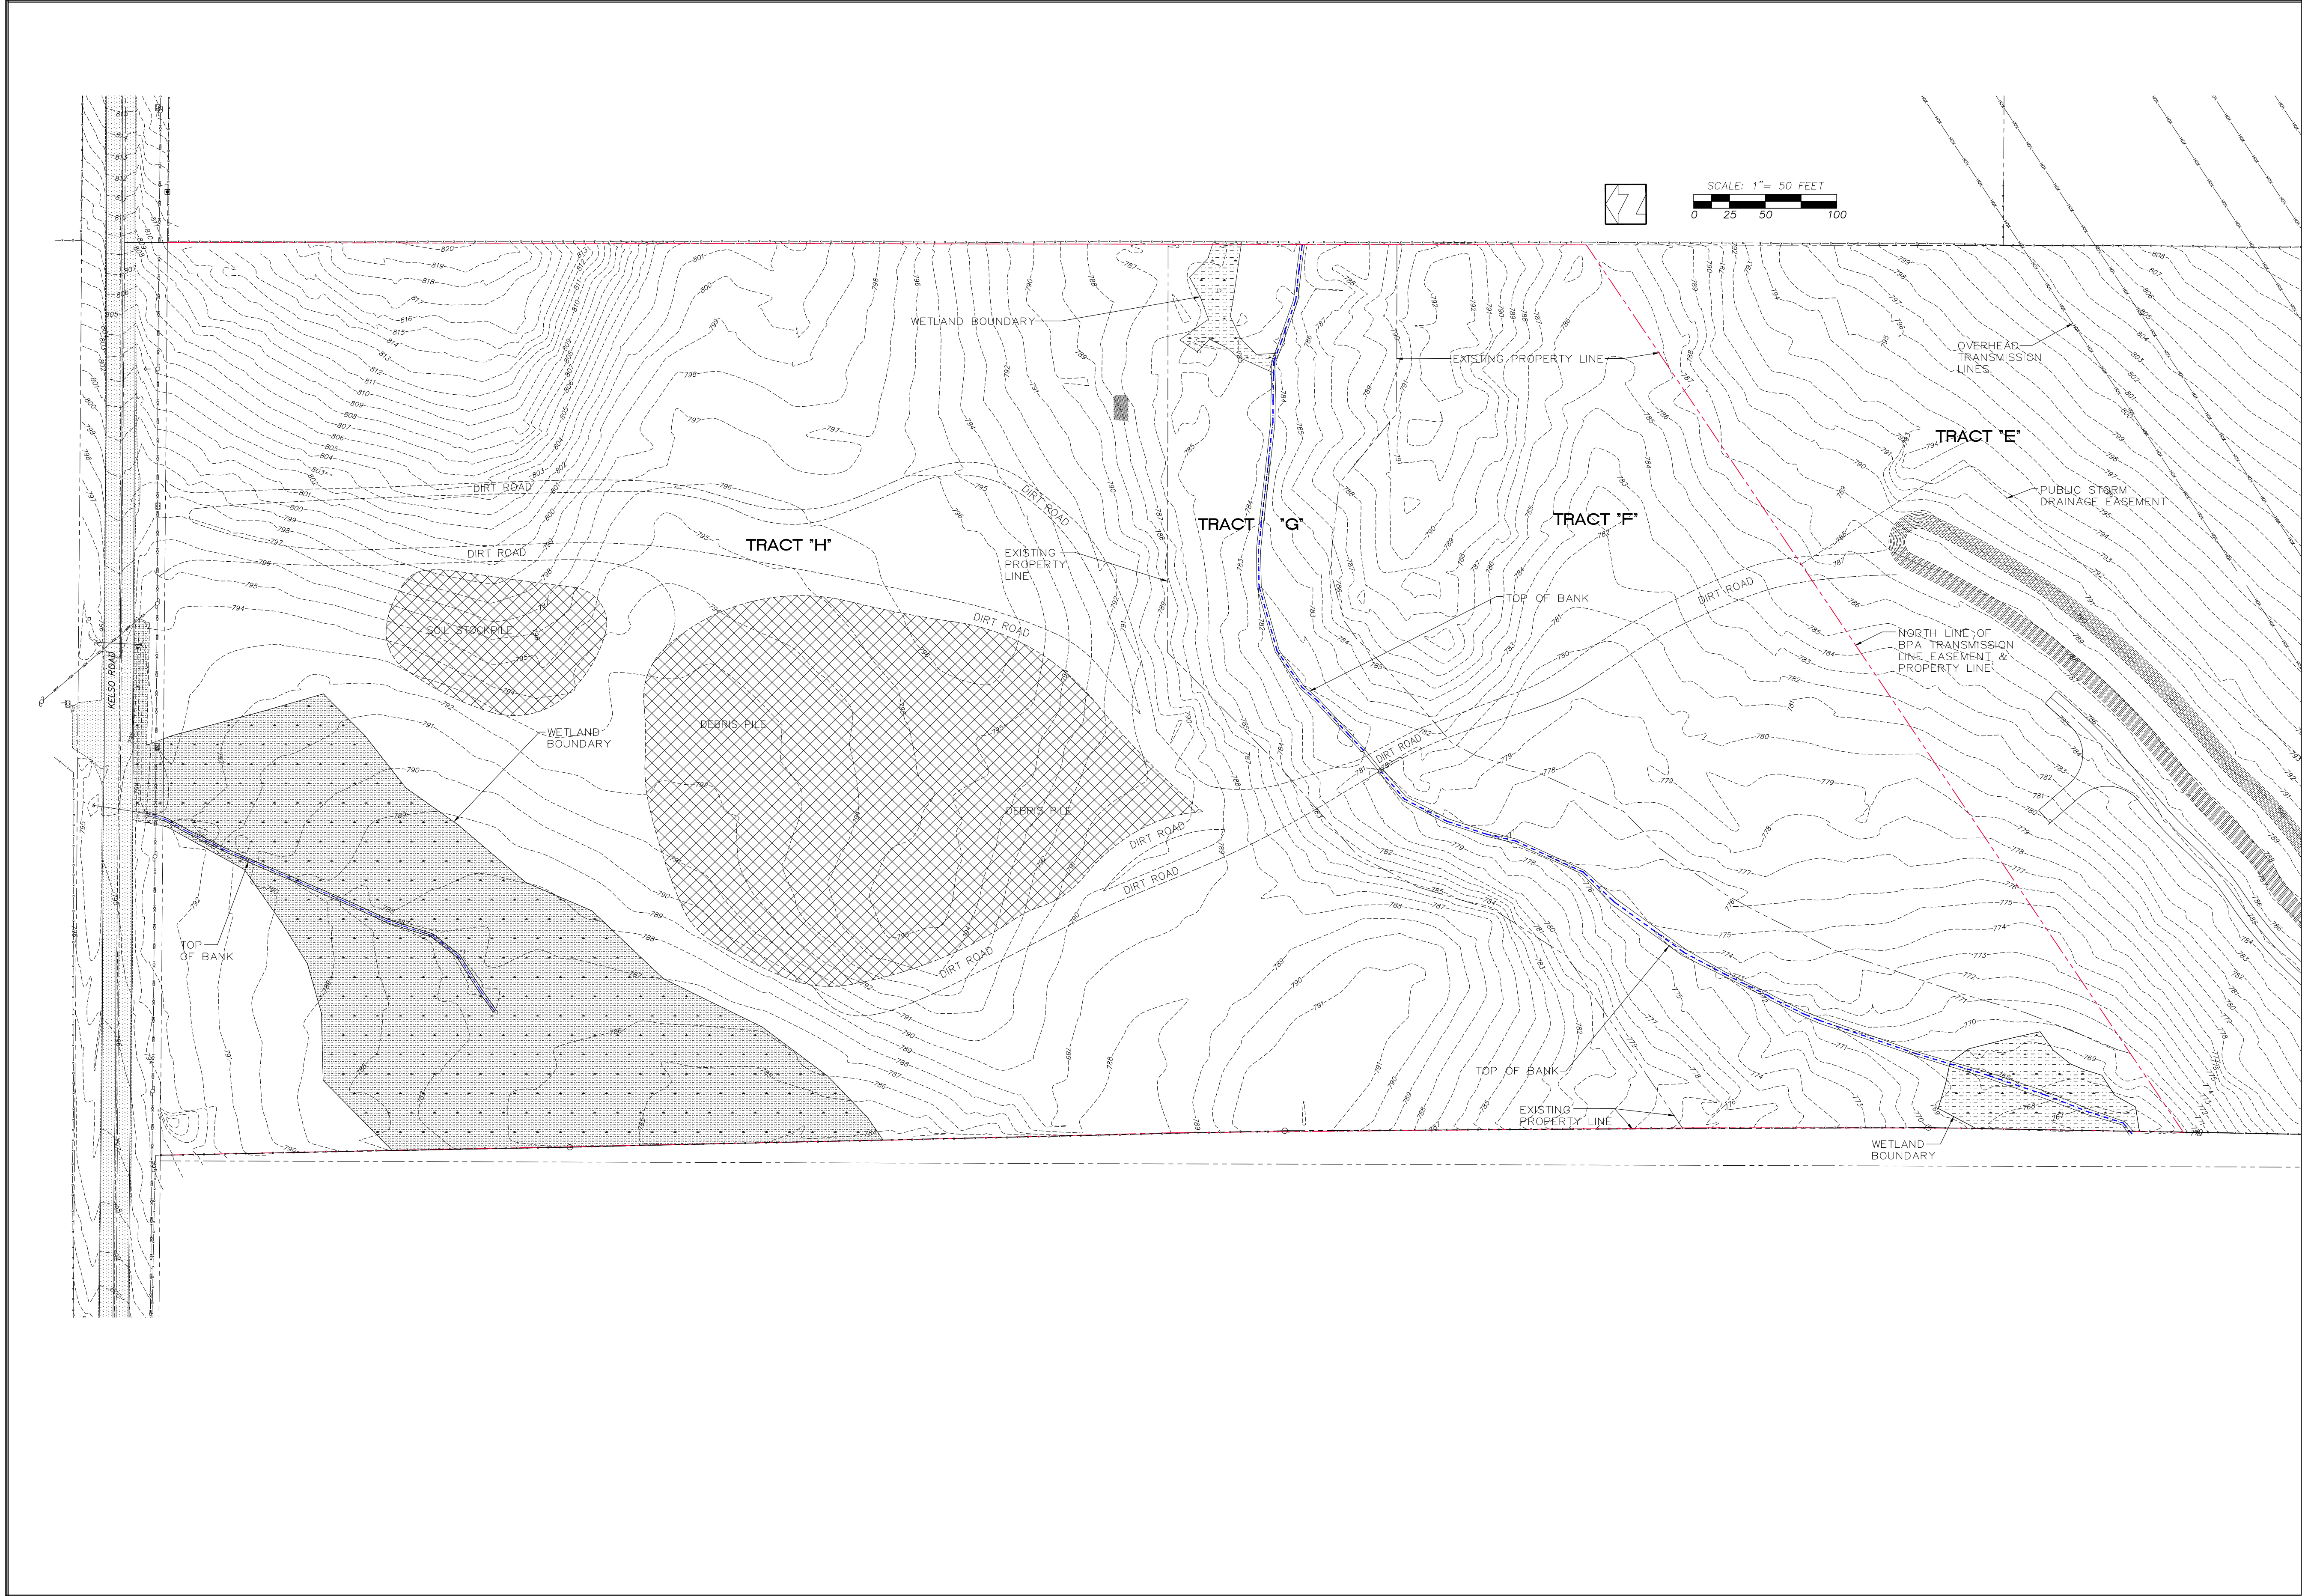
DATE	MAY, 2021
SCALE	1" = 50'
DRAWN	PS
JOB	SCL19-042
SHEET	3
OF 15 SHEETS

Existing Conditions

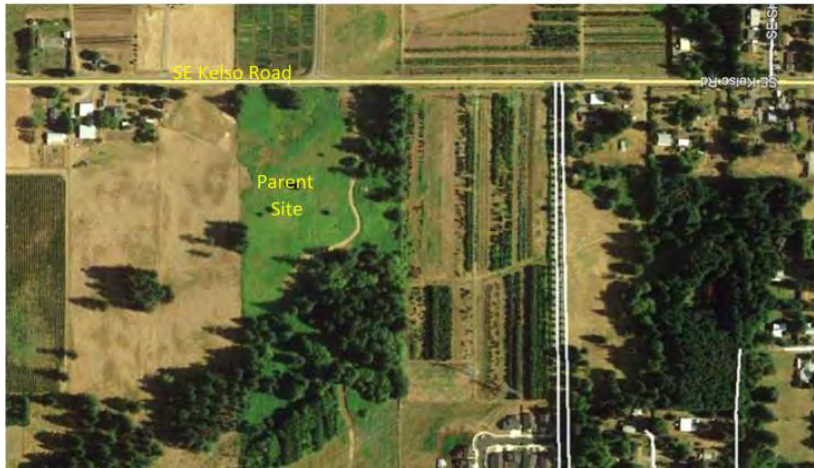
The pre-development site condition is primarily Himalayan blackberries mixed with some grass. The site also includes forest with light underbrush, wetlands, pasture, gravel/dirt driveway/roadway, and structures. The home, barn and shed were recently removed from the property. The highest point of the site is located along the eastern property line approximately 200 feet south of Kelso Road at elevation 820. The lowest point onsite is at elevation 767 along the western property line approximately 35 feet north of the SW corner.

An aerial view of the site is below:

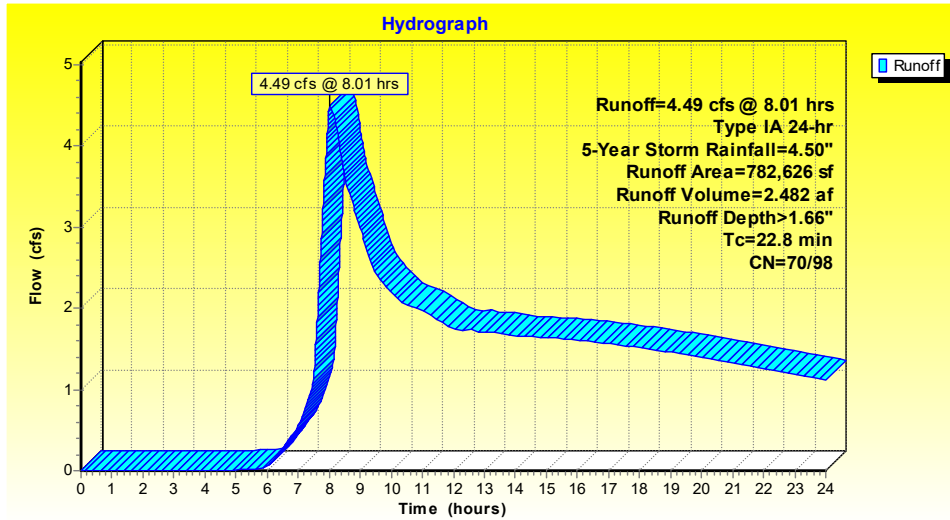
5-YEAR STORM

Per the above hydrograph, the runoff generated by the pre-developed conditions of the site is 4.49 cfs.

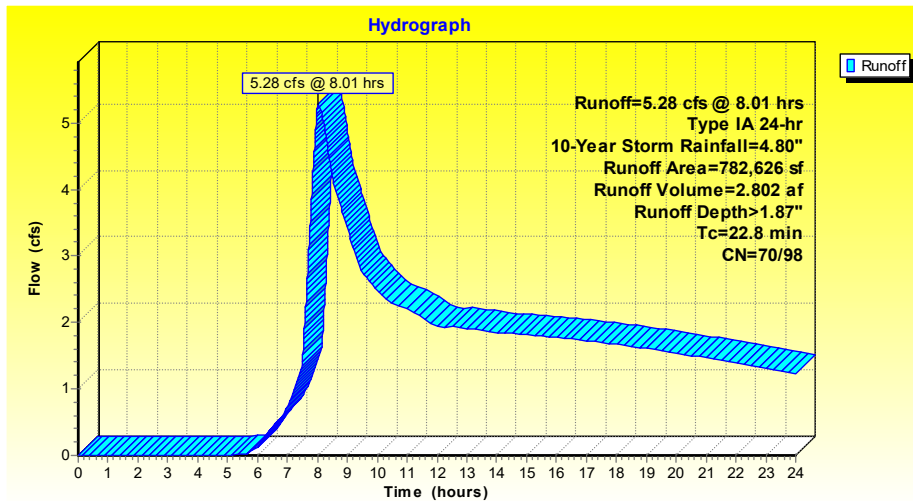
10-YEAR STORM

Per the above hydrograph, the runoff generated by the pre-developed conditions of the site is 5.28 cfs.

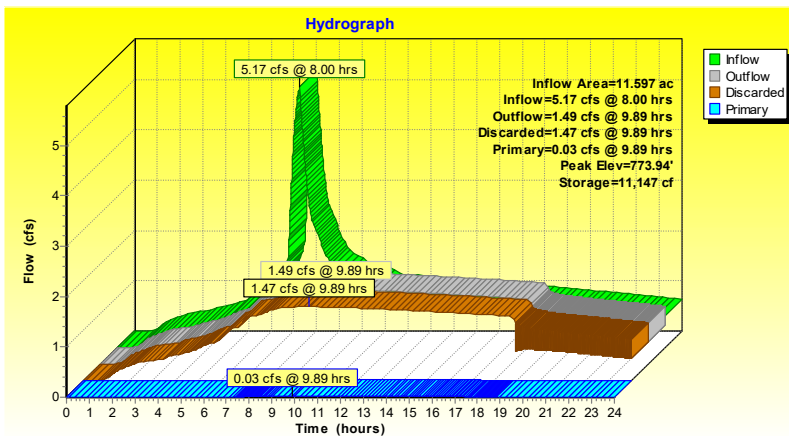
Primary OutFlow Max=0.03 cfs @ 9.89 hrs HW=773.94' (Free Discharge)
 ↳ 1=12" Outlet (Passes 0.03 cfs of 2.60 cfs potential flow)
 ↳ 2=1" Orifice (Orifice Controls 0.03 cfs @ 4.67 fps)
 ↳ 3=12" Overflow Riser (Controls 0.00 cfs)

Per the above hydrograph, the total runoff generated by the post-developed conditions of the site is 1.49 cfs. Since the brown hydrograph represents the discarded infiltration outflow which will not be released, this value will be excluded from the total release rate for the 2-year, 24-hour storm of the post-developed conditions. Therefore, the primary outflow from the structure (blue hydrograph) shall be the value for the release rate of this storm. The primary release rate is 0.03 cfs.

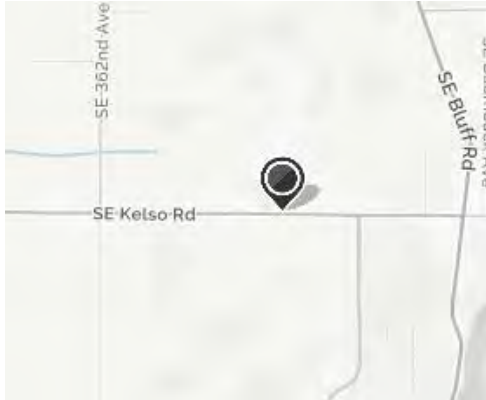
Rapid Soil Solutions (RSS) has performed eight (8) infiltration tests at the above-mentioned site. Soils found on site match those in below soils map by the USGS as fine grained Missoula Flood Deposits. Testing was performed for future storm water design.

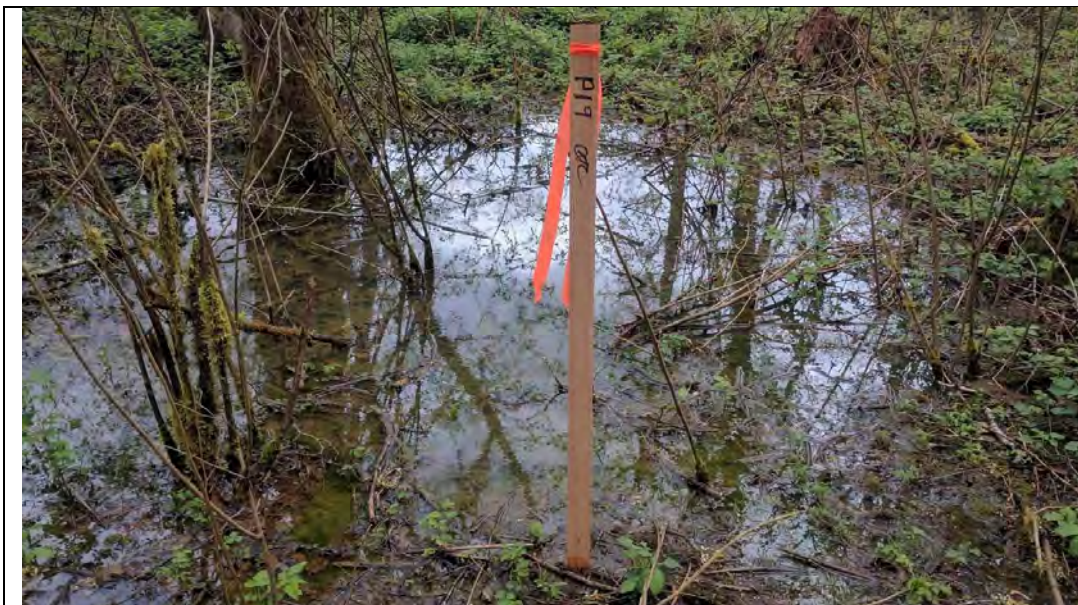
Photo 3. Wetland "B", a small depressional wetland in a forested area adjacent to Stream 2 in a forested area near where Stream 2 enters the subject property on the East border. ETC Photo 4/28/2017

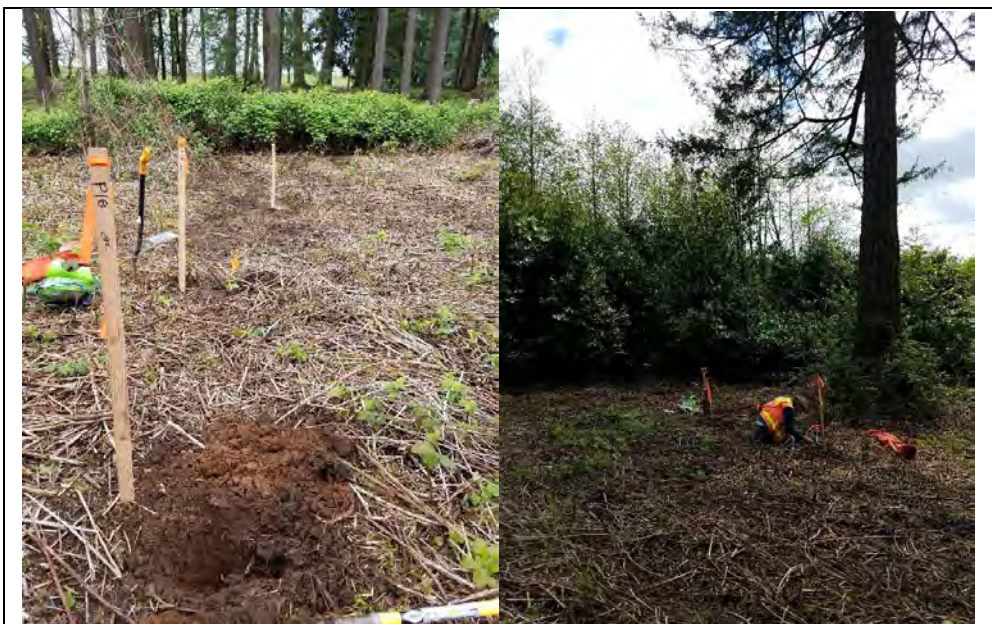
Photo 4, (left) and 5 (right). Wetland "C". Photo 4 looks down toward the stream, and 5 looks up from the stream. P18 had dry non-hydric soils, and saturated hydric soils were found at P17 which is slightly lower and closer to the stream.

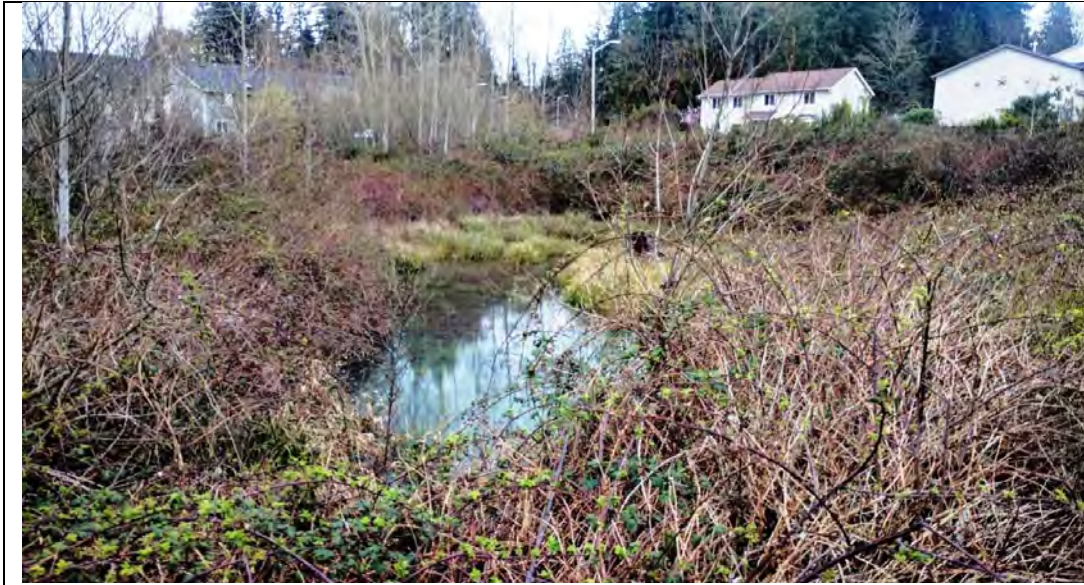
Photo 6. The wetland creation area in Track "E", as seen from Olson Road. ETC Photo 3/30/2017.

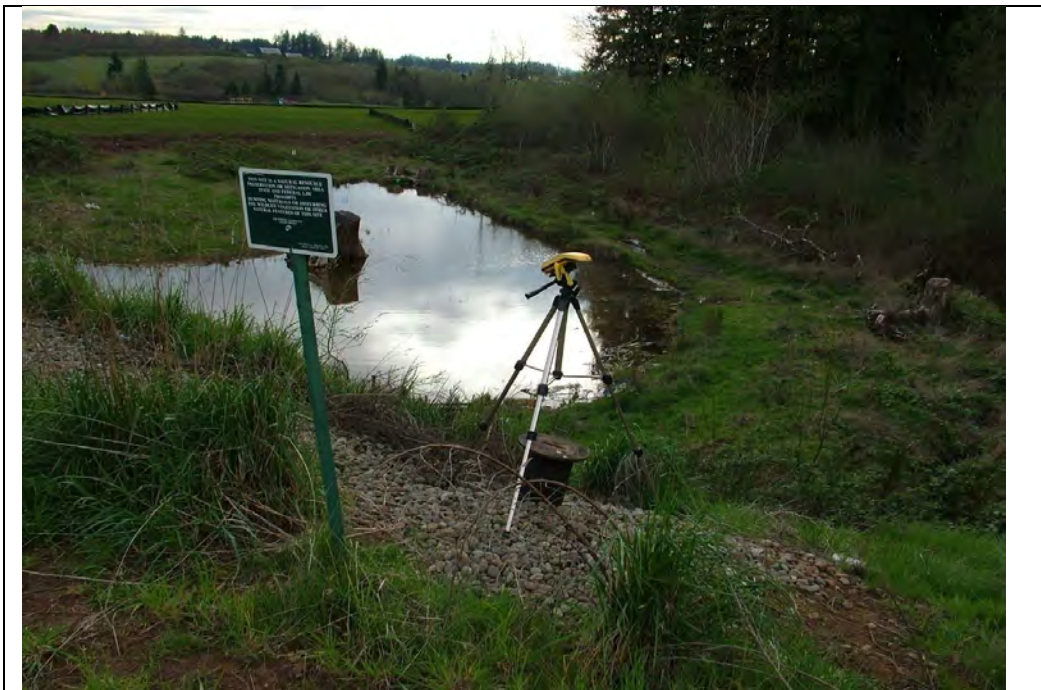
Photo 7 Track "E" mitigation area in April 2007. Olson Road had not been constructed, it would be later be built along the far side of the pond. ETC Photo 4/4/2007.

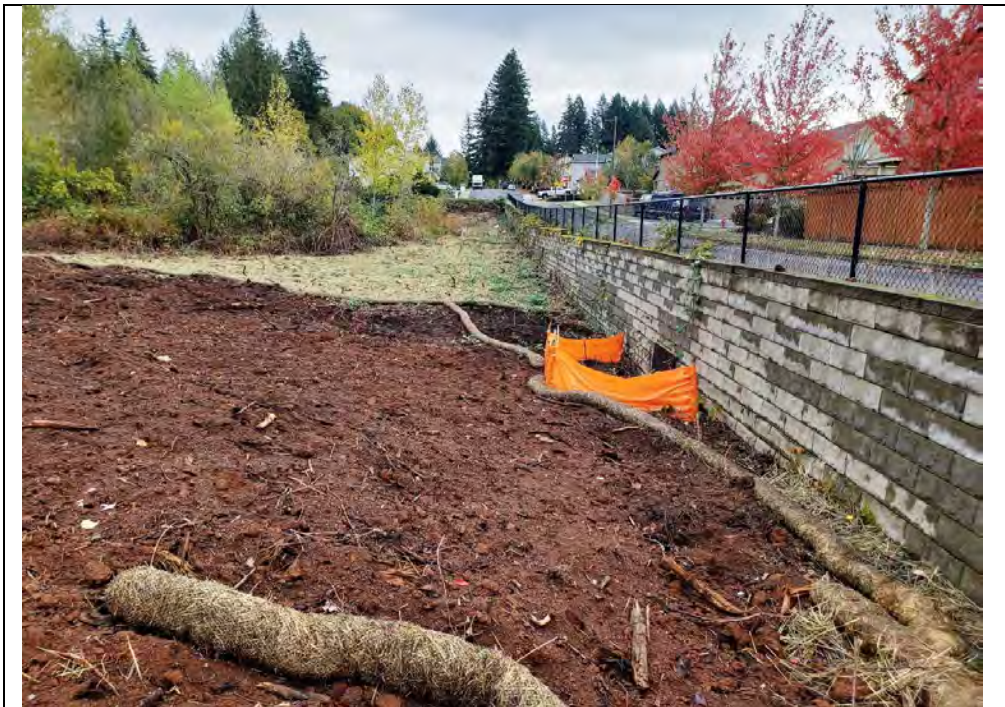
Photo 8 Track "E" after Blackberry clearing along Olson Road in preparation for the road widening. Photo looks East toward Jewelberry Road. ETC Photo 10/30/2018.

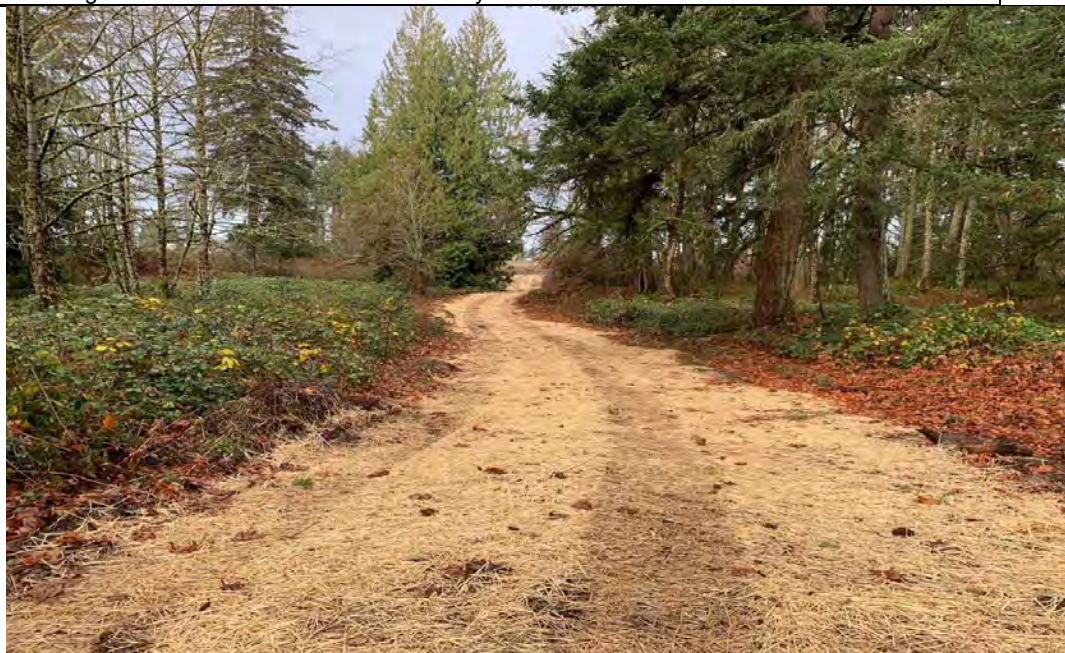
Photo 9 - Access road decommissioned January 2018, and erosion control measures complete.

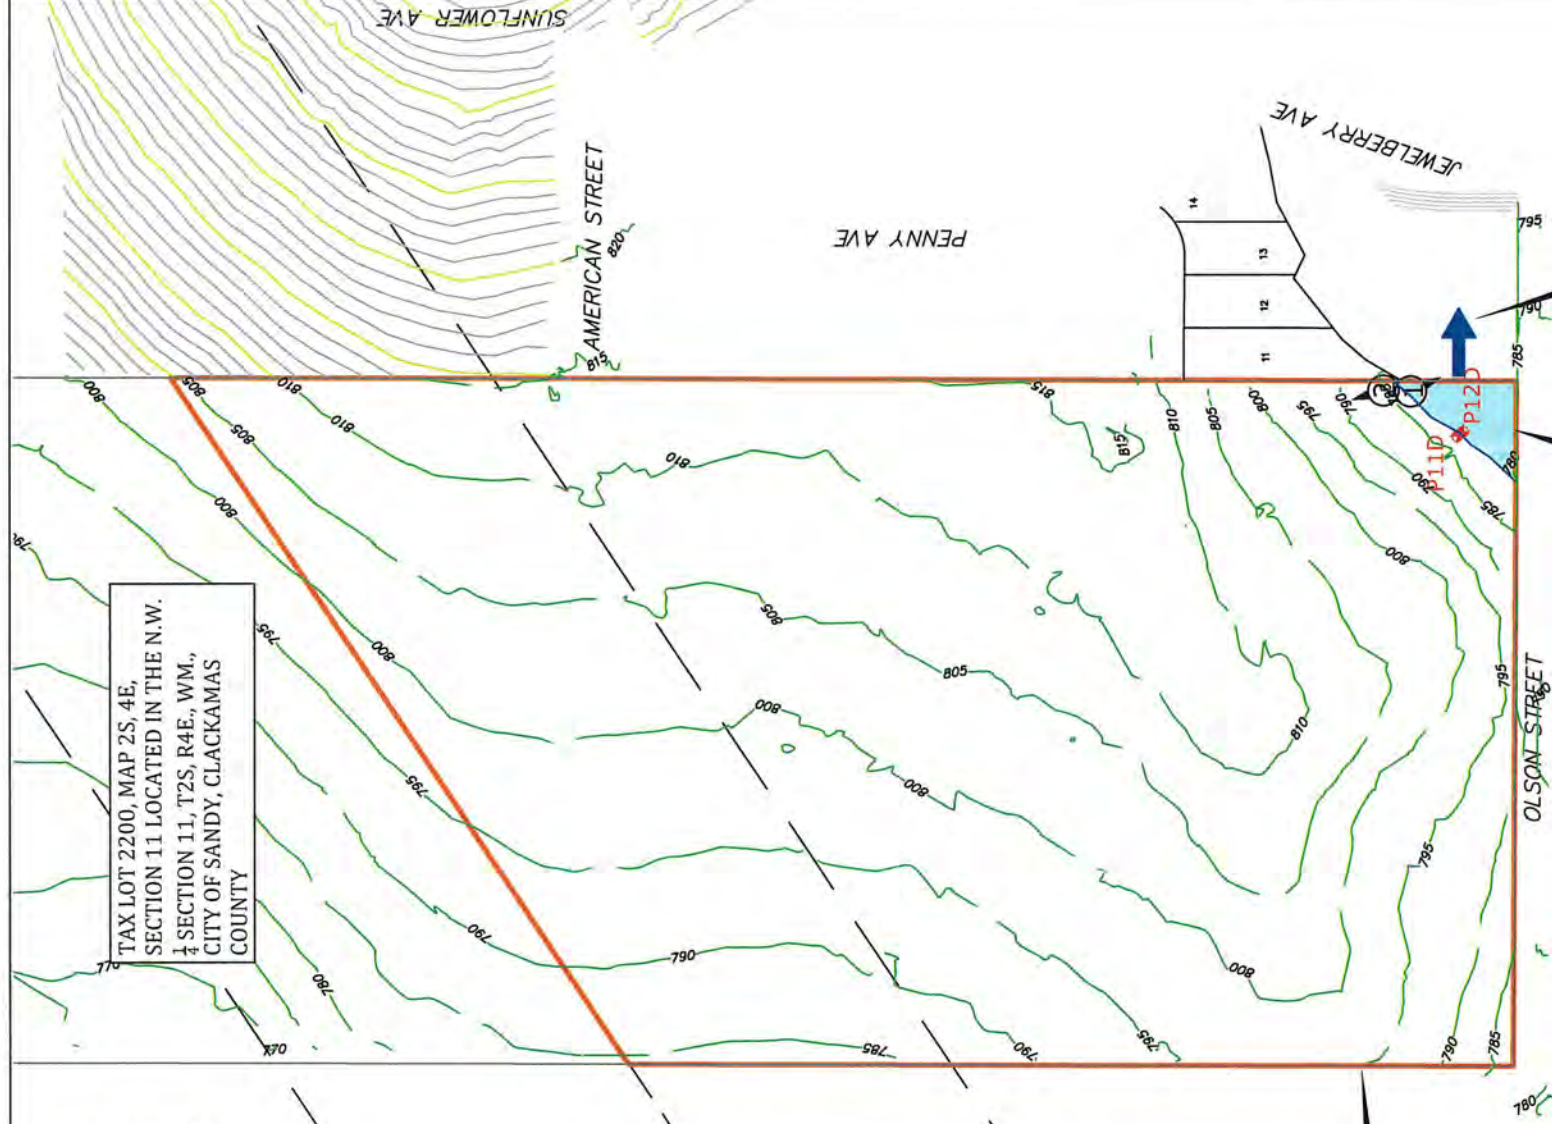
WETLAND "D" 5,516 SQFT

WETLAND D IS A FORESTED WETLAND AREA CONTIGUOUS WITH A WETLAND DESCRIBED BY WD# 2000-0612. THE COWARDIN CLASSIFICATION OF THE WETLAND AREA ON THE SUBJECT PROPERTY IS PALUSTRINE, FORESTED, DECIDUOUS, ARTIFICIALLY FLOODED, OR PFO1B TO PFO1F.

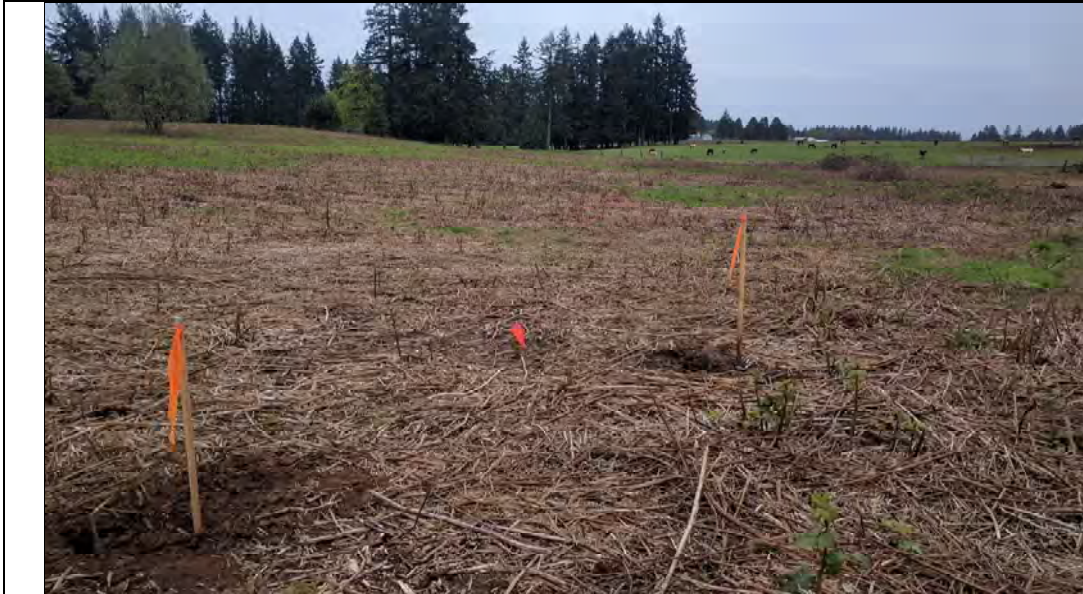
Photo 1. Wetland "A" data plots P1 Upland (left), and P2 Wetland (right). The blackberries had been recently mowed to give surveyors access. The wetland determination was based on soils and hydrology. ETC Photo 4/28/2017.

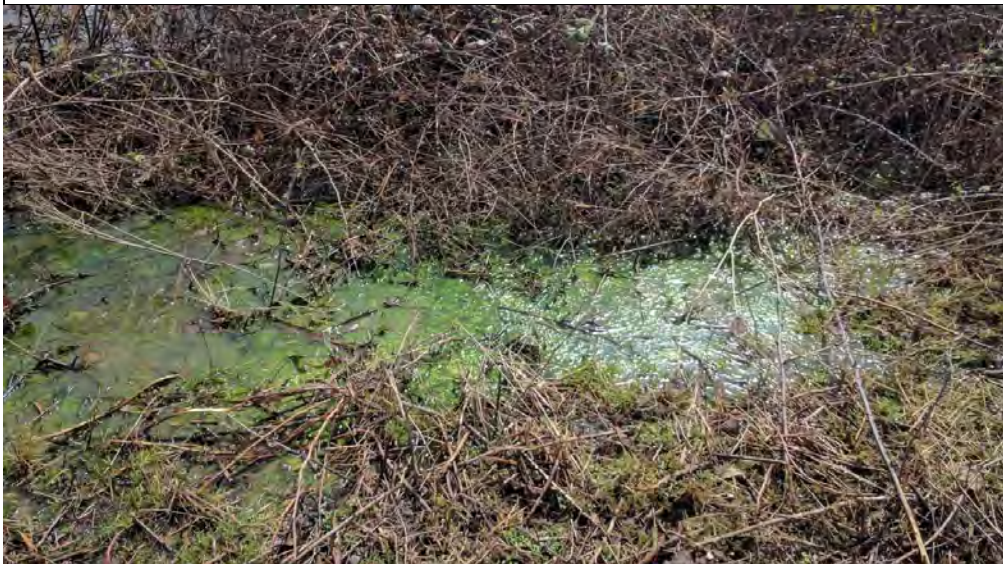
Photo 2. Lower portion of Wetland "A" showing excessive algal growth due to fertilizers washed down from farms and nurseries upslope. ETC Photo 4/28/2017

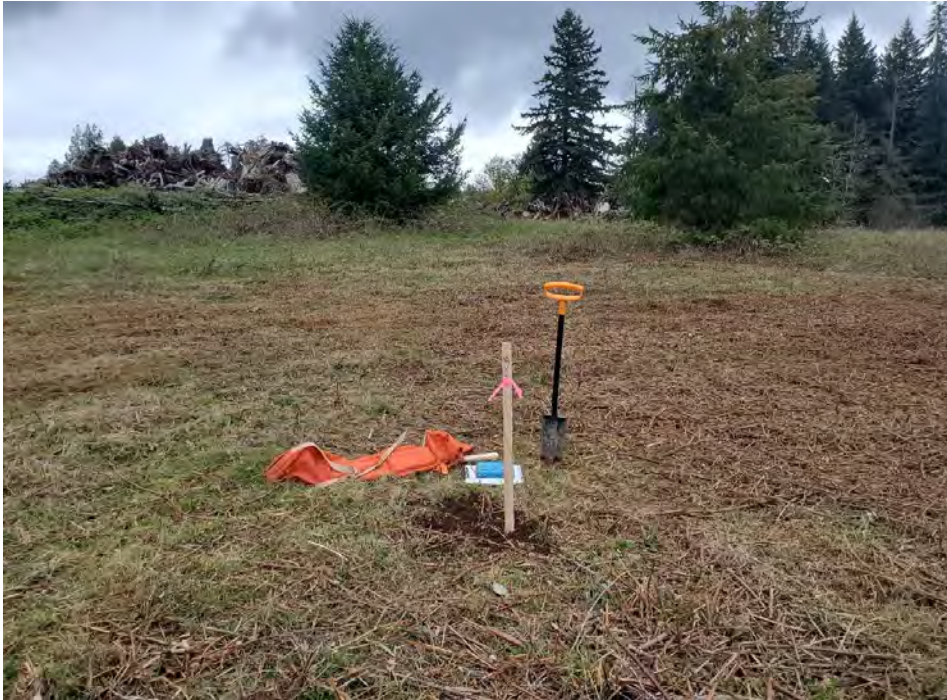
Photo 3. New P5B upland plot, photo looking into upland to the southeast. ETC Photo 4/15/2020

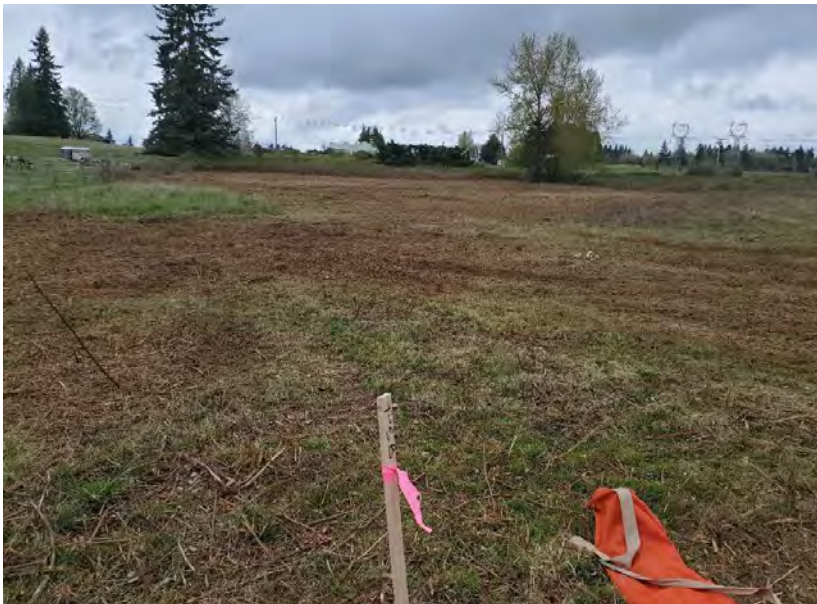
Photo 4: Looking the south at P5B into Wetland "A". ETC Photo 4/15/2020
