Geotechnical Report

3955 Stefenee Court
Sandy, OR

Alex Shamrai/ Pro Build

24 March 2021

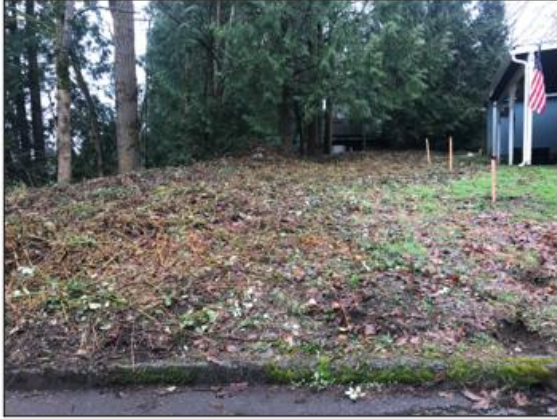
RSS traversed the slopes along the vicinity of the proposed residence envelope and surrounding area looking for any indications of slope instability. At the time of the site visit, RSS found a nearly level bench along the southern boundary line of the parcel. The area is cleared from vegetation with thin patches of grass. It smoothly descends northwest towards Stefenee Court with slopes of 5-10 percent. The bench extends about 20 feet towards the slope break to its northeast. Next to the nearly level bench is the steeper region of the parcel with slopes within 30-45 percent. The slope is enveloped with tall deciduous and coniferous trees, bush with low grass and descends north-northeast, towards the property line. RSS understands that the proposed new dwelling is located within the nearly level bench and partly within the steeper slopes.

Site Photo: NW-SE, proposed development area

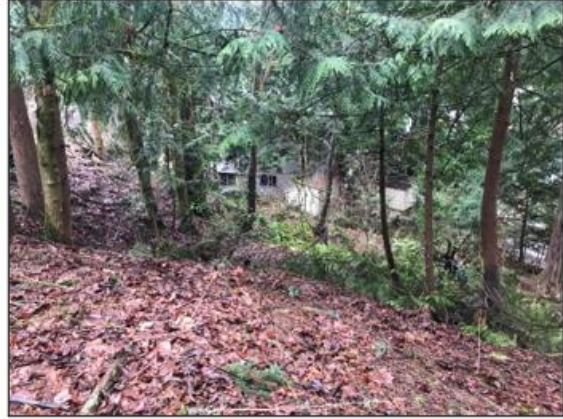
Site Photo: SW-NE, proposed development area
