STORMWATER REPORT

BARLOW TRAIL VETERINARIAN CLINIC

38952 PIONEER BLVD SANDY, OR 97055

JULY 2022

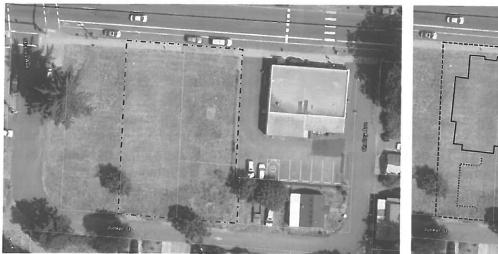
Figure 1: Subject site conditions, aerial image form Clackamas County (2018).

The subject site is currently occupied by a short-cropped lawn. There are no structures on the property. There are no major trees on the property. The site historically contained a single-family dwelling and a detached garage; a small concrete pad is located within the footprint of that dwelling. The grass texture and density are slightly different within the footprint of the now demolished structure. The northern edge of the property abuts the sidewalk along Pioneer Blvd and is at the same grade as the concrete. The southern end of the structure abuts the asphalt edge of Junker Street; a very slight southward slope in present along the southern margin of the site. The eastern property line contain fencing separating the parcel from the adjacent structures. The western property margin is un-marked, with the grass lawn extending across the subject site and the parcel adjacent to the west.

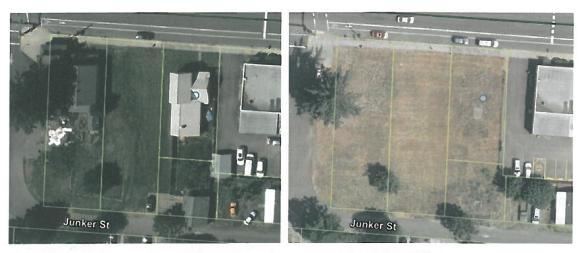
Figure 2: Subject stie conditions. LEFT: 2016. RIGHT: 2018.

Conditions within the subject parcel appear to remain consistent from 1952 through at least 2016. Between 2016 and 2018, both structures within the subject stie were removed. Additionally, the structures at the southeast corner of Pioneer Blvd and Strauss Ave were also removed. The site appears to have remained vacant and undeveloped since at least 2018. Small remnants from the structures once standing on the subject site, including a small concrete pad, remain on the parcel.

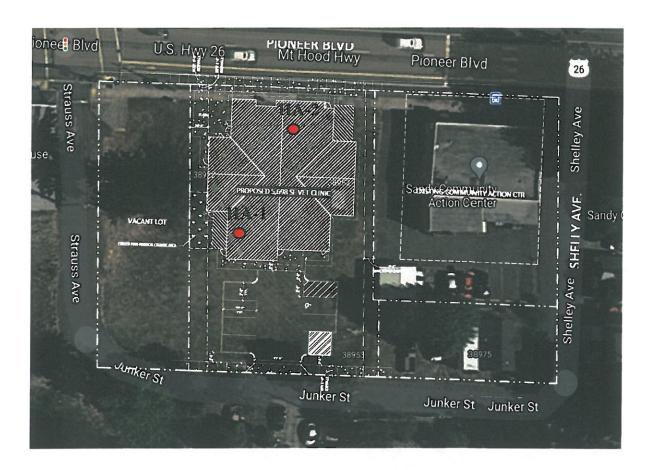
Figure 3: Testing Locations

A total of four (4) borings were excavated with a hand auger. The locations of the borings are shown on figure 3 in the appendix. An EIT, engineer-in-training, observed the excavation of the borings and logged the subsurface materials. A registered professional engineer reviewed the results. Boring logs detailing materials encountered is in the appendix. The logs were created using the Unified Soil Classification and Visual Manual Procedure (ASTM-D 2488). The soils found on site were highly plastic silty clay that stayed relatively the same up to the boring depths of 2 feet and 4 feet. Moisture contents ranged from 28.6% to 32.0%. Groundwater was not encountered.

RSS performed one infiltration tests per the Clackamas Storm water manual in a future storm water disposal area in the future parking area. The tests results and location are in the appendix. RSS had in HA#1a rate of 1.2in/hr and in HA#2 a rate of 1.1in/hr.

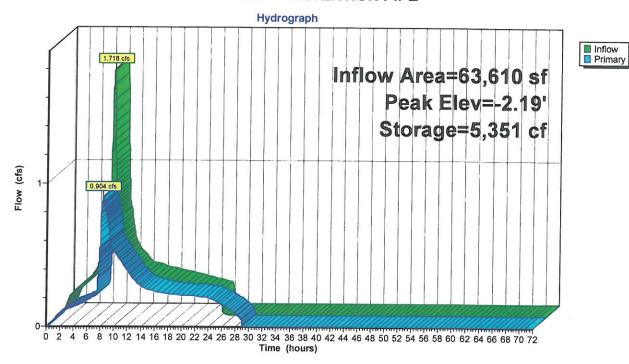
Pond 7: DETENTION PIPE
