**Jason Smith**

**Environmental Services**

September 30, 2020

SUBJ: Stream and Wetland Presence Determination - 19618 Bornstedt Road, Sandy OR

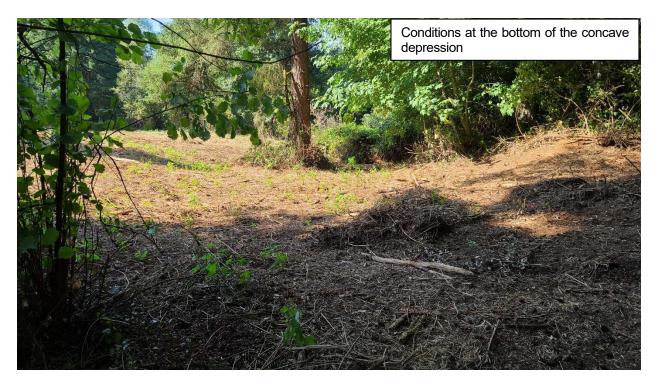
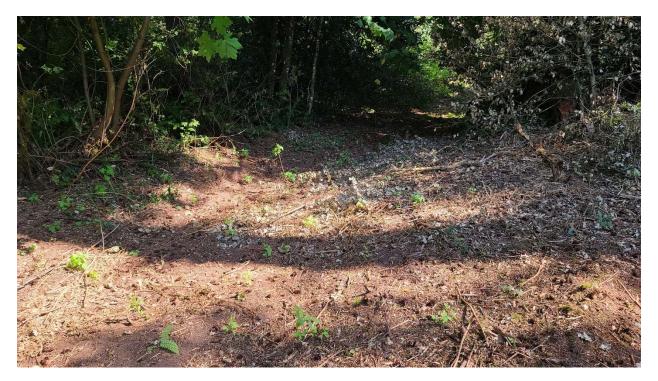
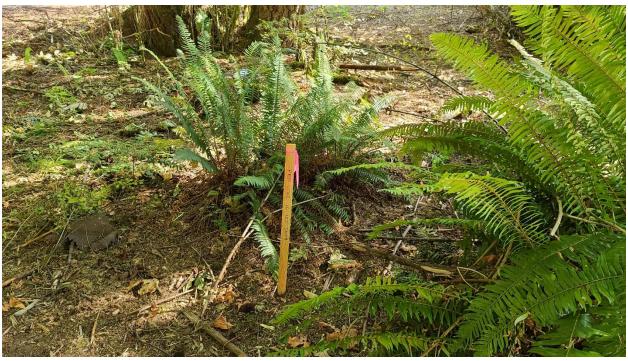
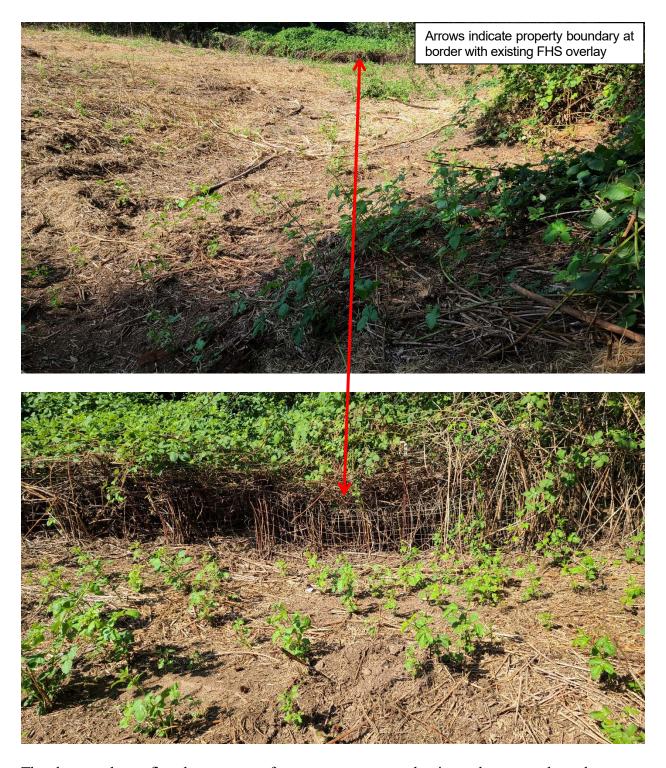
The photographs confirm that no stream features are present on the site, and a stream channel was assumed to be the wetland.

- Clear, natural line impressed on the shore, including scour, shelving and exposed roots
  - o No channel present.

- O No change in vegetation. No riparian or wetland vegetation observed. Fir trees dominate overstory vegetation.
- Textural change of depositional sediment or changes in the character of the soil (e.g. from sand, sand and cobble, cobble and gravel to upland soils). Sediments may appear stratified.
   This indicator may require careful evaluation on floodplains where certain farming practices regularly disturb the soil profile.

- No disturbed soils present. No depositional or other stream bed characteristics observed.
- Elevation below which no fine debris (needles, leaves, cones, seeds, soil organic matter) occurs

- o Not present.
- Presence of water-borne litter and debris, wrack accumulation, water-stained leaves, water lines on tree trunks, flattened vegetation. Certain farming practices can obscure these indicators.

- o No water-borne features present.

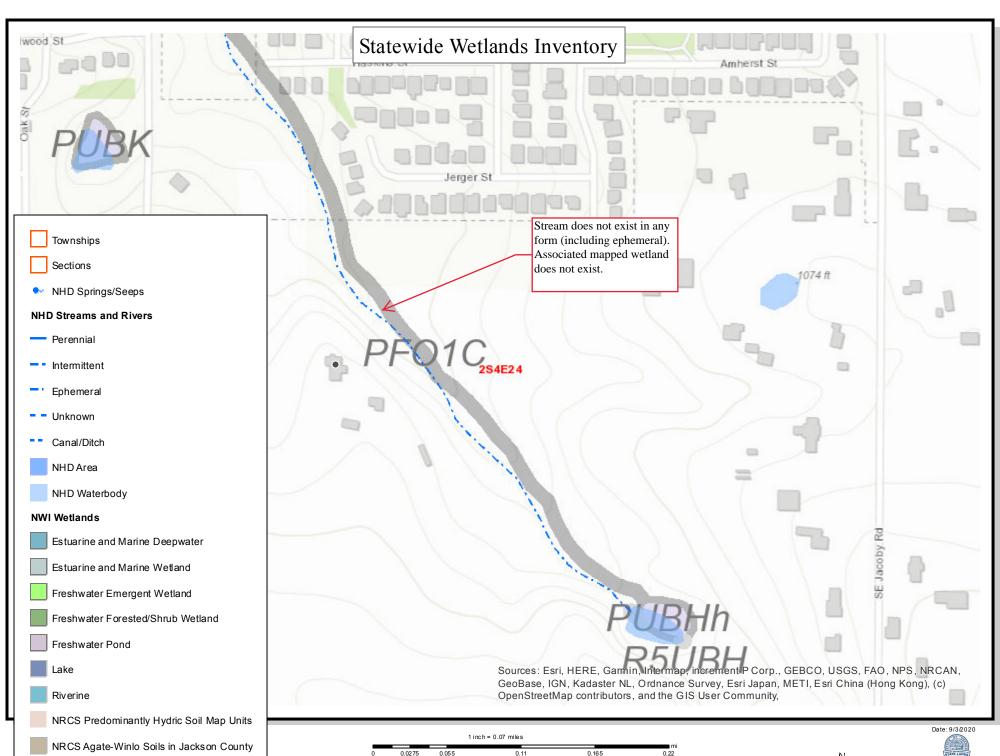
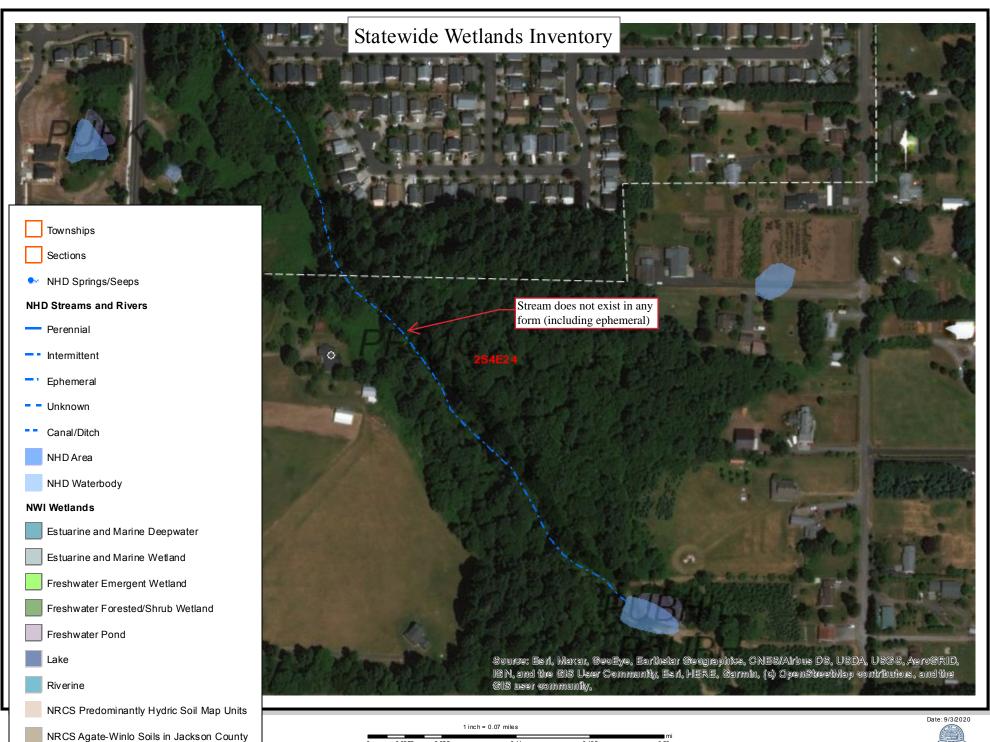
**ENCL: SWI Maps**

The project area in question is the small "valley" that runs through the center of the parcel. The area is mapped in the National Wetland Inventory with a 1.00 acre Freshwater Forested/Shrub Wetland habitat is classified as Palustrine (P), Forested (FO), Broad-Leaved Deciduous (1), Seasonally-Flooded (C) (PFO1C). The wetland is demarcated as a stream.

The NWI-mapped wetland is reflected in the Oregon Statewide Wetlands Inventory (SWI) database. The wetlands in this area were photo interpreted using 1:58,000 scale, color infrared imagery from 1981. The stream classification mapped in the National Hydrography Dataset is Intermittent.

The SWI database is a synthesis of NWI, National Hydrography Data Set and NRCS Soils data and generally meets Corps '87 manual requirements for preliminary data gathering and synthesis. Although the SWI shows the NWI-mapped wetland and associated intermittent stream, the area is not mapped with hydric soils (confirmed with the NRCS Soils Mapper database).
