4/21/2022

Jim Raze  
Raze Custom Homes, Inc.  
4020 NE 216th Ave  
Fairview, OR 97024

**RE: Level II, Basic Tree Risk Assessment for Three (3) Trees in Jewelberry Ridge Subdivision**

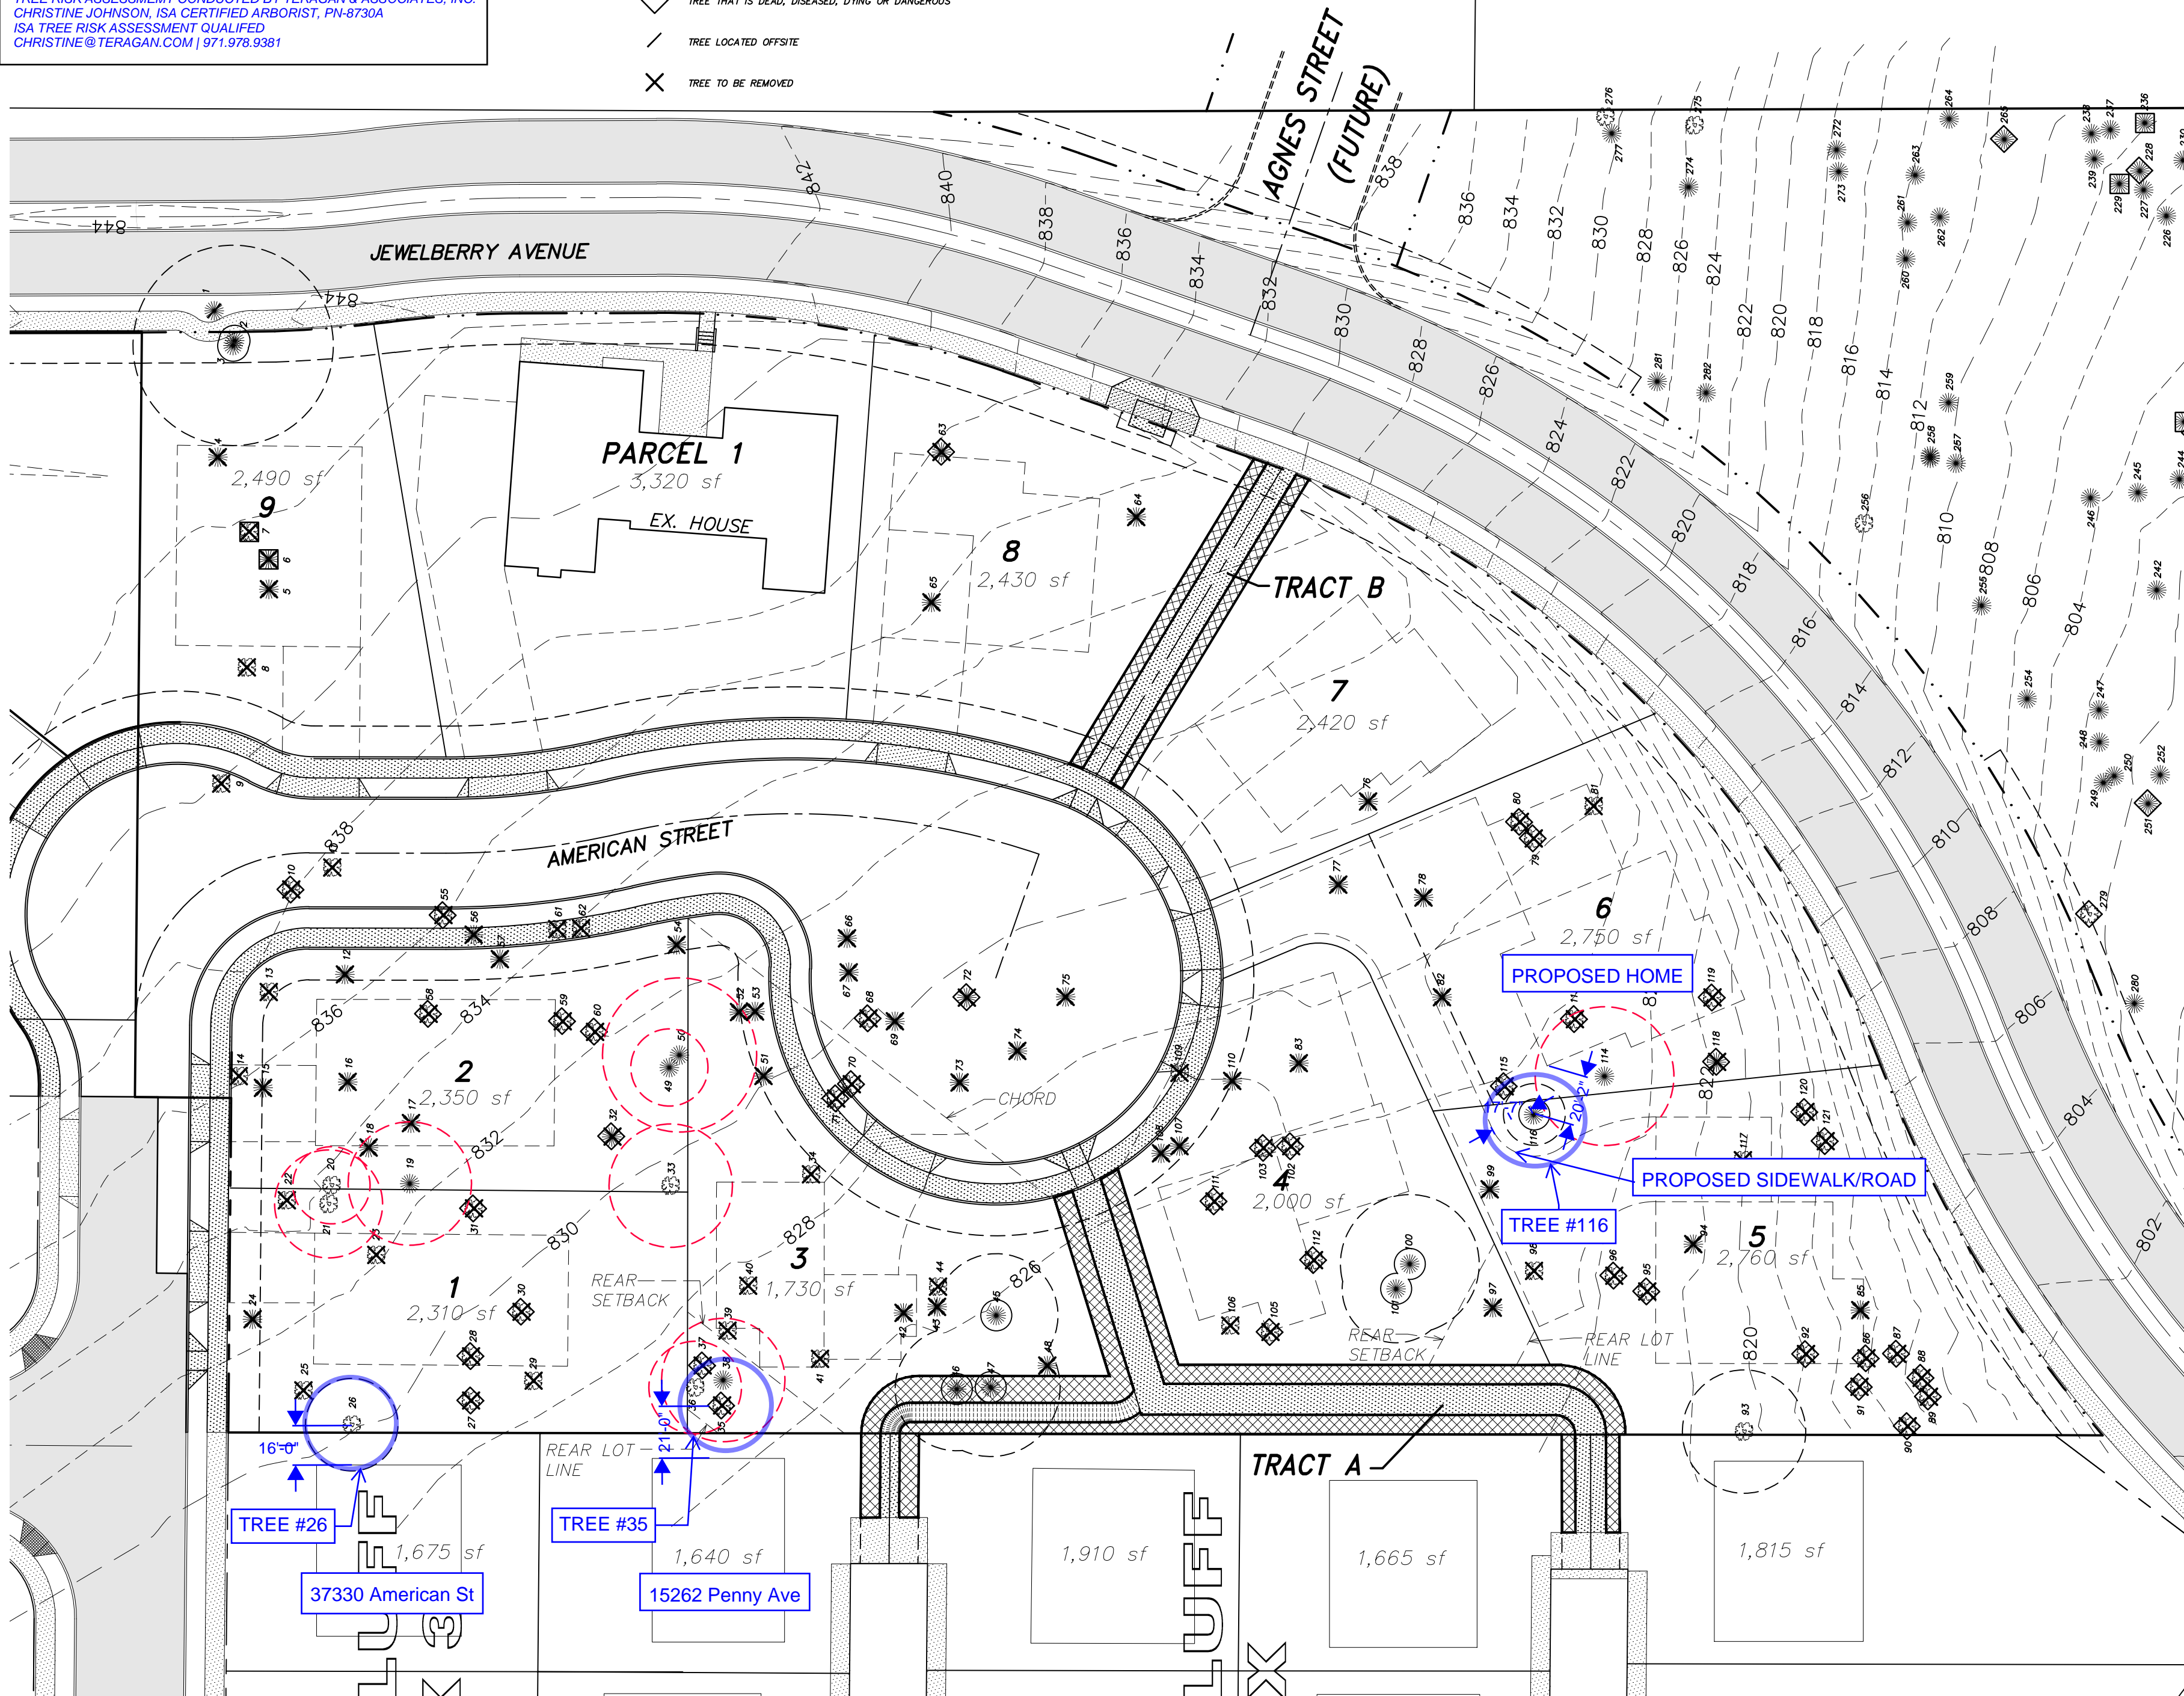
**Jewelberry Ridge**  
**Tree Preservation Plan**  
 4-J Land Co., LLC

SITE PLAN PROVIDED BY JIM RAZE, RAZE CUSTOM HOMES, INC.  
 TREE RISK ASSESSMENT CONDUCTED BY TERAGAN & ASSOCIATES, INC.  
 CHRISTINE JOHNSON, ISA CERTIFIED ARBORIST, PN-8730A  
 ISA TREE RISK ASSESSMENT QUALIFIED  
 CHRISTINE@TERAGAN.COM | 971.978.9381
